MA2019-2

**MARINE ACCIDENT
INVESTIGATION REPORT**

Accident type	Fatality of a crew member
Date and time	Around 17:26 on September 18, 2018 (local time, UTC+9 hours)
Location	Mitsubishi Naoshima wharf, Naoshima-cho, Kagawa Prefecture On a true bearing of approximately 236° and at a distance of 460 meters from Sanuki Terashima light house (approximately 34° 28.7' N, 133° 58.1' E)
Summary of the Accident	<p>At around 17:26 on September 18, 2018, while the cargo vessel ERIK was moored at Mitsubishi Naoshima wharf, with the master and fourteen crew members on board, four crew members were performing the cleaning work of the upper hatch coaming of the cargo holds after unloading cargo, and an able seaman fell from the upper deck to the bottom floor of the cargo hold.</p> <p>The able seaman was pronounced dead after being conveyed from the cargo.</p>
Process and Progress of the Investigation	<p>(1) Set up of the Investigation On September 19, 2018, the Japan Transport Safety Board appointed an investigator-in-charge and four other marine accident investigators to investigate this accident.</p> <p>(2) Collection of Evidence September 19 and 20: On-site investigations and interviews Octob

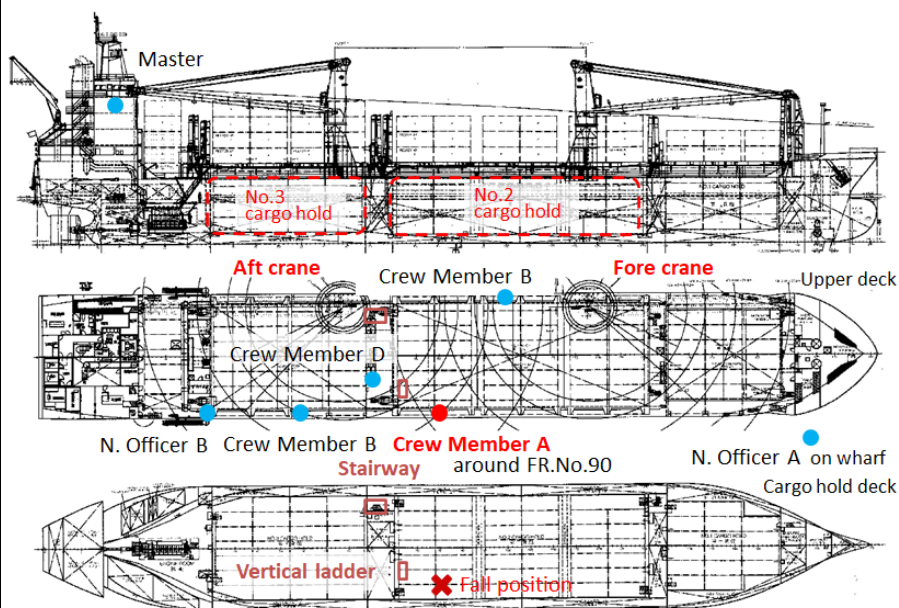
Figure 2 Position of crew members in general arrangement

The four crew members (Crew Member A, the boatswain (hereinafter referred to as “Crew Member B”), the other able seaman (hereinafter referred to as “Crew Member C”) and the ordinary seaman (hereinafter referred to as “Crew Member D”)) started “the cleaning work of the upper hatch coaming of the cargo holds on the upper deck” (hereinafter referred to as “the cleaning work”) at around 17:23 in the arrangement as shown in Figure 2.

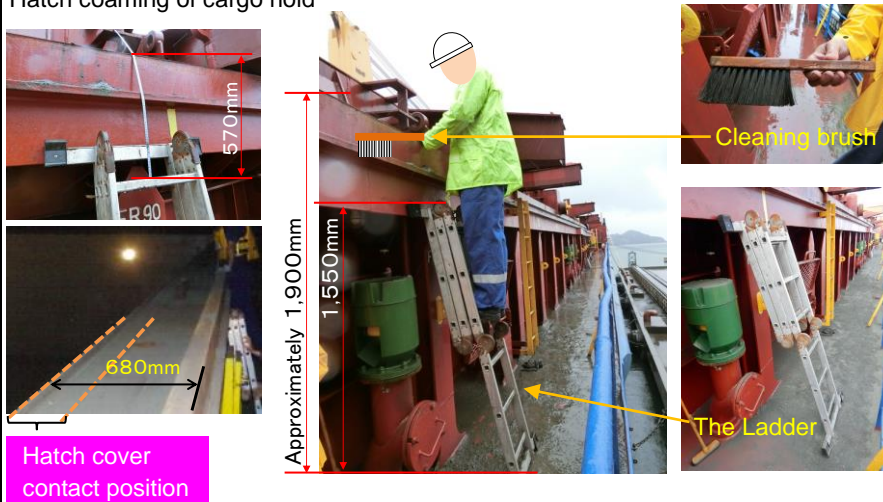
Photo 2 Environment of cleaning work and cleaning tools

The cleaning work was an item of routine works taking about 30 minutes, with the aim of maintaining the watertightness of the cargo hold. To prevent water invasion between the hatch cover of the cargo hold and the hatch coaming, the crew members were sweeping cargo mineral dust using the potable ladders (hereinafter referred to as “the Ladder”) and cleaning brushes after the cargo

unloading operation. At the time of the accident, the cleaning work was being conducted in the same way as usual. (See Photo 2)

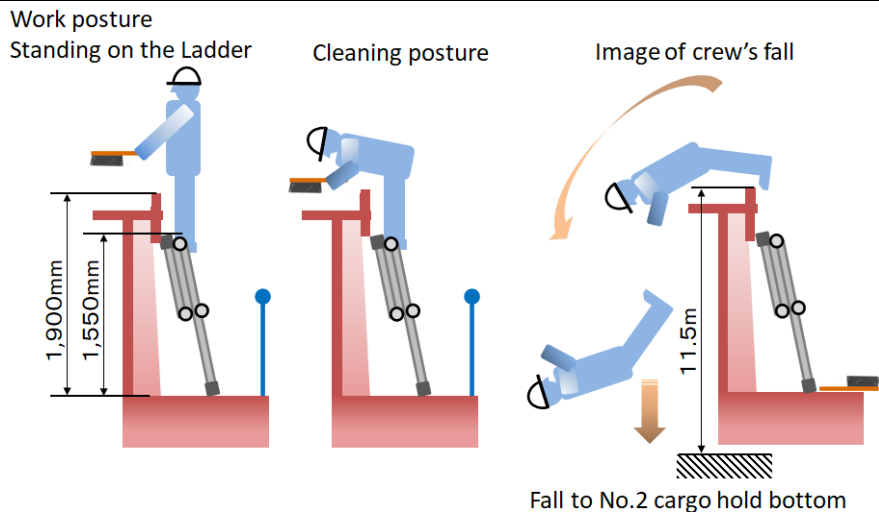
Figure 3 Work posture on the Ladder and Fall situation

When conducting the cleaning work, Crew Member D, who was at the aft starboard side of the No.2 cargo hold, saw that Crew Member A's upper body from his thigh was higher than the top of the hatch coaming on the upper deck starboard side of the No.2 cargo hold, and then he was conducting the cleaning work utilizing the cleaning brush.

Crew Member D looked at Crew Member A, who came to be in an unstable posture and fell forward, and then twisted his body and tried to clutch at the upper hatch coaming of the No.2 cargo hold with his left hand. However, he fell head-first with his back facing downward to the bottom of the No.2 cargo hold at around 17:26.

<p>Probable Causes</p>	<p>It is considered probable that the accident occurred at around 17:26 on September 18 when Crew Member A fell forward and fell from the upper deck to the bottom of the cargo hold because Crew Member A was working while being in an unstable posture on the Ladder when the Vessel was conducting the cleaning work, while the Vessel was moored at Mitsubishi Naoshima wharf.</p> <p>It is considered probable that the Vessel conducted the cleaning work by the methods that differed from the Ladder guideline of the CSWP, and that because there was nothing to support his upper body on the Ladder, Crew Member A was performing the cleaning work while being in an unstable posture on the Ladder.</p> <p>It is somewhat likely that Company A was insufficient in monitoring that the crew members clearly understood the Ladder guideline of the CSWP and then applied and performed the Ladder guideline in the cleaning work, because the Vessel carried out the working methods being different from the Ladder guideline in everyday work.</p>

- (1) Company A should have the master supervise the crew members to certainly take preventive measures of fall accident in the cleaning work.
- (2) The master and Designated Person Ashore of Company A should implement the risk assessment of the cleaning work on an individual work basis, and Company A should take the necessary measures for all the vessel operated by Company A to prevent fall accident by using a safety harness, etc. according to this assessment.

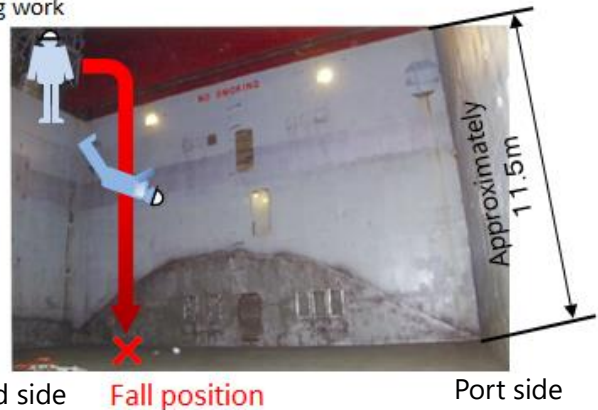
Figure 4 No.2 cargo hold and fall location of Crew Member A

At the same time, Crew Member B heard the sound of something falling when he was walking toward the stern in the passage of the No.2 cargo hold port side on the upper deck. And then Crew Member B looked out into the interior of the No.2 cargo hold and noticed Crew Member A lying on his back on the cargo hold floor. Crew Member B descended the stairs to the floor to confirm the condition of Crew Member A, where it appeared that Crew Member A was no longer breathing.

Conducting the cleaning work at around FR. No. 90

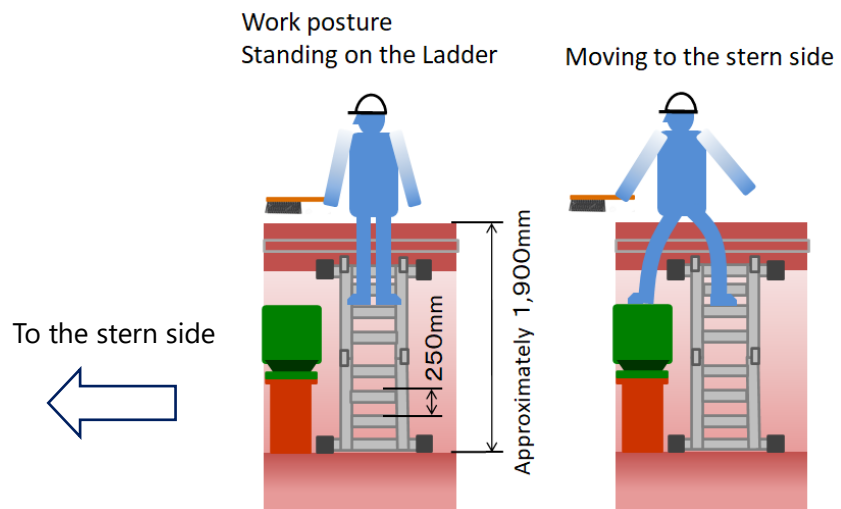
Figure 5 Image of Moving the Ladder

N. Officer A and N. Officer B knew that this method of moving the Ladders was being carried out in everyday work. Figure 4 shows the image of moving the Ladder.

- (3) Company A should have all the vessels operated by Company A observe the Ladder guideline of the CSWP. On the other hand, Company A should take other safety measures all the vessels operated by Company A including changing the use of the Ladder if it seems that it is difficult to confirm to the Ladder guideline in the cleaning work.

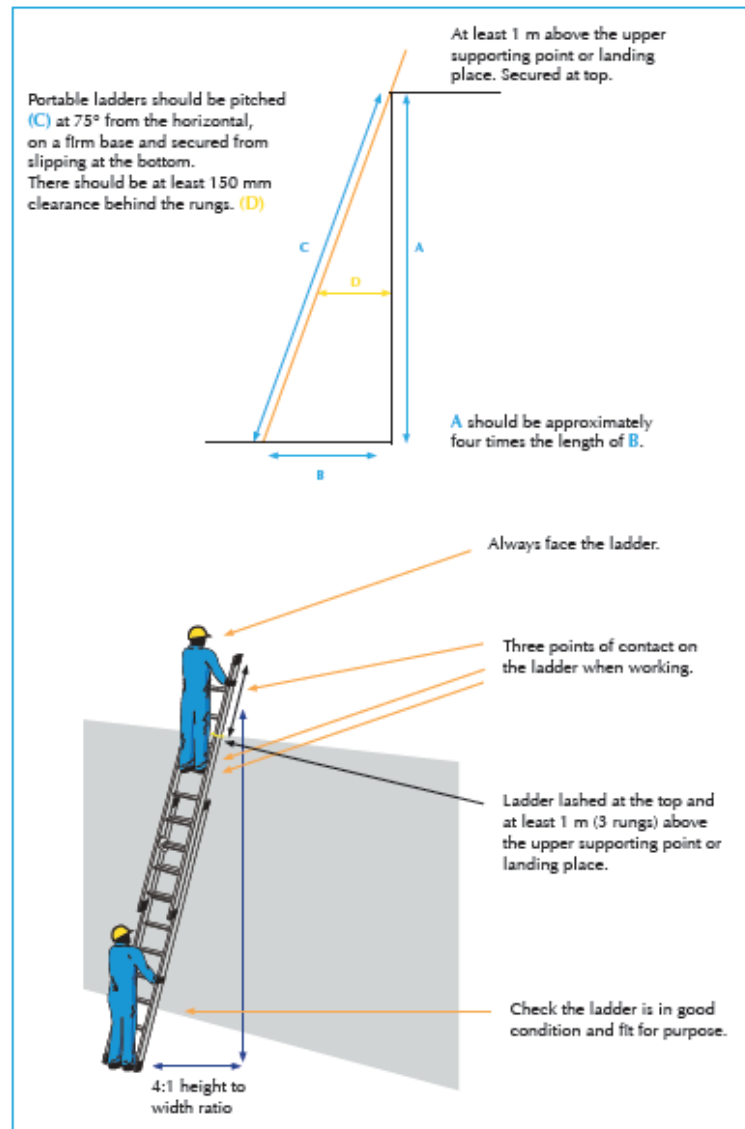
Figure 6 The Ladder guideline in the CSWP
Published by the Maritime & Coastguard Agency, UK

- a. Portable ladder is lashed at the top and the upper supporting point.
- b. Portable ladder should extend to at least 1 m (3 rungs) above the upper supporting point or landing place.
- c. Portable ladder should be pitched at 75° from the horizontal.

- d. There should be three points of contact on a portable ladder when working
- e. The body should always face the portable ladder.
- f. Personnel must use a safety harness with a lifeline secured above the work position, where practicable.

According to an initial report received from Company A, which had been drawn up and sent by a survey company, the method of using the Ladder was different from the Ladder guideline and the reason why Crew Member A fell was unknown because it was not clear how Crew Member A had used the Ladder at the time of the accident; however, the Ladder was in an unstable position so that Crew Member A was in an unbalanced position and fell off from the unbalanced Ladder and fell to the bottom of the cargo hold; and furthermore, the Vessel complied with the ISM system and carried out education and training in accordance with the guidelines, and the Safety Meeting was carried out every month.
