MA2019-12

**MARINE ACCIDENT  
INVESTIGATION REPORT**

# MARINE ACCIDENT INVESTIGATION REPORT

<b>Accident type</b>	Collision with seawall
<b>Date and time</b>	Around 01:47 on October 1, 2018 (local time, UTC+9 hours)
<b>Location</b>	Kawasaki section, Keihin Port, Kanagawa Prefecture (seawall at JFE Steel in Ogishima) Around 355° true bearing, 550 m from Toden-Ogishima LNG Berth Light (approximately 35°28.5' N, 139°44.3' E)
<b>Summary of the Accident</b>	Under the situation where Typhoon No. 24 was approaching, while being anchored at an anchorage in Yokohama section, Keihin Port, a cargo ship, MARINA, with 12 crew members, including the master, dragged the anchor and drifted toward to the northeast, and collided with the seawall at Ogishima, Kawasaki section. MARINA suffered dents, etc. to her starboard stern. The seawall suffered collision damage, etc.
<b>Process and Progress of the Investigation</b>	(1) Set up of the Investigation The Japan Transport Safety Board appointed an investigator-in-charge and two other marine accident investigators to investigate this accident on October 1, 2018. (2) Collection of Evidence On-site investigation and interview on October 1 and 2, 2018; i

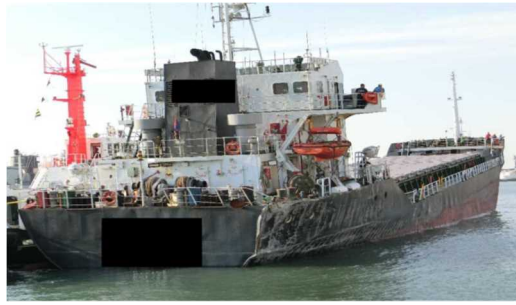
Photograph 2: Situation of damages to the vessel

<p>Injuries to Persons</p>	<p>None</p>
<p>Damage to Vessel (or Other Facilities)</p>	<p>Vessel: There were dents including broken holes and cracks at the starboard stern and bottom, breakage of the rudder, bending and partial breakage of the propeller blades, and loss of the starboard anchor and chain cable. (Total loss of the ship).</p> <p>Seawall: There were crushed sections and cracks on the concrete breast wall</p> <p>(See Photographs 2 and 3.)</p>
