**MARINE ACCIDENT
INVESTIGATION REPORT**

Vessel type and name: Cargo ship SM3

Vessel type and name: Oil tanker KOUTOKU MARU

Accident type: Collision

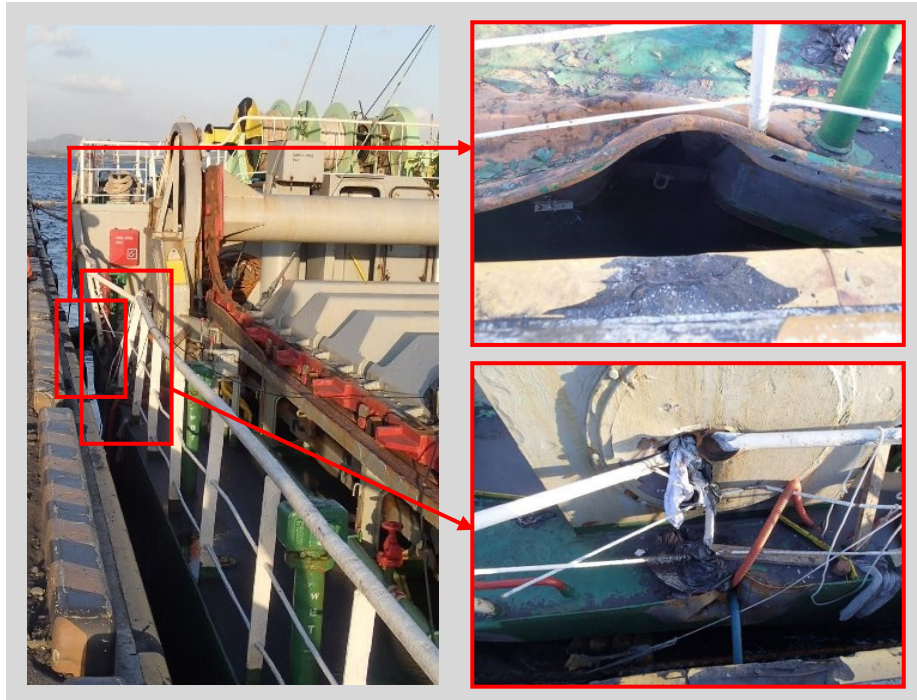
Figure 1 Damage to Vessel A

- (1) Vessel A suffered a dent with a breach in the shell plate of her fore port part, bent handrails, a dent on the shell plate of her port aft part, etc.

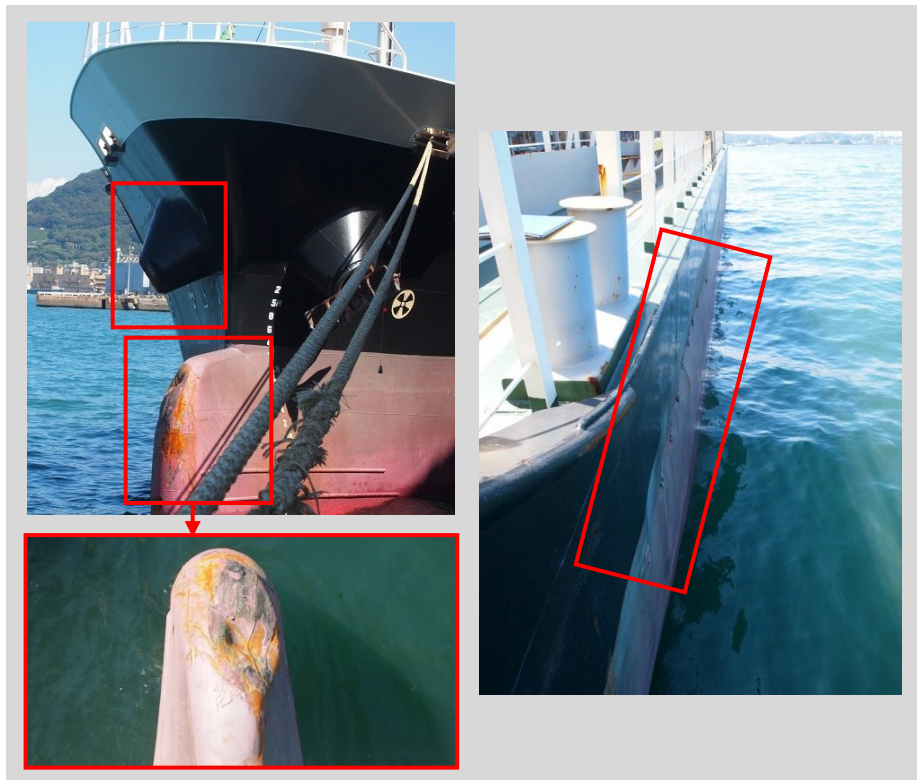
Figure 2 Damage to Vessel B

(2) Vessel B suffered a dent in her bulbous bow, a lost starboard anchor, a dent of a length of 8 m in the shell plate of her aft starboard part, etc.
(See Figure 2)

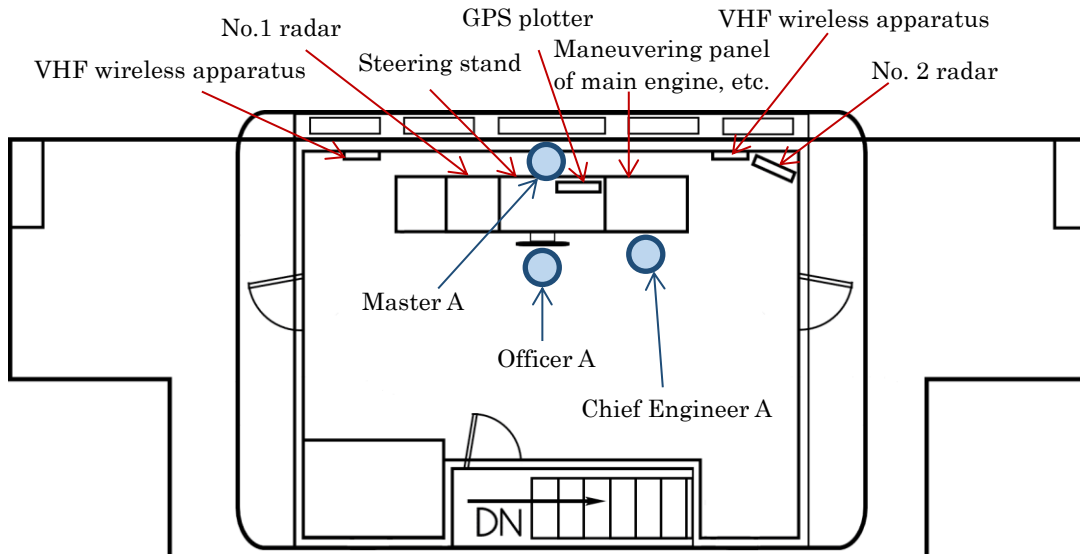
Figure 5 Navigation Bridge status of Vessel A

According to the statement of Master A, at the time of the accident, Master A had set the range of the No. 1 radar to 0.5 mile (M) and the No. 2 radar to 0.75 M, and set off-center indication of approximately 1.25 M to the fore side on both radars.

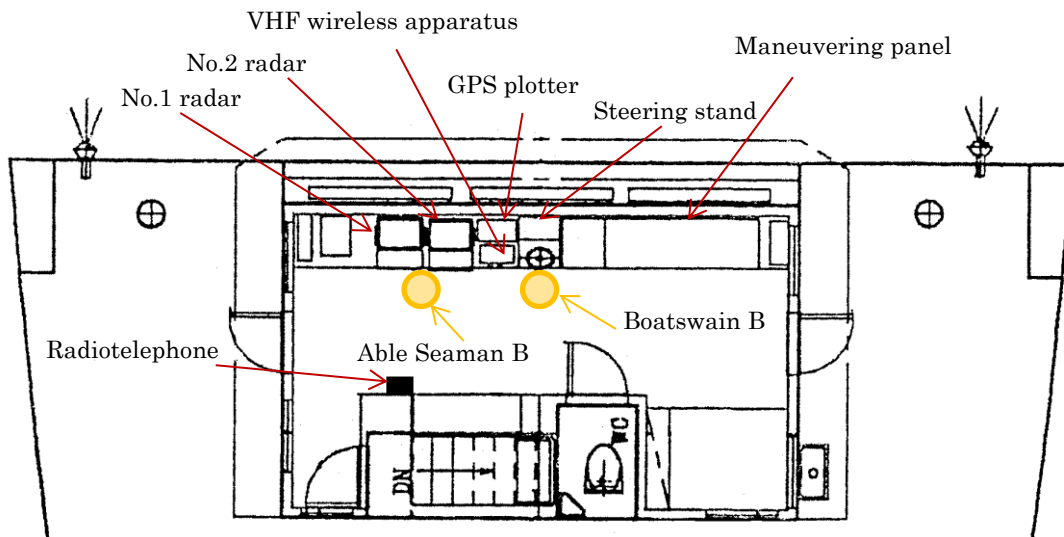
Figure 6 Navigation Bridge status of Vessel B

According to the statement of Boatswain B, at the time of the accident, Boatswain B had set the range of the No. 1 radar to 2 M and the No. 2 radar to 3 M.

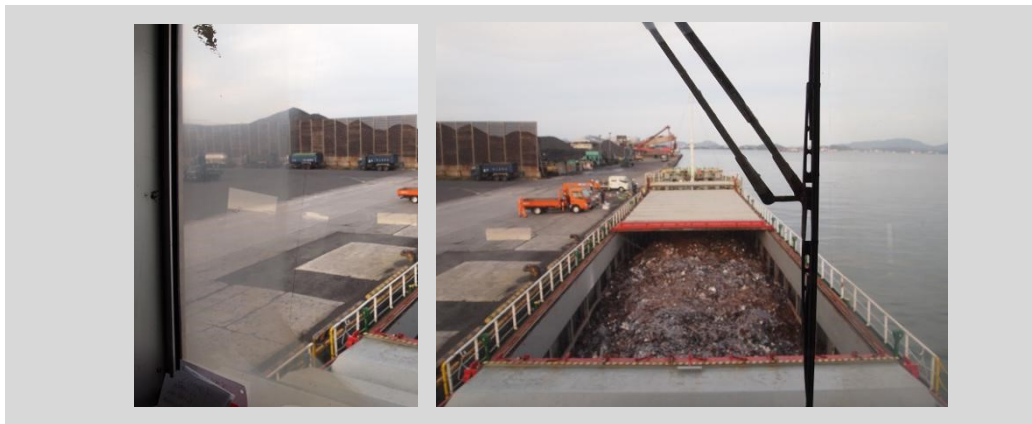
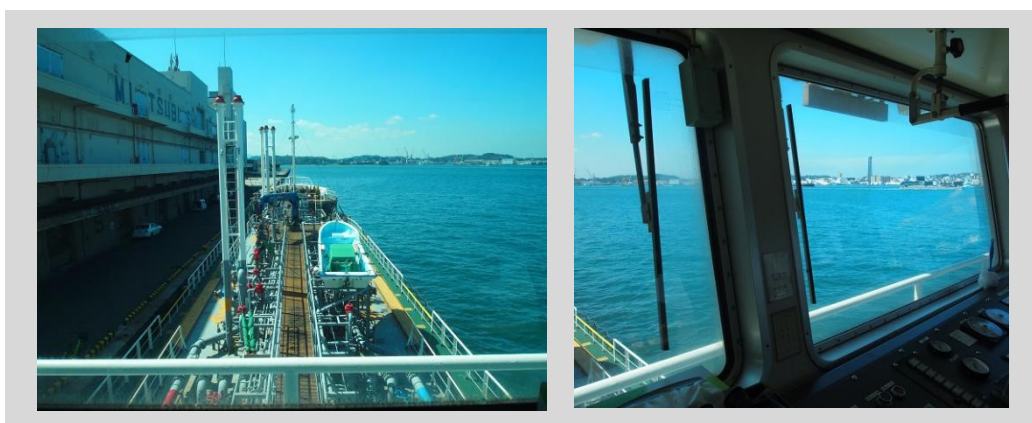
There were no structures that caused a blind spot on the bow of Vessel A or on the bow of Vessel B.

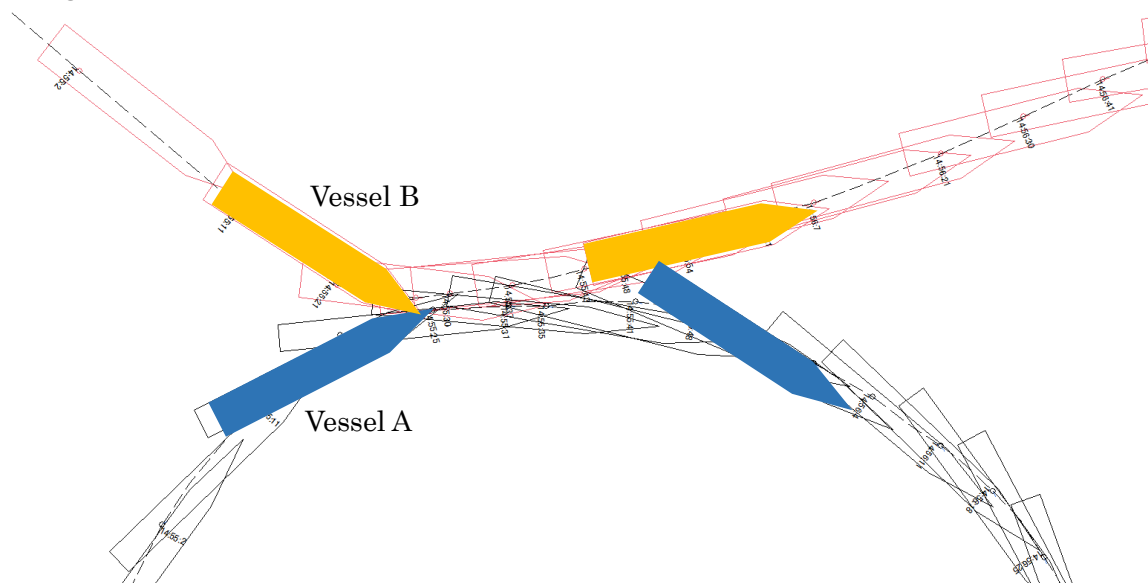
Figure 9 Schematic view of the collision

of Vessel B collided, and that after this, the port aft part of Vessel A and the starboard aft part of Vessel B collided.
