**MARINE ACCIDENT
INVESTIGATION REPORT**

Accident type	Collision
Date and time	Around 17:20 on March 11, 2019 (local time, UTC+9 hours)
Location	North Passage, Nagoya Port, Aichi Prefecture Around 095° true bearing, 760 m from Kinjo signal station, Nagoya-Ko Vessel Traffic Service Center (approximately 35°02.1'N, 136°51.3'E)
Summary of the Accident	As the oil tanker and chemical tanker EOS was proceeding southwest and the cargo ship AISHO No. 8 was proceeding north, both vessels collided in the Nagoya Port North Passage. EOS sustained a breach and other damage to her port bow plating shell and AISHO No. 8 sustained dents and other damage to her bow bulwark.
Process and Progress of the Investigation	The Japan Transport Safety Board (hereinafter referred to as "JTSB") appointed an investigator-in-charge and two other marine accident investigators to investigate this accident on March 12, 2019. March 12, and 13, 2019: On-site investigations and interviews March 14, 2019: Interviews June 3, 19, 26, 27, July 5, August 1 and 19, 2019: Collection of questionnaires Comments on the draft report were invited from parties relevant to the cause of accident. Comments on the draft report were i

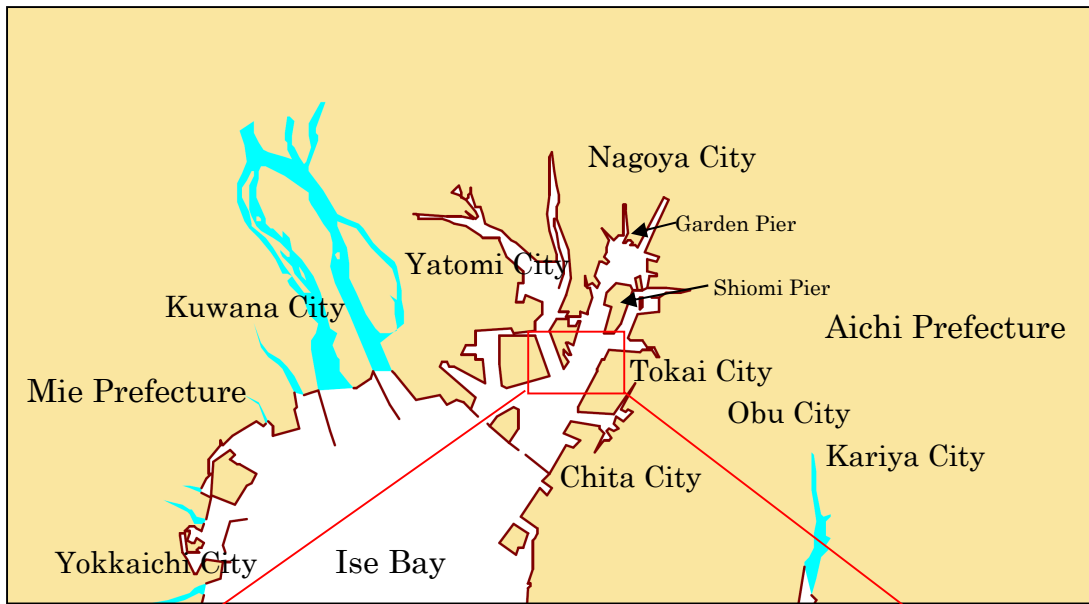
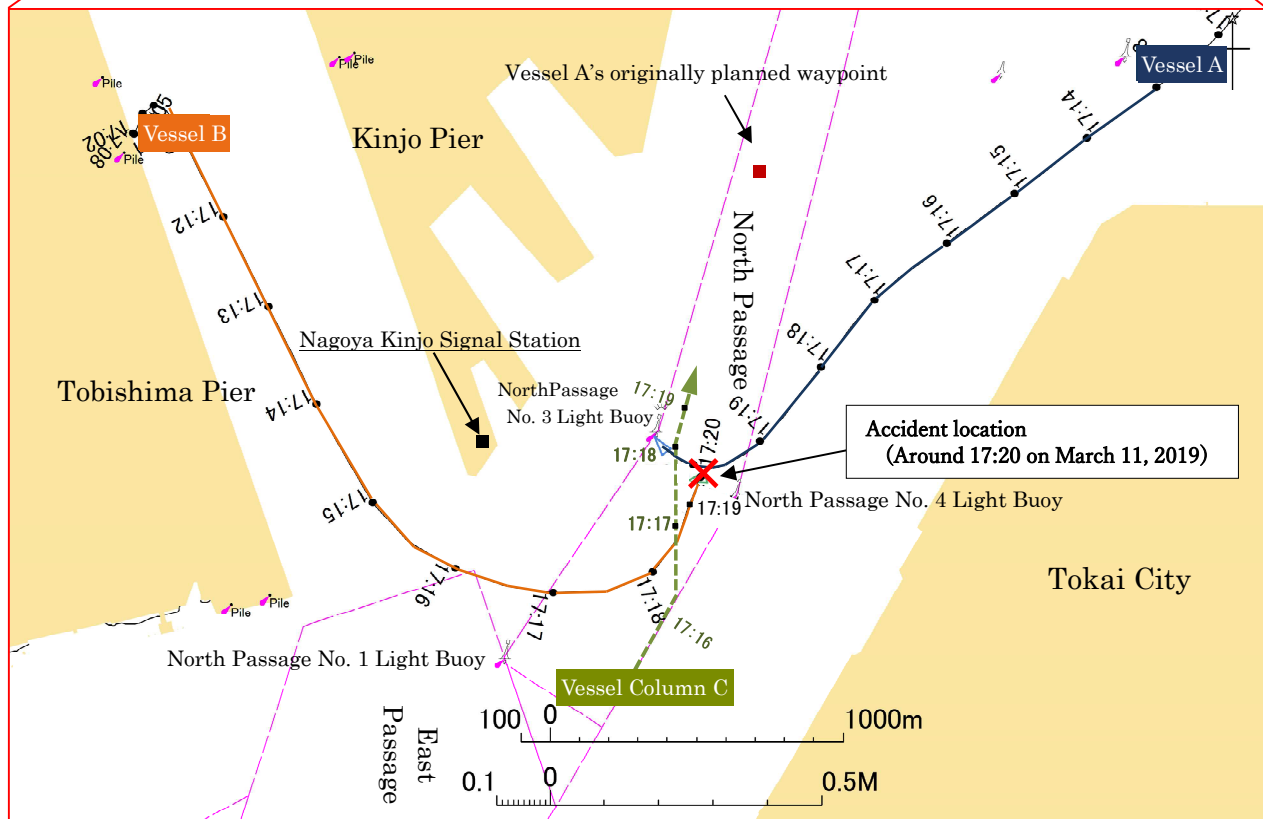
Attached Figure 1 Outline Map of the Course of the Accident Events

Events Leading to the Accident	<p>At around 17:00 on March 11, 2019, Vessel A, with Master A and 17 other crew members aboard (two nationals of the Republic of Korea, 14 nationals of the Republic of the Philippines, and one national of the Socialist Republic of Vietnam) weighed anchor in an anchorage near Shiomi Pier and headed toward Yokkaichi Port, Mie Prefecture, with an empty hold and with a plan of going through Nagoya Port North Passage (hereinafter, when a passage name starts with “Nagoya Port,” this portion shall be omitted).</p> <p>With Master A conning the vessel and stationing two crew members, a navigation officer and an able seamen, on the bridge, Master A decided, with the intention of shortening sailing time in order to have more cargo handling time at the destination, to enter the North Passage from the area near the passage intersection on the North Passage’s south side and not pass the waypoint near the North Passage’s midpoint as originally planned, and therefore had Vessel A proceed southwest on a course of 236° (true bearing; hereinafter the same) and speed of approximately 9 knots (kn) (speed over the ground; hereinafter the same).</p>

At around 17:15, Master A observed a vessel towing another vessel heading north diagonally across the North Passage ahead (hereinafter "Vessel Column C") and decided to pass Vessel Column C starboard-to-starboard.

After Vessel Column C crossed the bow on the starboard side, Master A observed Vessel B off of the bow at around 17:17 but he assumed that Vessel A and Vessel B were in a meeting relationship and would pass port-to-port, and that Vessel B would cross the North Passage on an easterly course and head in the direction that Vessel A had come.

At around 17:18, Master A decided to alert Vessel B, which he could see off of the bow, and he sounded the whistle; however, thereafter, he noticed that Vessel B had turned to port and was heading north in the North Passage.

Vessel B approached Vessel A's bow, at this time Master A sensed the danger of collision and he set the rudder hard to starboard, sounded the whistle in short blasts repeatedly and stopped the main engine with the intention of avoiding a collision by passing port-to-port because Vessel B had come too close for Vessel A to pass Vessel B's stern; Thereafter, although he continued to blow the whistle, Vessel A's port bow and Vessel B's bow collided at around 17:20.

At around 17:10, Vessel B, with Master B and four other crew members aboard, left Tobishima Pier with an empty hold, with Master B handling ship maneuvering alone, and headed to an anchorage near Nagoya Port Garden Pier with a plan of going through the North Passage.

Master B decided to enter the North Passage by making a wide turn near the eastern edge of the passage with the intention of staying to the passage's right side as a vessel navigating the passage. At around 17:15, he began a gradual turn to port at a speed of approximately 12 kn while watching the North Passage No. 1 Light Buoy on the starboard side.

At around 17:16, Master B observed Vessel A proceeding southwest in the sea area to the east of the North Passage, he gradually reduced speed, he saw that Vessel A and Vessel Column C were in a state where they would pass starboard-to-starboard,

<p>and he thought that Vessel A would pass Vessel B starboard-to-starboard in a similar manner as with Vessel Column C.</p> <p>At around 17:18, Master B was heading north on the same course after turning to port, thinking that Vessel B, which was navigating within the North Passage, was in a position of maintaining her course and Vessel A, which was about to enter the North Passage, would give way to Vessel B. At around 17:19, Master B saw Vessel A's bow approaching off the bow and make a sudden turn to starboard, he sensed the danger of collision and sounded the whistle once in a prolonged blast, and he set the main engine to full astern. However, despite these actions, Vessel B collided with Vessel A.</p> <p>At around 17:24, Master B notified Nagoya-ko Vessel Traffic Service Center of the accident and subsequently berthed at a wharf in Nagoya Port in accordance as instructed by Japan Coast Guard. (See Attached Figure 1 "Outline Map of the Course of the Accident Events," Attached Table 1 "AIS Record of Vessel A (Excerpt)," Attached Table 2 "AIS Record of Vessel B (Excerpt)," Attached Table 3 "Information on Voice Communication, etc., Recorded by Vessel A's VDR (Excerpt)")</p>
