MA2020-6

**MARINE ACCIDENT  
INVESTIGATION REPORT**

<b>Accident type</b>	Collision
<b>Date and time</b>	Around 4:22 on September 2, 2019 (local time, UTC+9 hours)
<b>Location</b>	Akashi Kaikyo Traffic Route Around 019° true bearing, 1.3 nautical miles (M) from Esaki Lighthouse (approximately 34°37.6'N, 135°00.0'E)
<b>Summary of the Accident</b>	<p>The car carrier GLOVIS COMPANION was proceeding west in the Akashi-Kaikyo Traffic Route and the fishing vessel HIGASHIDA MARU was proceeding southeast and attempting to cross the Akashi-Kaikyo Traffic Route when both vessels collided in the Akashi-Kaikyo Traffic Route.</p> <p>The master of HIGASHIDA MARU was injured, and her bow sustained crushing and other damage, while GLOVIS COMPANION sustained abrasions on her starboard- side shell plating.</p>
<b>Process and Progress of the Investigation</b>	<p>(1) Set up of the Investigation The Japan Transport Safety Board (hereinafter referred to as “JTSB”) appointed an investigator-in-charge and two other marine accident investigators to investigate this accident on September 2, 2019.</p> <p>(2) Collection of Evidence September 3 to 5, December 9 and 10, 2019: On-site investigations and Intervi

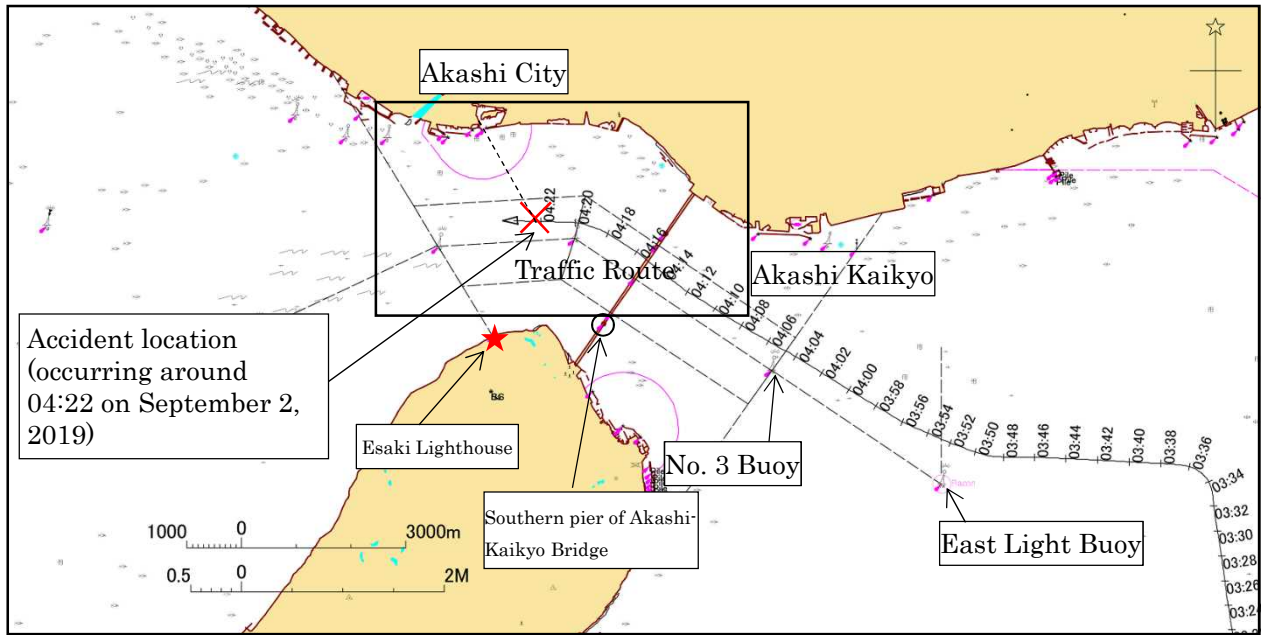
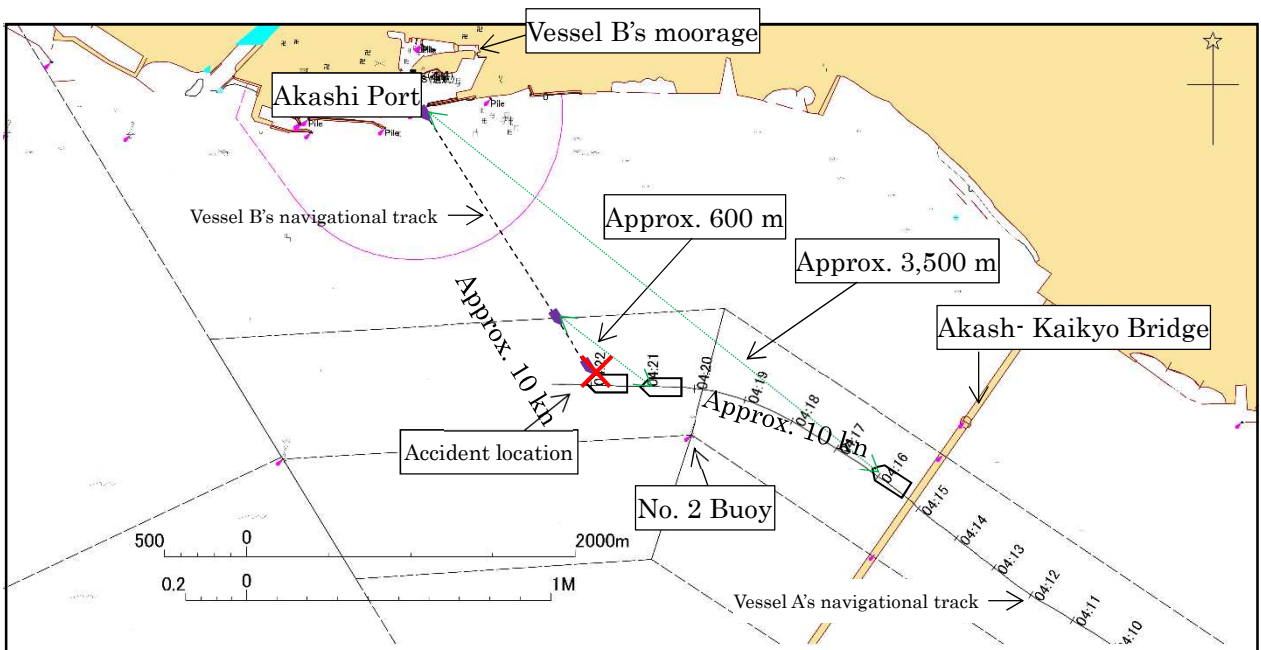
Attached Figure 1 Outline Map of the Course of the Accident Events

<p>Pilot A notified Osaka MARTIS of the accident and reported that Vessel B was moving away from Vessel A's starboard stern.</p> <p>At around 04:05, Vessel B, with Master B being the only crew member aboard, departed her moorage at Akashi Port, Akashi City, Hyogo Prefecture, with navigation lights on for fishing grounds to the east of Awaji-shima Island for the purpose of conducting pole-and-line fishing of Japanese Spanish mackerel.</p> <p>At around 04:16, Master B passed Akashi Port's breakwater, sat on a chair in the wheelhouse, and performed ship maneuvering by manual steering.</p> <p>Vessel B proceeded southeast at a speed of about 10 kn, with Master B thinking that there were no vessels proceeding west from the direction of Akashi-Kaikyo Bridge at the time he set the south pier of Akashi-Kaikyo Bridge as his heading mark.</p> <p>Master B was observing several vessels proceeding east in the Traffic Route and was considering which of the vessels to pass by their sterns when crossing the route.</p> <p>Vessel B entered the Traffic Route from the north side of the route at around 04:21 and, as Master B was observing the movements of vessels proceeding east, she collided with Vessel A at around 04:22.</p> <p>Master B's forehead, etc., struck a clear view screen in the collision, and after he returned to Akashi Port under his own power without knowing what he had collided with, he was diagnosed at a hospital as having a forehead bruise, lacerations, and chest fracture. (See Attached Figure 1 "Outline Map of the Course of the Accident Events")</p>

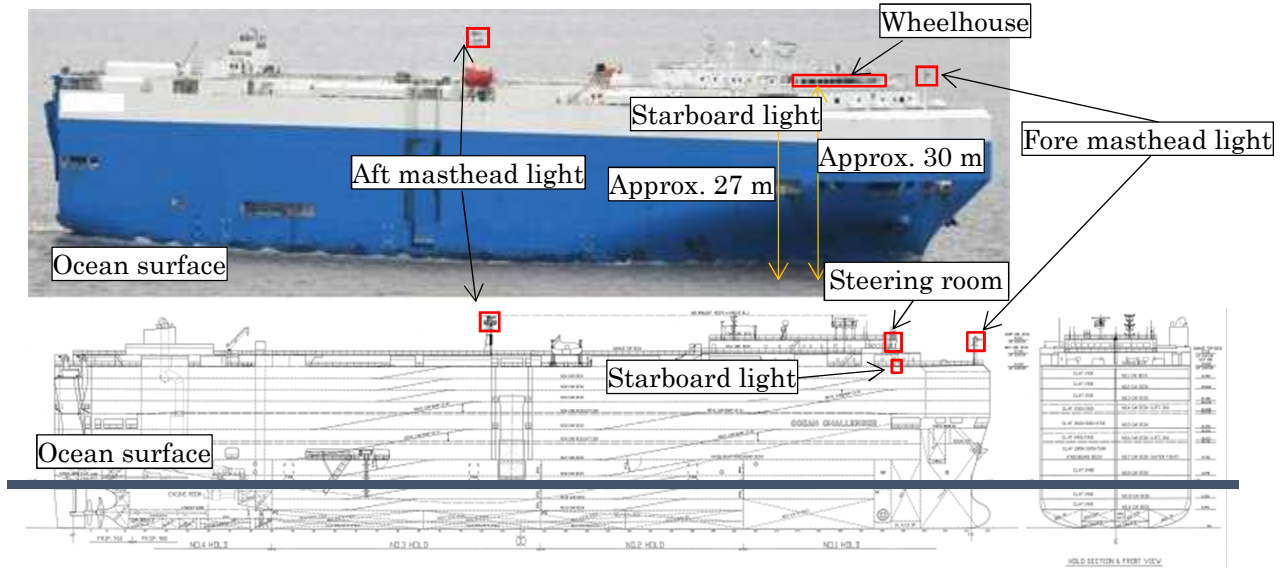
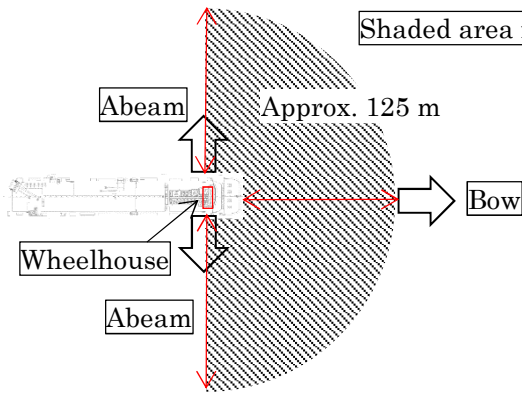
Attached Figure 2 Vessel A

Other Matters	<p>(1) Circumstances of visual sighting, etc., from Vessel A's wheelhouse</p> <p>According to the reply to the questionnaire by Master A, the wheelhouse is approximately 30 m above the ocean's surface, and the visible area from the wheelhouse was the ocean's surface beyond approximately 125 m directly abeam and forward at horizontal distance.</p> <p>According to Vessel A's general arrangement plan, the navigation lights were at a height of approximately 27 m or higher from the ocean's surface.</p> <p>(Attached Figure 2)</p> <p>(2) Circumstances, etc., of Vessel B's navigation lights</p> <p>(a) An awning was installed from the bow to the stern, and a masthead light and a bi-colored light were installed above the awning and below the awning, respectively.</p> <p>(b) The angles from the bi-colored light to the awning at the bow's end and both sides were approximately 10° upward in the direction of the bow and approximately 20° upward directly</p>

Shaded area indicates area that cannot be seen from the wheelhouse.

Area visible from the wheelhouse  
The ocean surface beyond 125 m (horizontal distance) ahead and abeam can be seen from Vessel A.

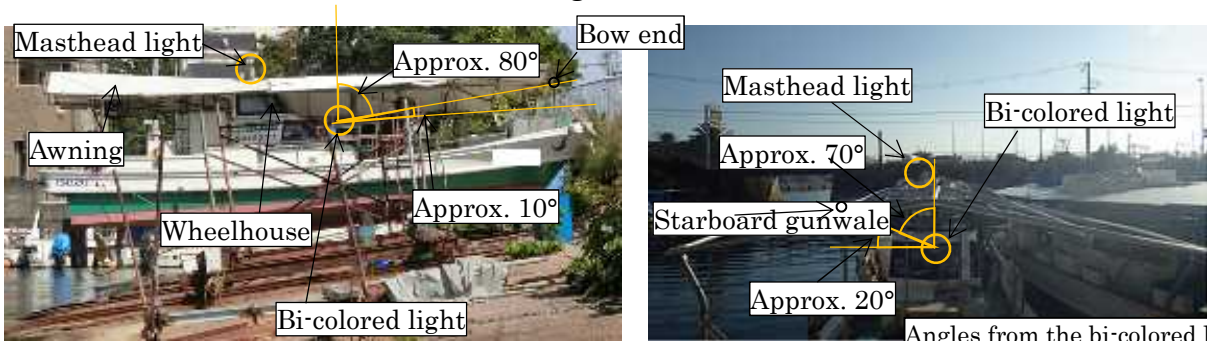
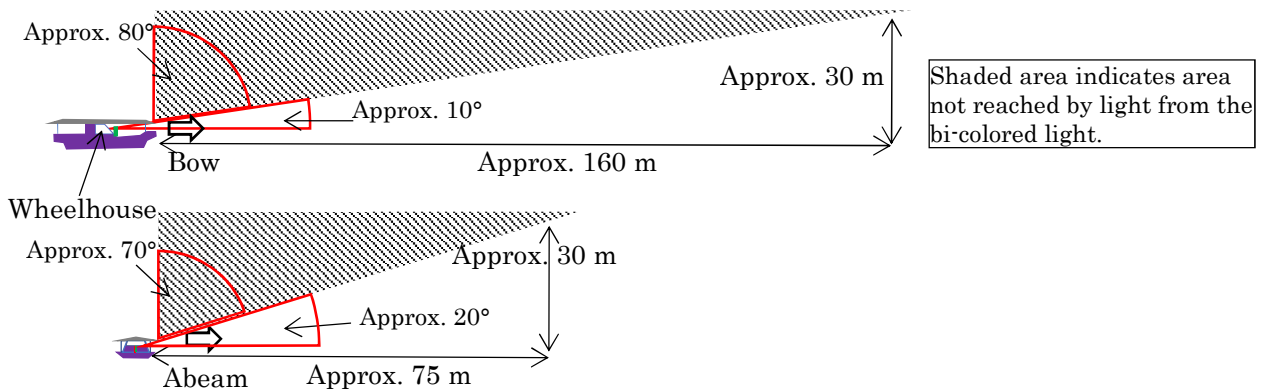
Attached Figure 3 Vessel B

(d) The condition of the light of the bi-colored light was such that light would reach a target at a height of approximately 30 m above the ocean's surface when the target was at a horizontal distance from Vessel B of approximately 160 m or more in the direction of the bow and approximately 75 m or more directly abeam.

Reach of light from the bi-colored light at a target 30-m above the ocean's surface

Angles from the bi-colored light to the bow end and both sides of the awning  
Approx. 10° upward toward bow  
Approx. 20° upward directly abeam

Shaded area indicates area not reached by light from the bi-colored light.

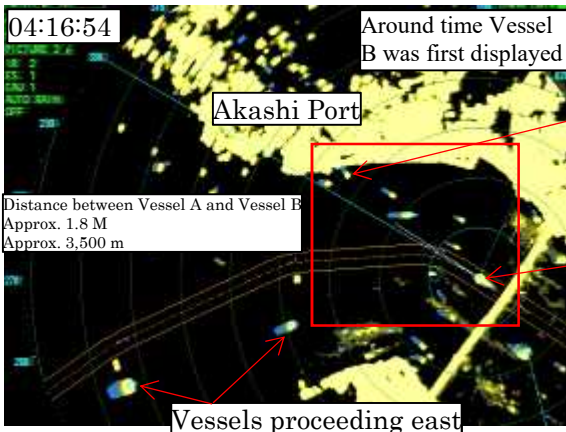
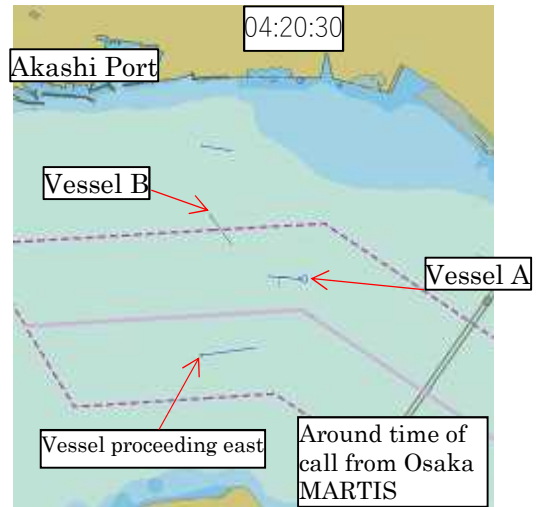
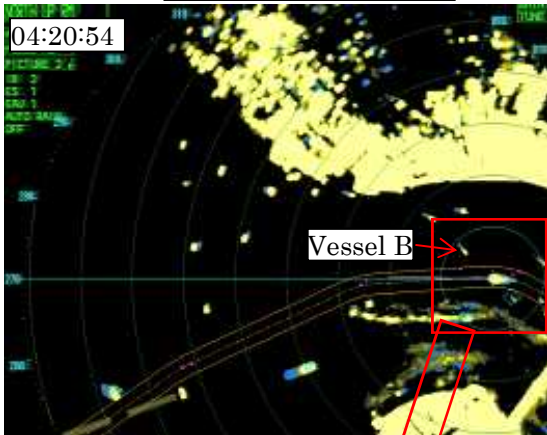
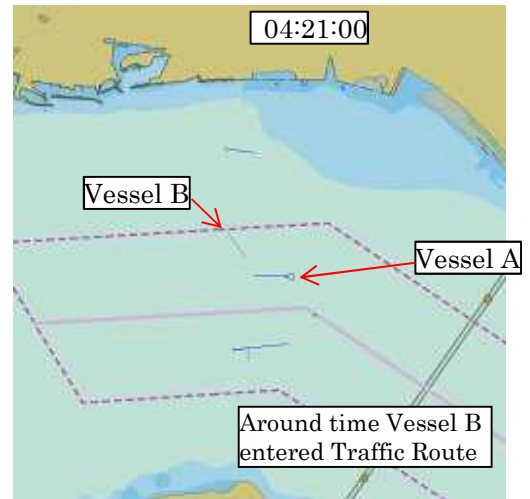
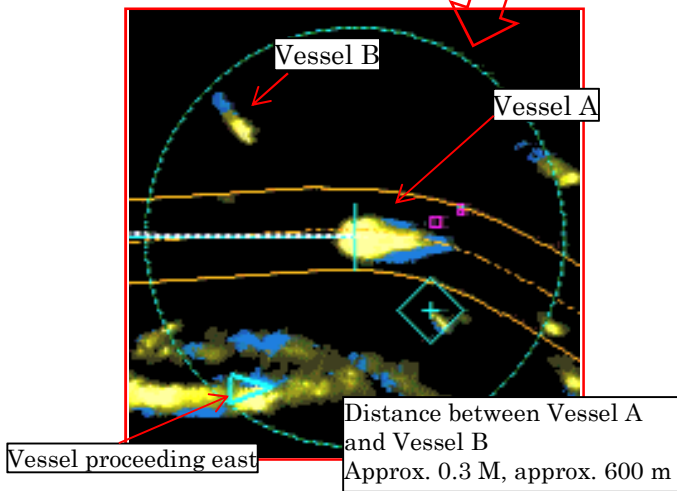
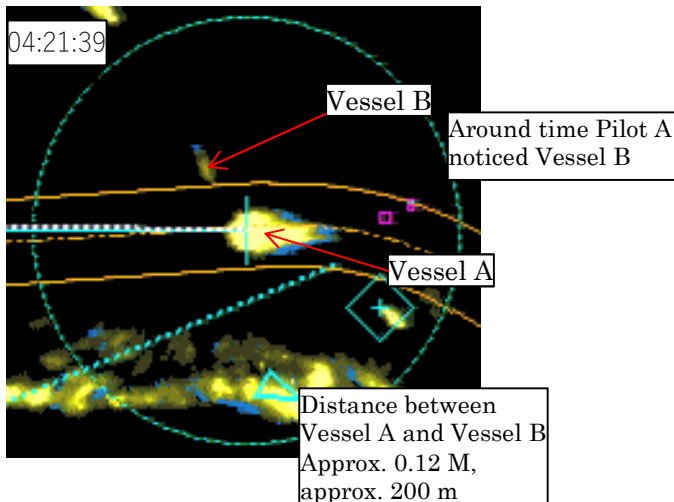
Attached Figure 4 Radar Images, etc., from Vessel A's VDR

- Vessel B proceeded southeast from Akashi Port and entered the route and, after approaching to approximately 200 m at 330° (true bearing; hereinafter the same) from Vessel A, proceeded south-southwest until just prior to the collision.
- From between around 04:16 and 04:22, passage in the Traffic Route was displayed as being one vessel proceeding west (Vessel A) and four vessels proceeding east.

○ Image provided by Osaka MARTIS  
The ends of vectors indicating vessel course and speed show predicted vessel position after one minute.

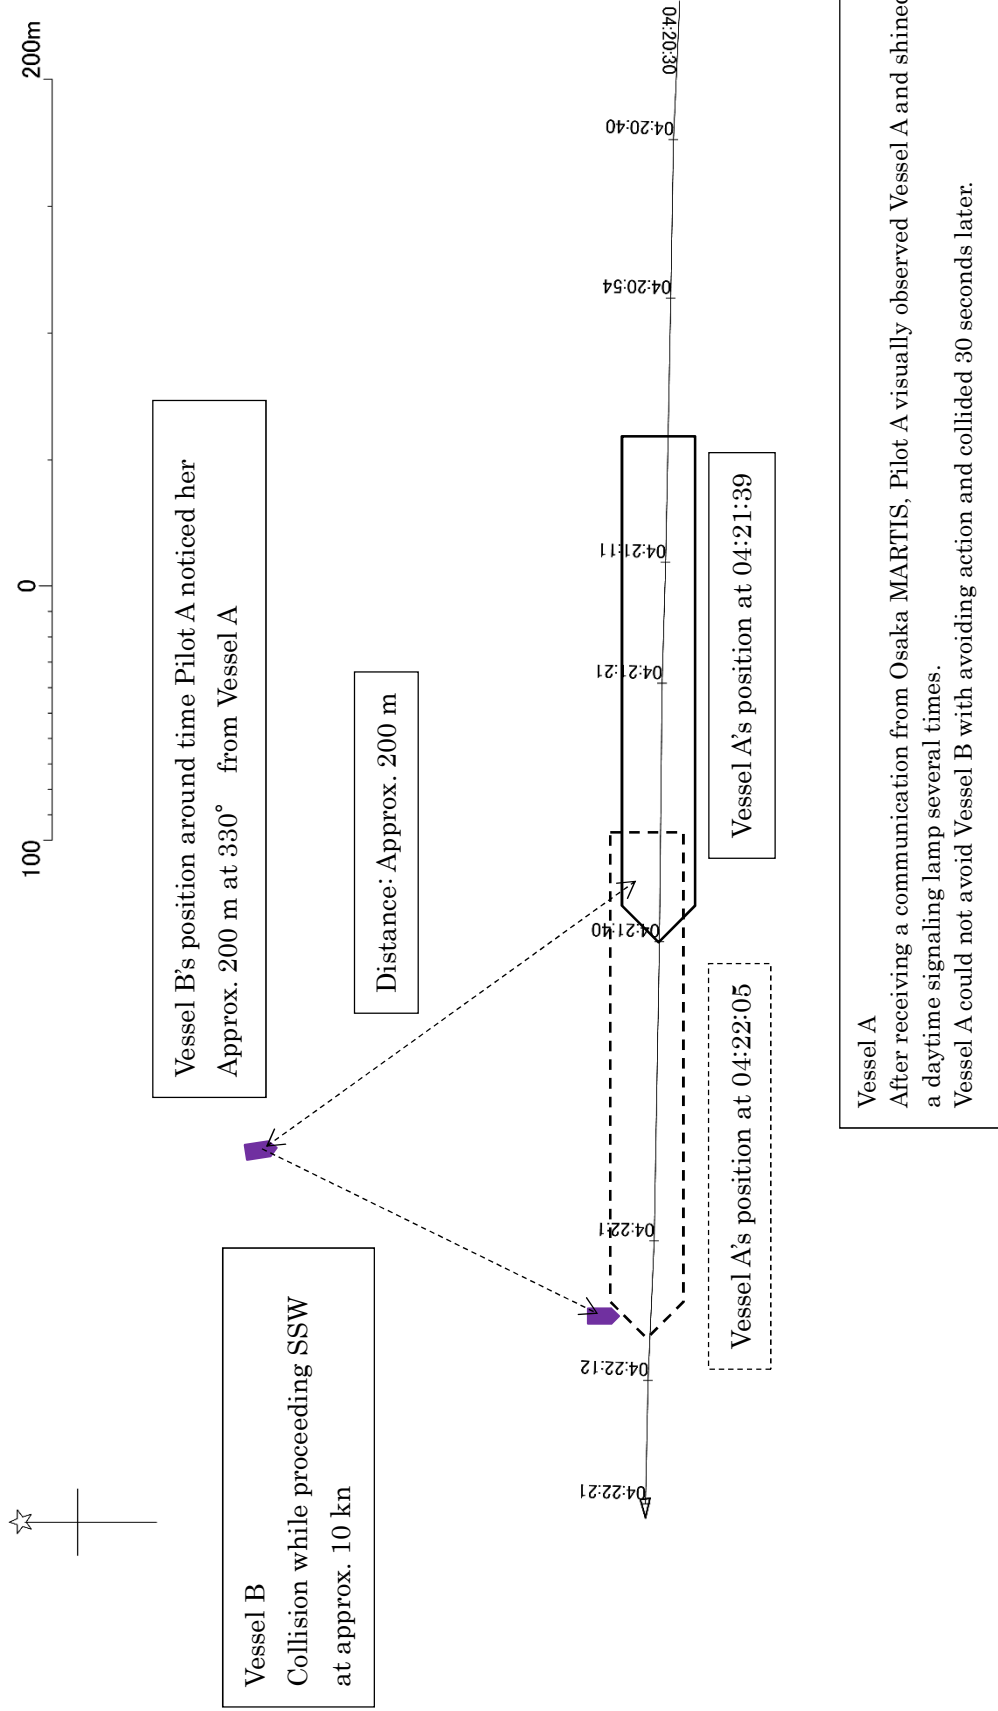
Attached Figure 5 Situation from the Time Pilot A Noticed Vessel B until the Collision

It is probable that, when Pilot A noticed Vessel B, Vessel A could not evade Vessel B, which had approached to approximately 200 m, by her own action alone.
