**MARINE ACCIDENT
INVESTIGATION REPORT**

Vessel type and name: Cargo Ship BUNGO PRINCESS

Accident type: Collision (bridge)

Date and time: Around 03:12, September 9, 2019 (local time, UTC+9 hours)

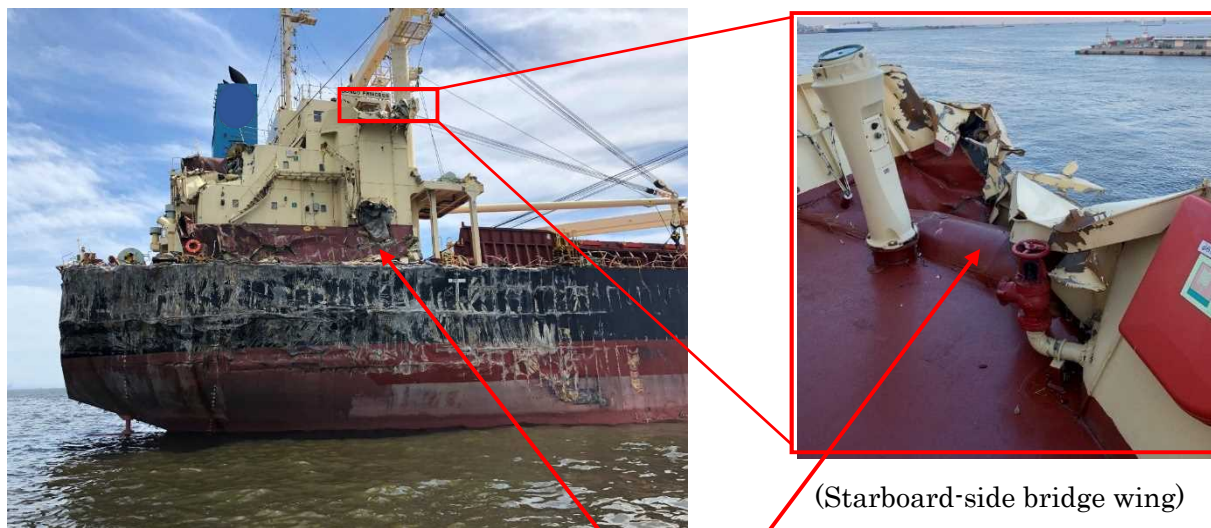
According to on-site investigation and the reply to the questionnaire by Company A, the Vessel sustained crushing, denting, and other damage to her starboard-side stern plating shell and starboard bridge wing and crushing of her bulbous bow. Additionally, a starboard-side lifeboat cradle and lifeboat that were installed below the bridge were lost. (See Photo 1)

(Starboard-side stern and bridge)

(Starboard-side bridge wing)
Crushing and other damage

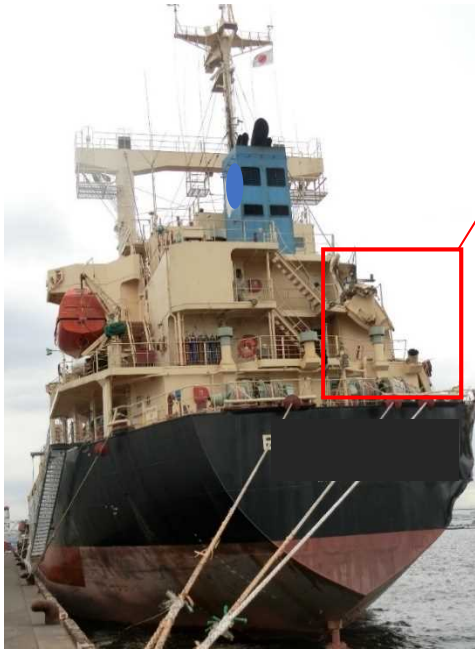
(View of the hull from astern)

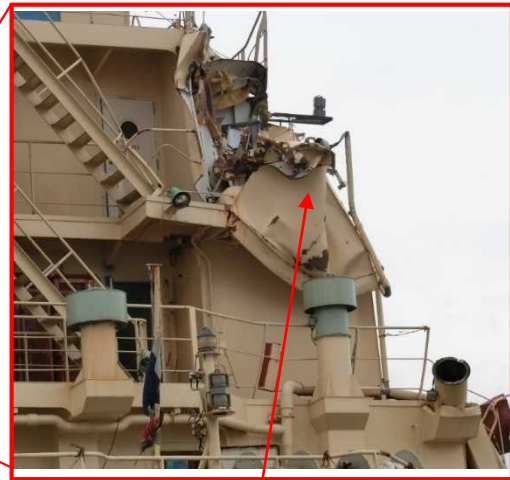
Location of the lost starboard lifeboat and cradle

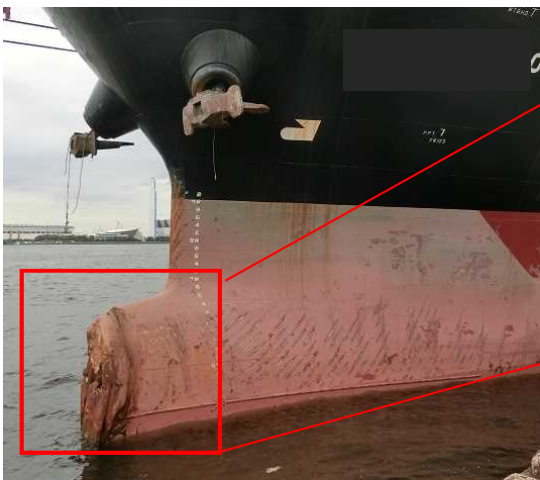
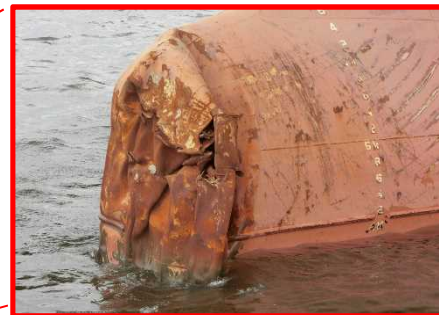
(Crushed bulbous bow)

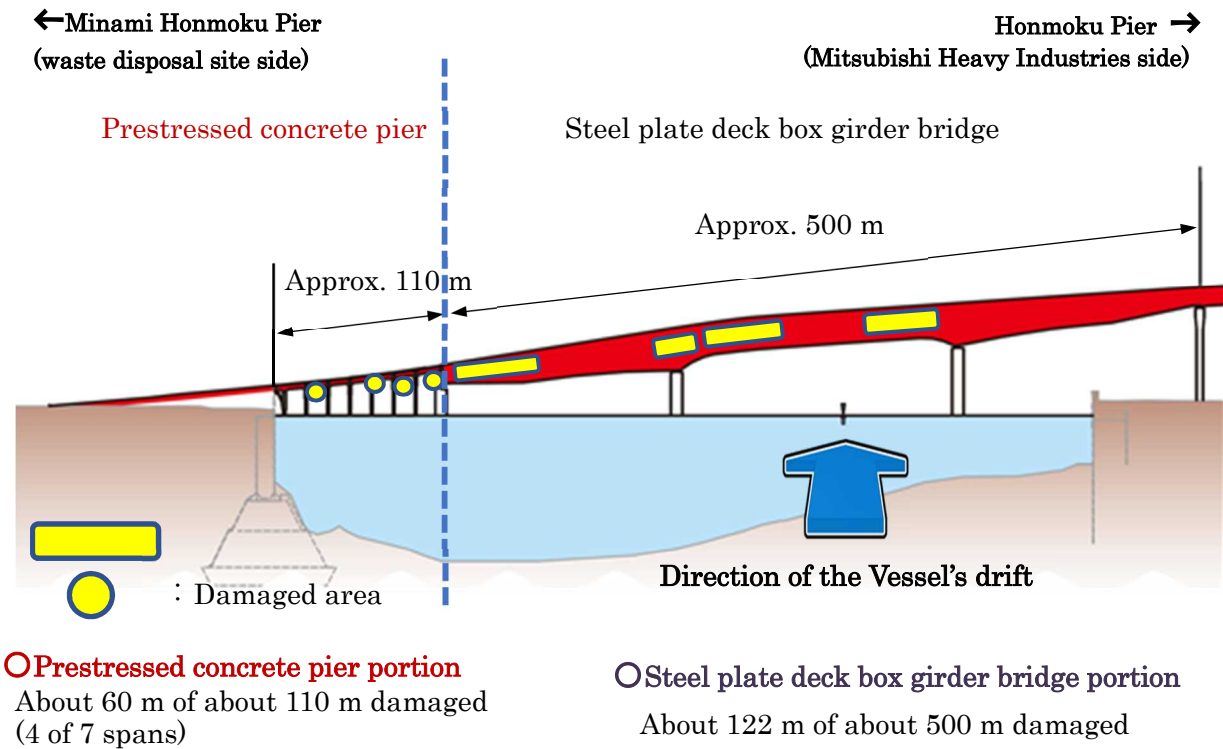
Figure 1 Damaged Areas of the Bridge (Summary)

According to the on-site investigation and the reply to the questionnaire by the Kanto Regional Development Bureau, which owns the Minami-Honmoku Hama Road, crushing, deformation, and other damage were sustained by about 122 m of the roughly 500-meter-long steel plate deck box girder bridge^{*2} and about 60 m of the roughly 110-meter-long prestressed concrete pier^{*3} constituting the Bridge, and damage was sustained by road lighting and other

- 1) Crushing, deformation, and other damage were sustained along about 122 m of the steel plate deck box girder bridge portion and about 60 m of the prestressed concrete pier portion, and damage was sustained by road lighting and other fixtures.
- 2) Gouges, abrasions, and other damage were sustained by about 460 m of seawall.

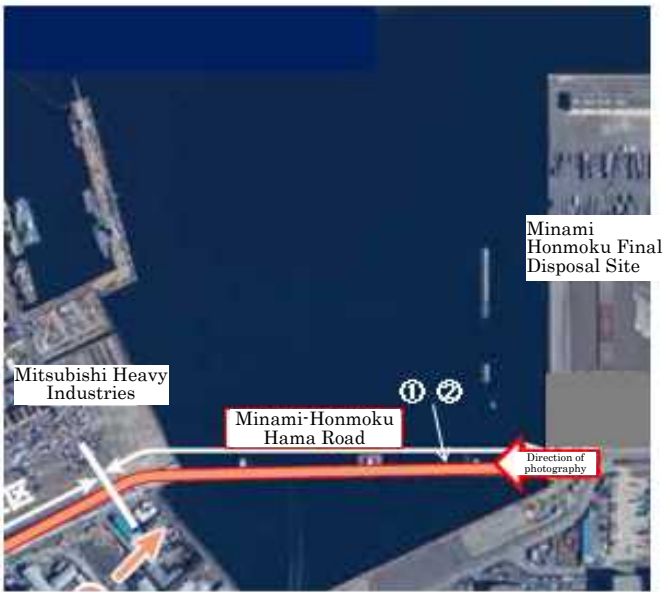
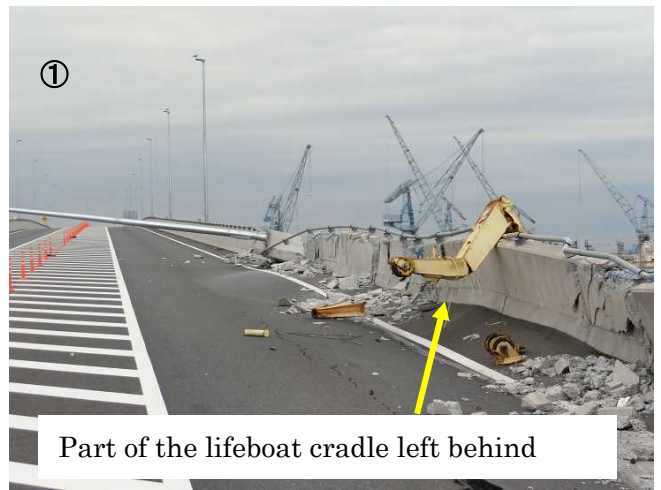
Part of the lifeboat cradle left behind

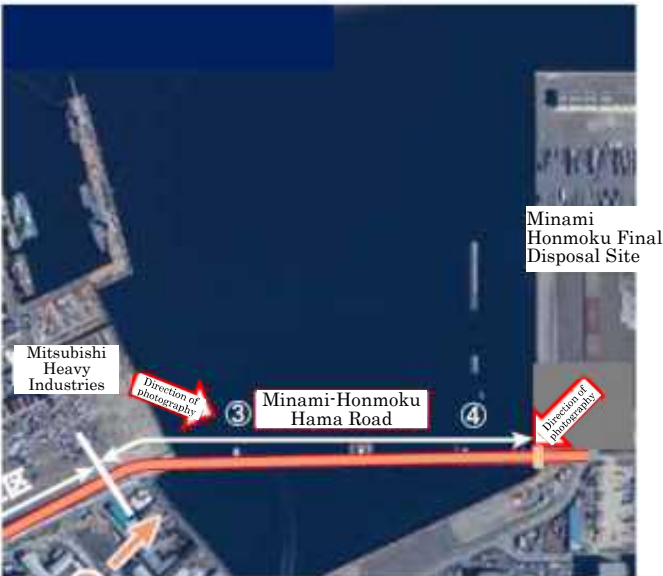
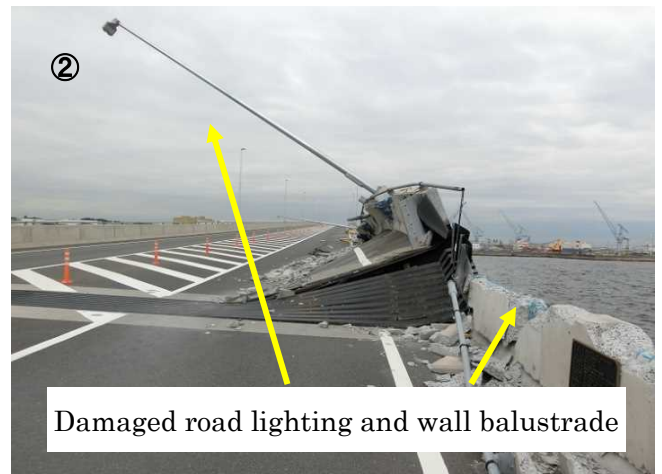
Damaged road lighting and wall balustrade

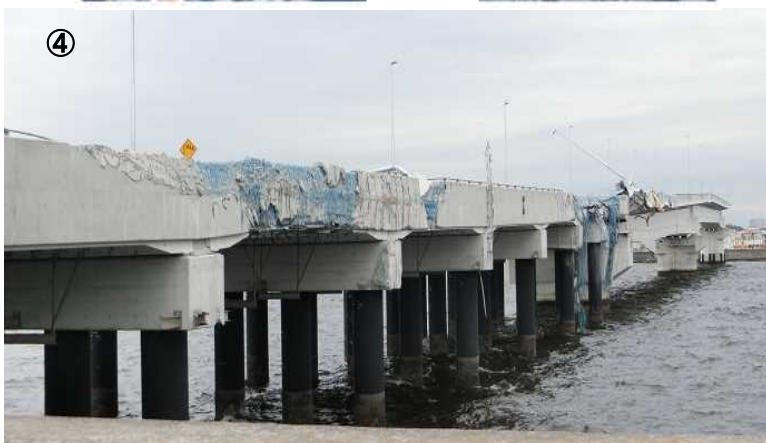
Prestressed concrete pier

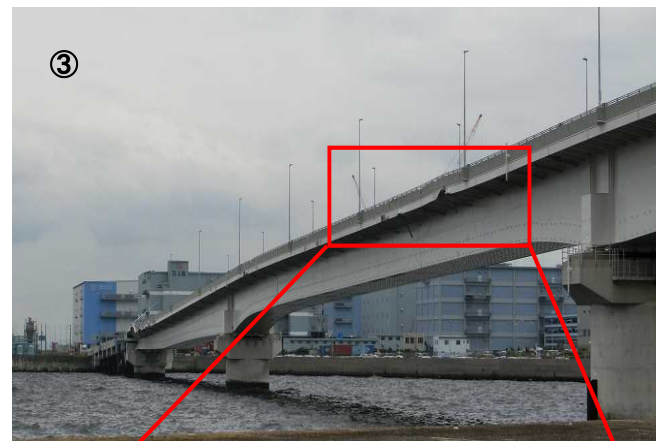
Steel plate deck box girder bridge

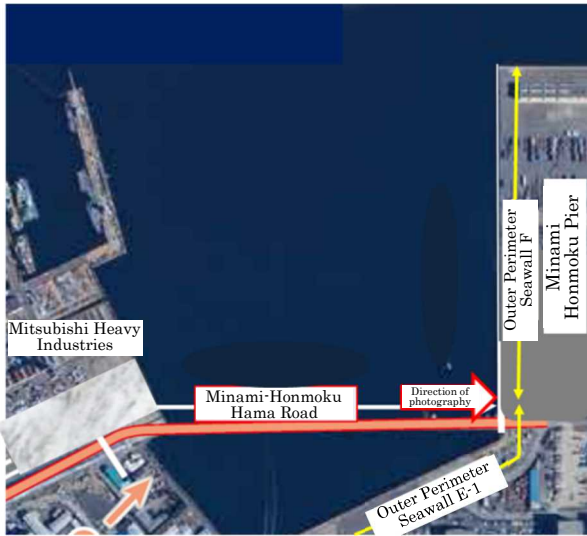
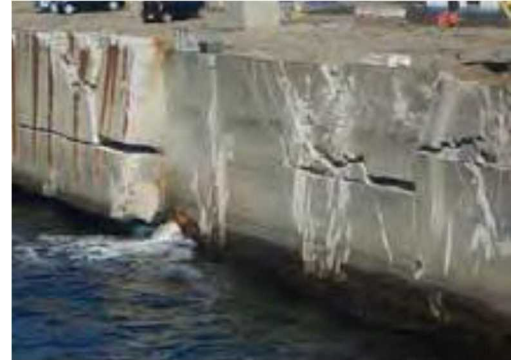
According to the on-site investigation, the reply to the questionnaire by the Port and Harbor Bureau of the City of Yokohama, and the statement of the person in charge at said bureau, gouges, abrasions, and other damage were sustained by about 460 m of an approximately 560-meter-long seawall (concrete) that is adjacent to the eastern side of the Bridge. (See Photo 3)

Gouges and abrasions in the concrete

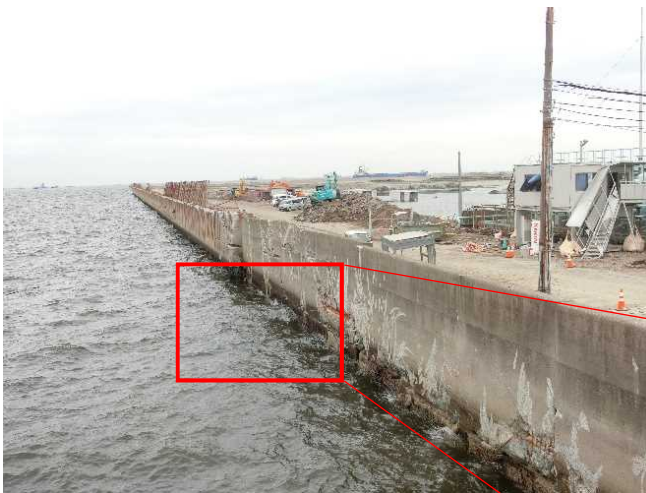
Abrasions and detached concrete
