**MARINE ACCIDENT
INVESTIGATION REPORT**

Vessel type and name: Cargo Ship WAKASHIO

Accident/Incident type: Grounding

Location: Shallows off the southeast coast of the island of Mauritius, Republic of
Mauritius
(approximately 20°26.5'S, 057°44.7'E)

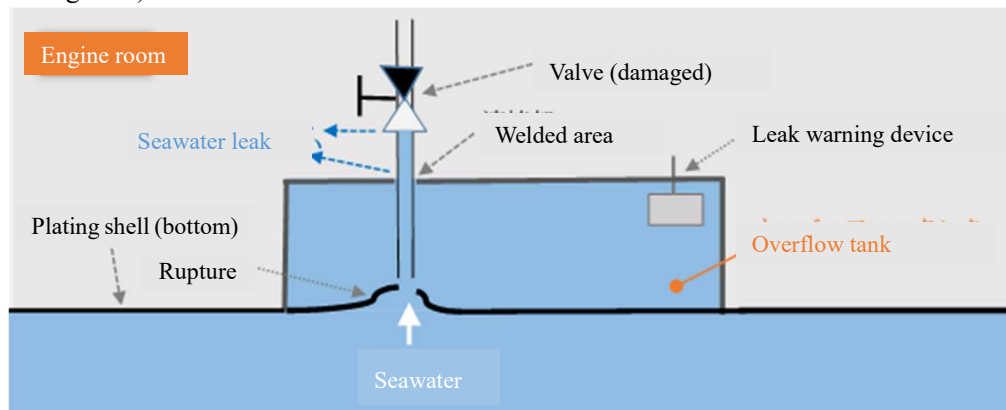
Figure 3 The Condition of the Fuel Oil Overflow Tank (Conceptual Image)

At around 20:29, an alarm indicating a leak in a fuel oil overflow tank^{*17} sounded, and the Chief Engineer ordered two oilers to check on the condition of the tank. The oilers reported to the Chief Engineer that a weld suction pipe near the tank had torn loose, that a valve was broken, and that seawater was flooding into the engine room from the damaged location.

The engineering personnel suspected that the tank's plating shell had been damaged, and because repairing pipes and valves near the tank would be difficult, they worked to stop the flooding of seawater by stuffing pieces of wood into the damaged area while also pumping out the seawater in the engine room with a drainage pump. They continued this work until the morning of July 26.

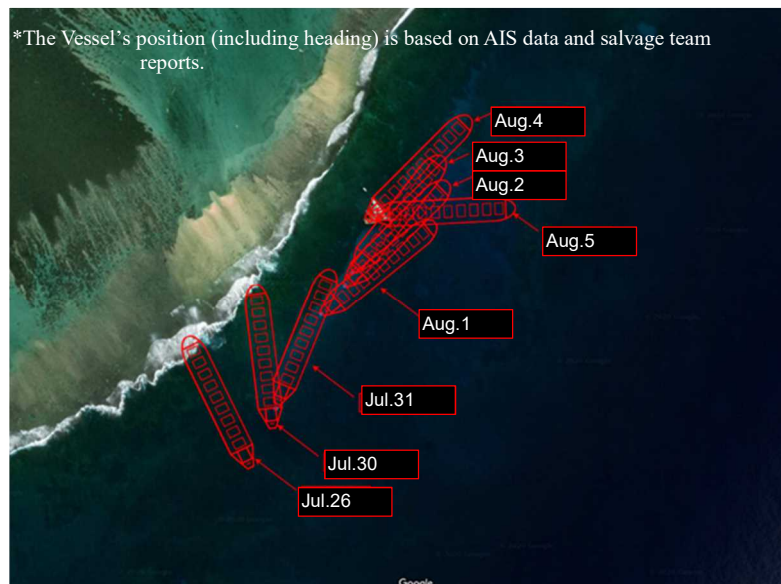
Figure 4 The Hull's Movement After Grounding

- (1) The Vessel did not move significantly immediately after the grounding. However, subsequently, waves and swells gradually increased due to worsening sea conditions, and the Vessel received swells from the southeast and moved in a northeasterly direction with her hull grounded.

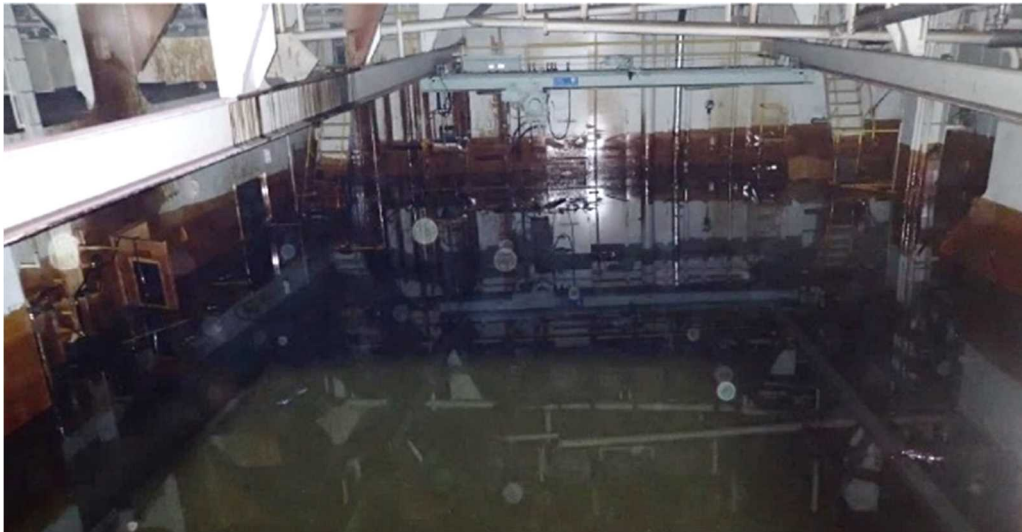
Photo 3 The Flooded Engine Room

The buckling was observed to be progressing at around 18:00 of the same day. At around 13:30 on August 3, seawater was observed entering the engine room from buckled locations of the No. 9 cargo hold and air vent welds of the Vessel.

At around 11:50 on August 4, the area above the Vessel's propellor shaft began to buckle and, at around 13:50 of the same day, the level of seawater flooding the engine room rose. At around 20:00 on the same day, the coolant pump for auxiliary machinery became submerged and the Vessel switched to its emergency generator. (See Photo 3)

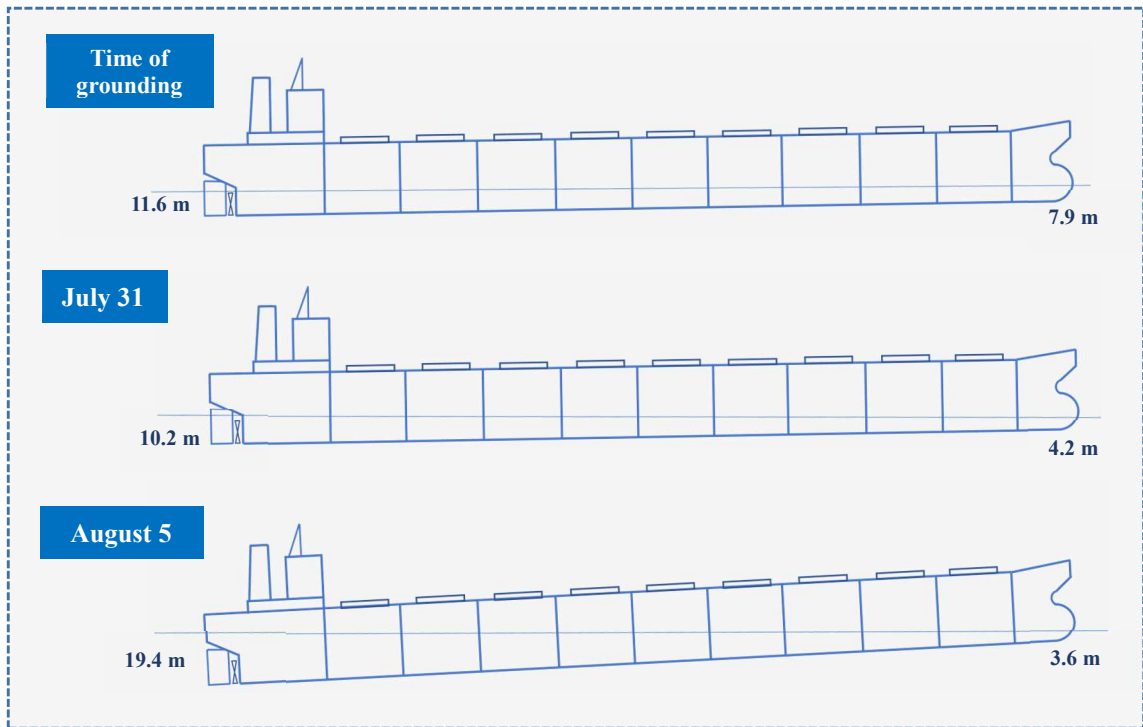
Figure 5 Changes in Draft

The Vessel's port-side stern draft was approximately 15.5 m at around 08:30 on August 5, but it subsequently increased gradually, reaching approximately 17.9 m at around 13:00 and approximately 19.4 m at around 15:45. (See Figure 5)

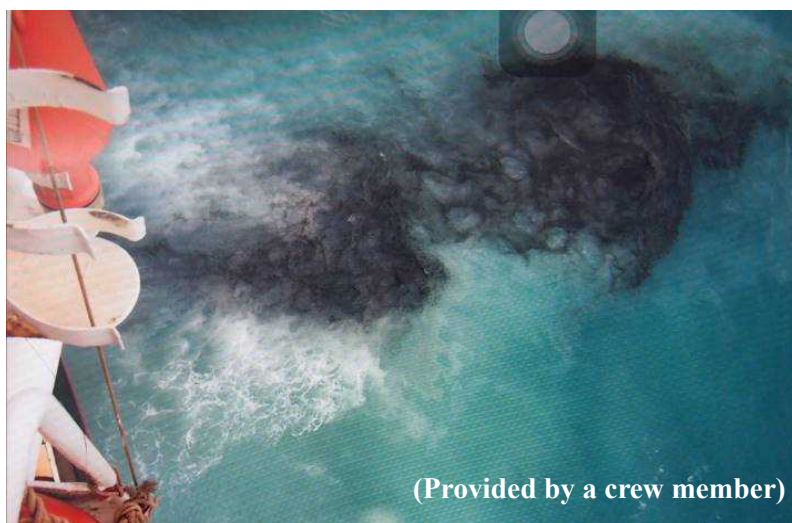
Photo 4 Fuel Oil Leaking from the Vessel's Stern

Serious buckling occurred on the Vessel's starboard side and, at around 10:30 on August 6, the No. 1 fuel oil tank (starboard) ruptured as cracks resulting from the buckling occurred and spread, and fuel oil (bunker C) leaked from the cracks onto the sea surface. (See Photo 4)

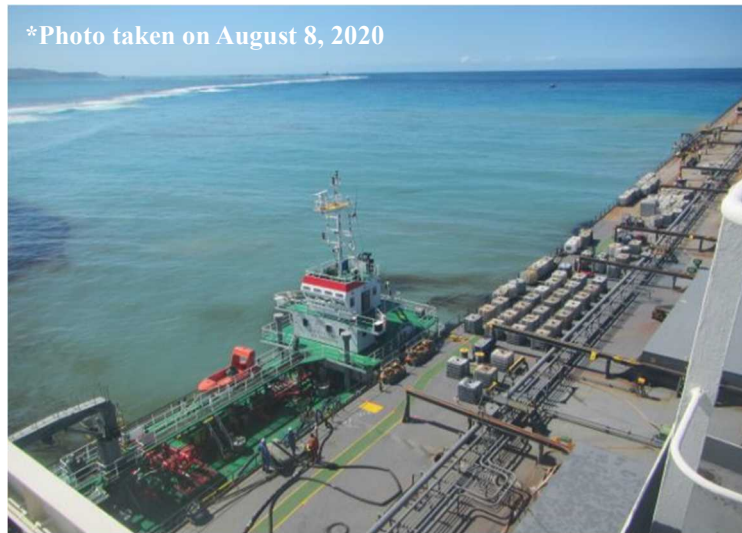
Photo 5 A Tanker Pumping Out Fuel Oil

The work of pumping out oil by the tankers had been carried out from 7 to 12 of August. By that day, a total of approximately 3,193t of fuel oil had been pumped out of the Vessel by the tankers, etc. (See Photo 5)

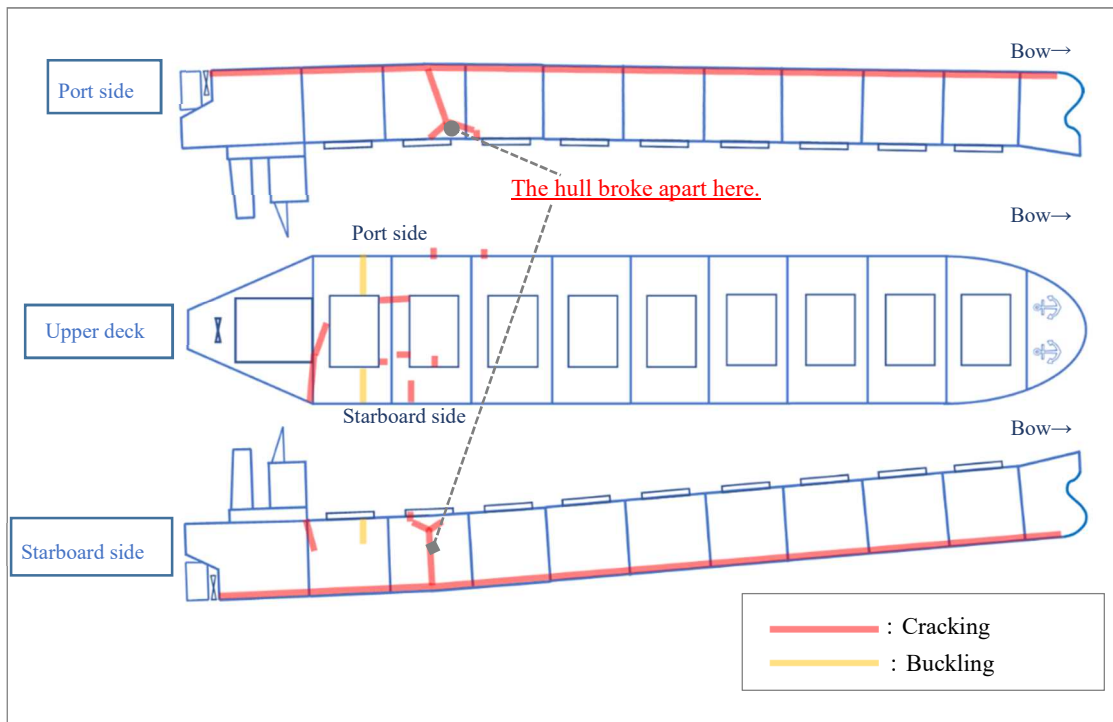
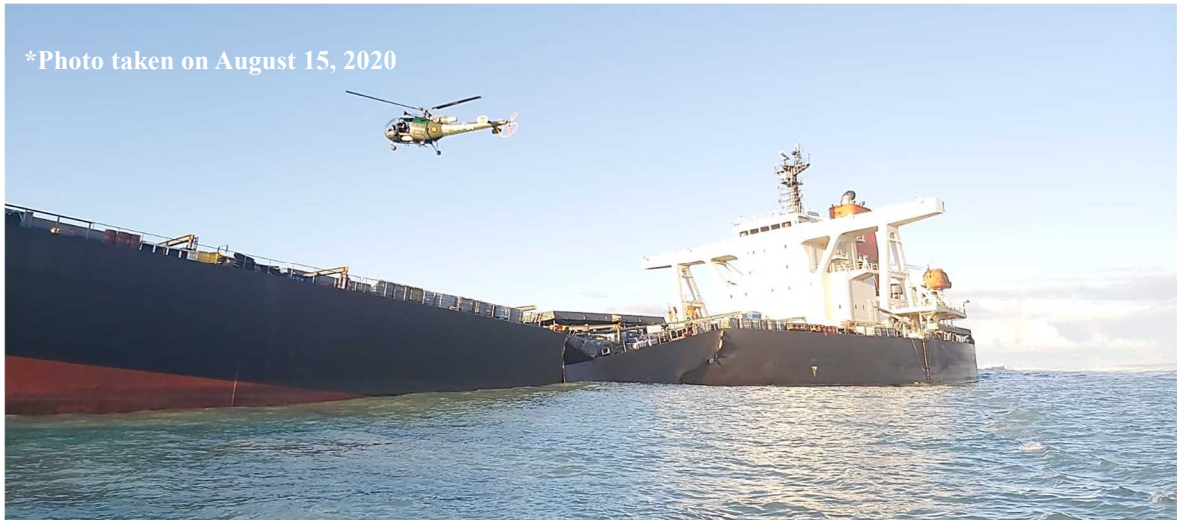
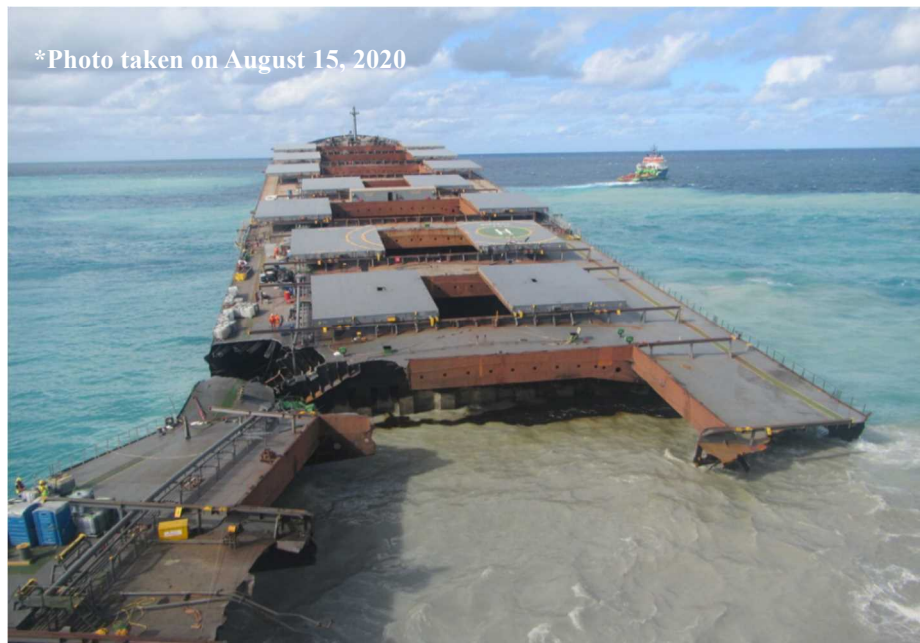
As of August 11, the bow and stern sections of the Vessel's hull remained connected by the upper deck only; however, at around 14:00 on August 15, the bow and stern completely separated and the hull broke into two. (See Figure 6, Photo 6 and Photo 7)

Figure 6 Cracking and Buckling Situation (as of August 11)

Photo 6 The Broken Hull

Photo 7 The Vessel's Bow Separated from the Stern

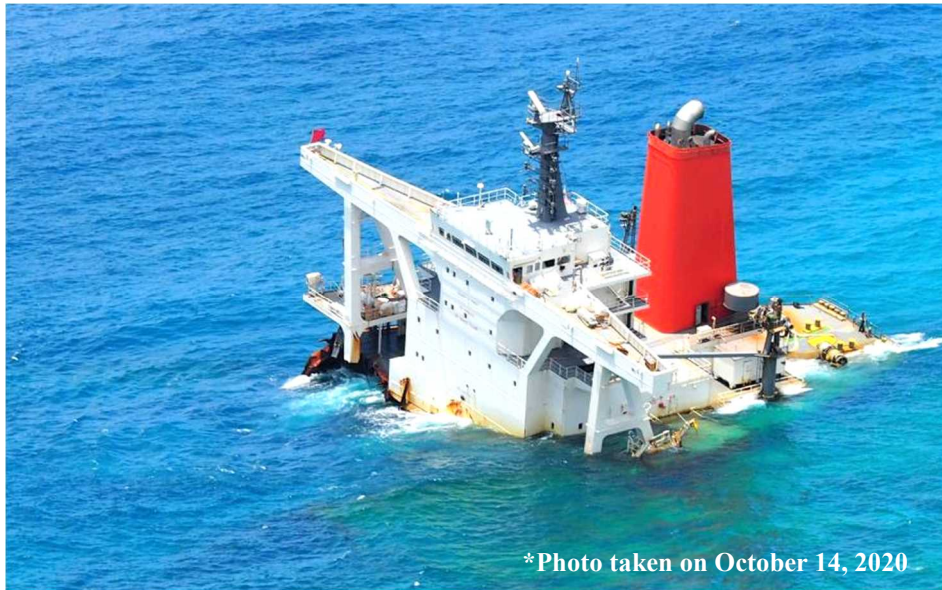
Photo 10 The Broken Hull (Stern Portion)

After grounding, the Vessel's bulkheads buckled and sustained other damage, her hull broke in two, and she became a total loss. (See Photo 10)

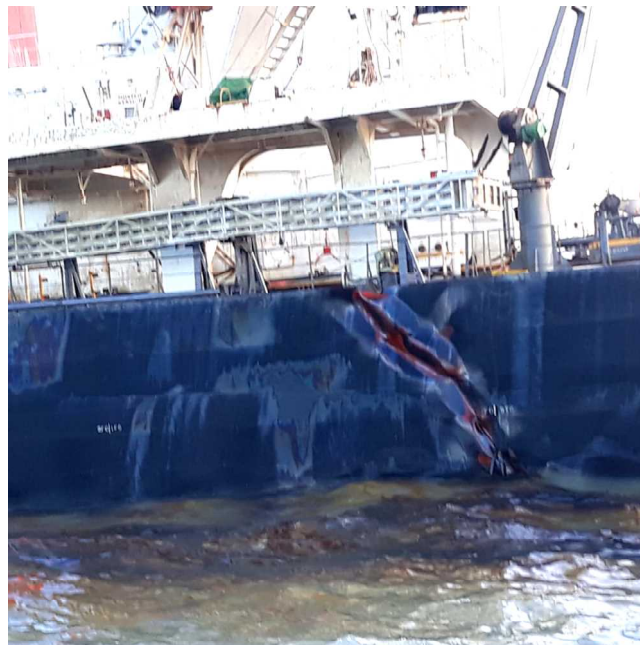
Photo 11 Fuel Oil Spilling from the Rupture

Approximately 1,000 tons of fuel oil in the No. 1 fuel oil tank (starboard) spilled from a rupture that occurred in the starboard stern's plating shell. (See Photo 11)

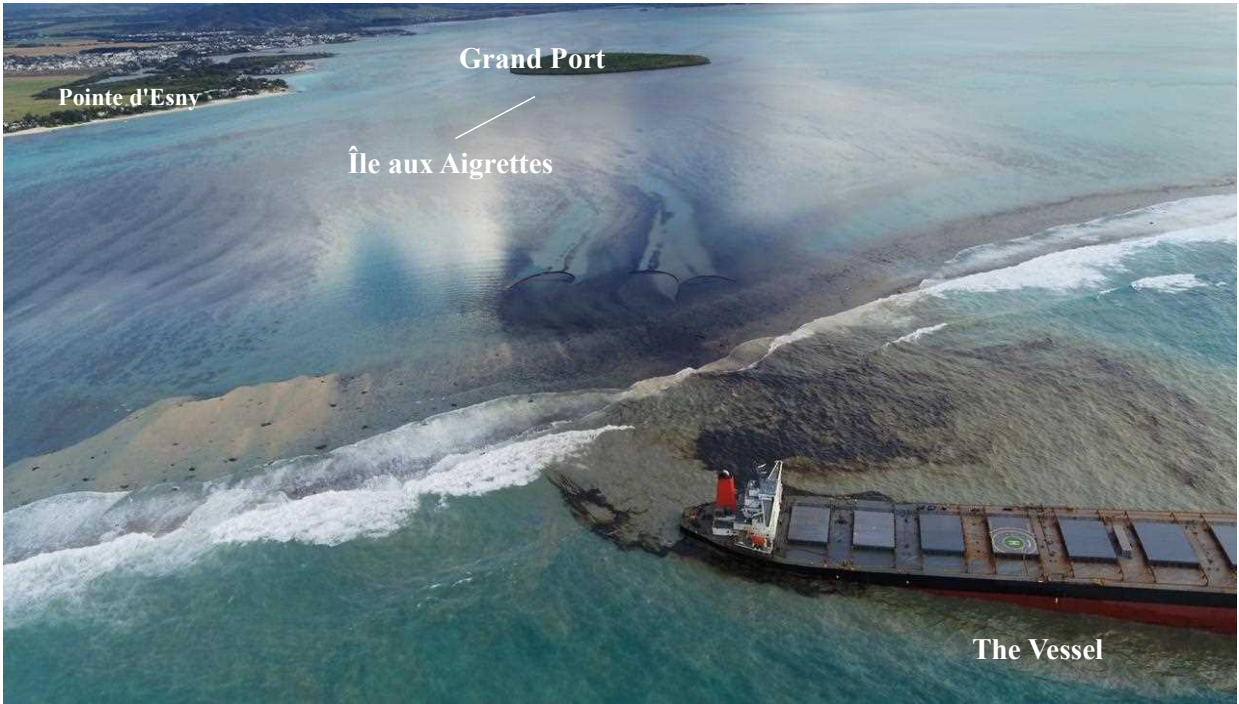
Photo 12 The Oil Spill

The spilled oil spread from the Accident location toward the interior of Grand Port, which is an inlet to the north-northwest. (See Photo 12)

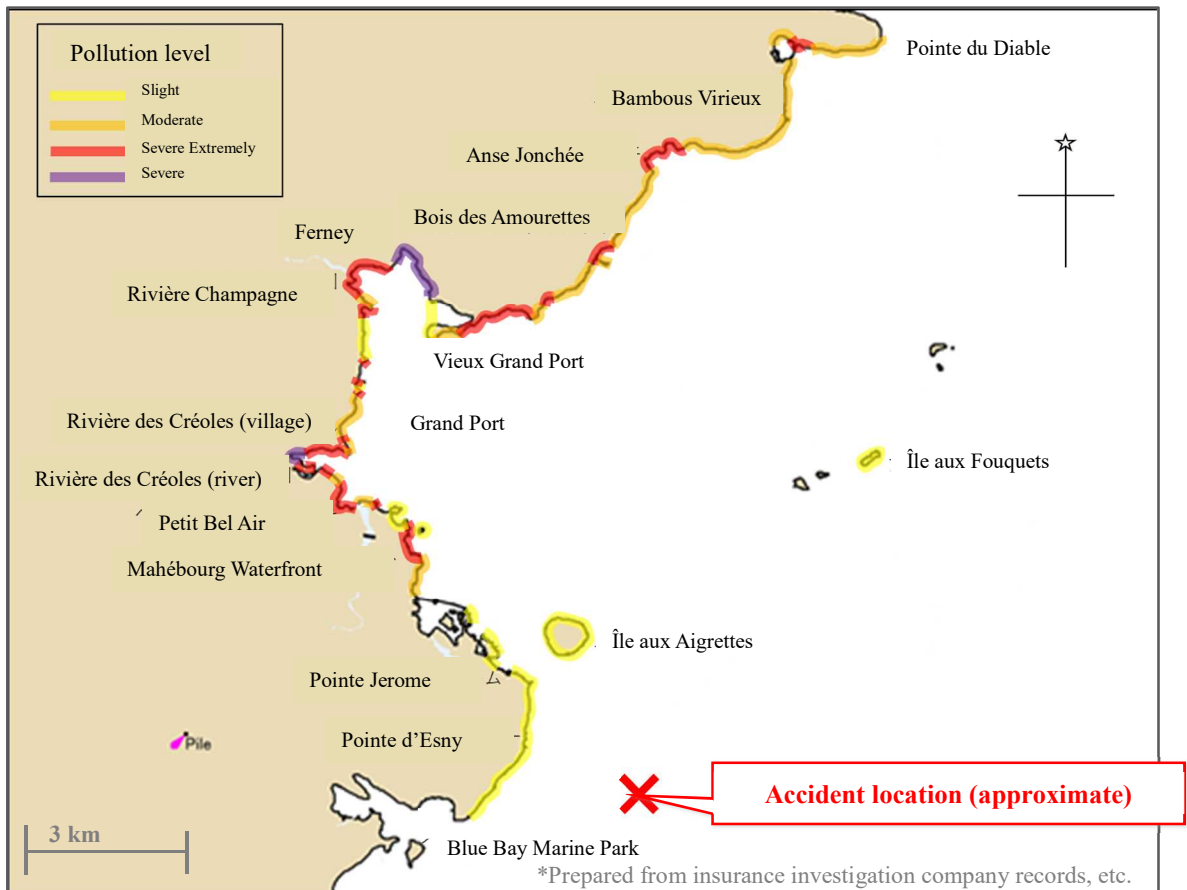
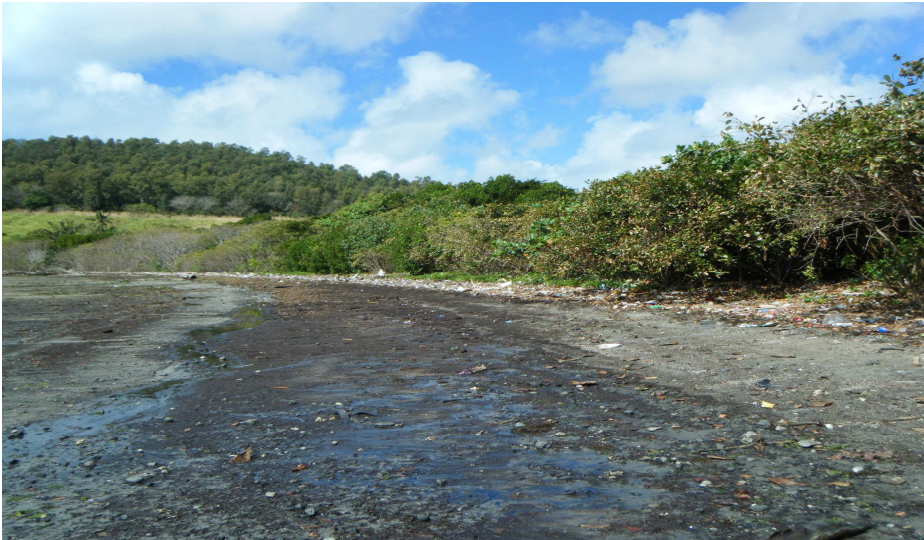
The oil spilled on the sea washed ashore along a wide section of the southeastern coast of Mauritius, from Blue Bay to Trou d'Eau Douce, covering a linear distance of approximately 25 km and a coastline length of approximately 35 km. Oil also spread into coastal inlets due to the effects of the wind and currents. (See Figure 8, Figure 11 and Photo 13)

Figure 8 Extent of Spilled Oil Washing Ashore and Pollution Level

Photo 13 The Oil Spill Washed Up on the Coast

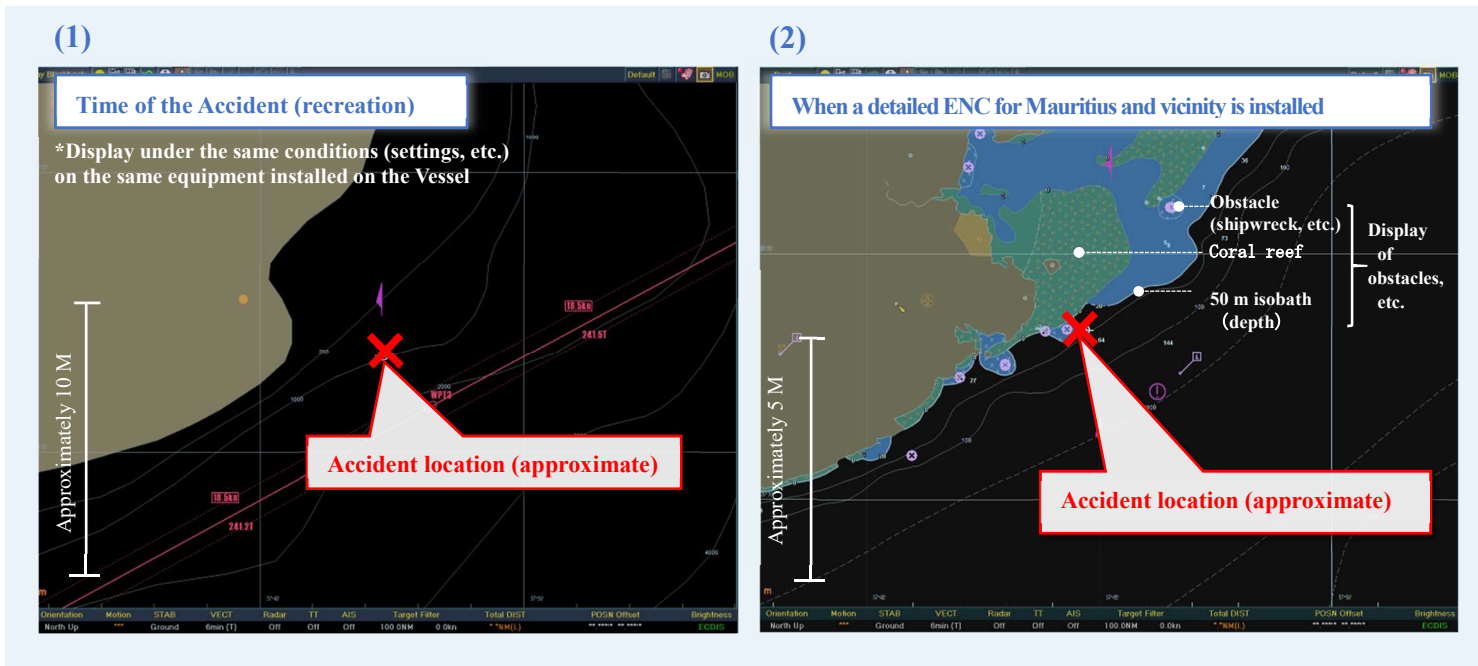
Figure 15 Recreation of ECDIS Display Conditions

With the cooperation of the ECDIS's manufacturer, the ECDIS display screen at the time of the Accident was reproduced based on the charts that were possessed by the Vessel, it was found that shoreline details, shoals, and other features along Mauritius's coast were not displayed (see Figure 15(1)). In contrast, when a detailed ENC of the island's vicinity was installed, coral reefs, obstacles, and other features were displayed in the vicinity of the Accident location. (See Figure 15(2))
