MA2024-03

**MARINE ACCIDENT  
INVESTIGATION REPORT**

<b>Accident type</b>	Grounding
<b>Date and time</b>	Around 09:20 on January 24, 2023
<b>Location</b>	Off the northwest of Taketomi Island, Taketomi Town, Okinawa Prefecture Around 268° true bearing, 3.8 nautical miles (M) from Ryukyu Kannonzaki Lighthouse (Approx. 24°21.8'N 124°02.6'E)
<b>Summary of the Accident</b>	The cargo ship XIN HAI ZHOU 2 was drifting for the purpose of time adjustment off the west of Ishigaki Island, Ishigaki City, Okinawa Prefecture, when she was pushed by the wind and waves. She therefore started her main engine and navigation; however, she continued to be pushed without gaining sufficient propulsion or rudder effect and ran aground on a shallow reef off the northwest of Taketomi Island. XIN HAI ZHOU 2's hull subsequently broke in two at her center section.
<b>Process and Progress of the Investigation</b>	The Japan Transport Safety Board appointed an investigator-in-charge and two other marine accident investigators to investigate this accident on January 24, 2023. January 26 and 27, 2023: Interviews January 28, 2023: On-site investigation February 1, 7 to 9, 14, and 15; March 3 and 31; April 19 and 2

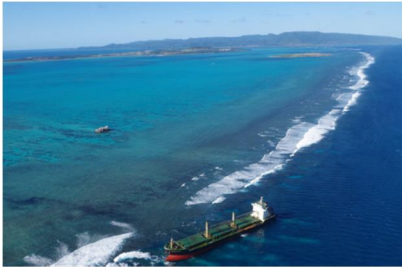
<p>Courtesy of the salvage company</p> <p>Photo 2</p> <p>The Situation After the Vessel’s Grounding  (January 26, 2023)</p> </div> <div style="text-align: center;">

The Vessel remained grounded at the accident location with her heading east-southeast. With a portion of her cargo leaking out from a hole in her port-side shell plating, the salvage company began work to remove her hull and cargo and to recover her leaked cargo, etc., on July 13. However, the Vessel's hull broke into two at her No. 3 hold when Typhoon No. 6 (Khanun) approached the accident location on August 4.

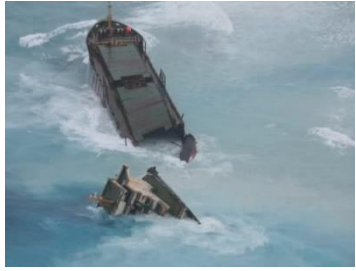
<p>Courtesy of Japan Coast Guard</p> <p>Photo 3</p> <p>The Situation After the Vessel’s Grounding  (August 4, 2023)</p> </div> </div>

The Vessel's entire cargo leaked into the ocean as a result of the breakage of her hull. The hull's rear portion collapsed with an inclination of approximately 65° to port.

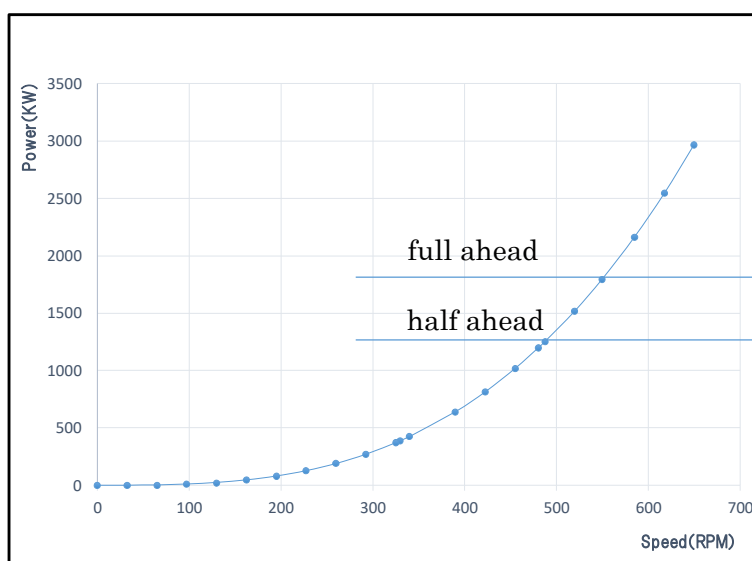
Figure 4 Speed-Power Curve of the Vessel’s Main Engine

The Vessel’s speed-power curve obtained from the maximum continuous output of the Vessel’s main engine (2,970 kW, 650 rpm; hereinafter referred to as “MCR”) and marine engine characteristics (diesel engine output proportional to the cube of revolutions) is as shown in Figure 4. According to the speed-power curve and the Vessel’s speed table, as shown in Table 2, at the time of the accident, the Vessel was operating at 480 rpm with her main engine set at half ahead and at approximately 40% of her output relative to the MCR.

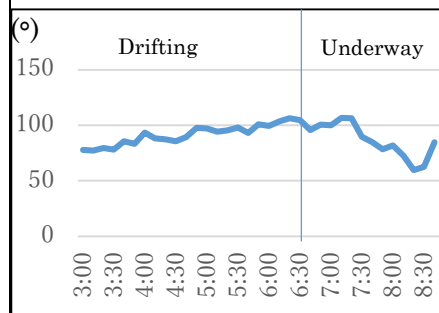
Figure 5 Angle of Pushing (to Starboard)

According to the Vessel's AIS record, the angle of pushing by the wind and waves (direction of course over the ground relative to heading) and speed over the ground from 03:00, when the Vessel was drifting with her main engine stopped, was as shown in Figure 5 and Figure 6. Even after the main engine was started after 06:30, the Vessel was being pushed in the direction of 60-100° to starboard at a speed of approximately 1 to 2 kn.

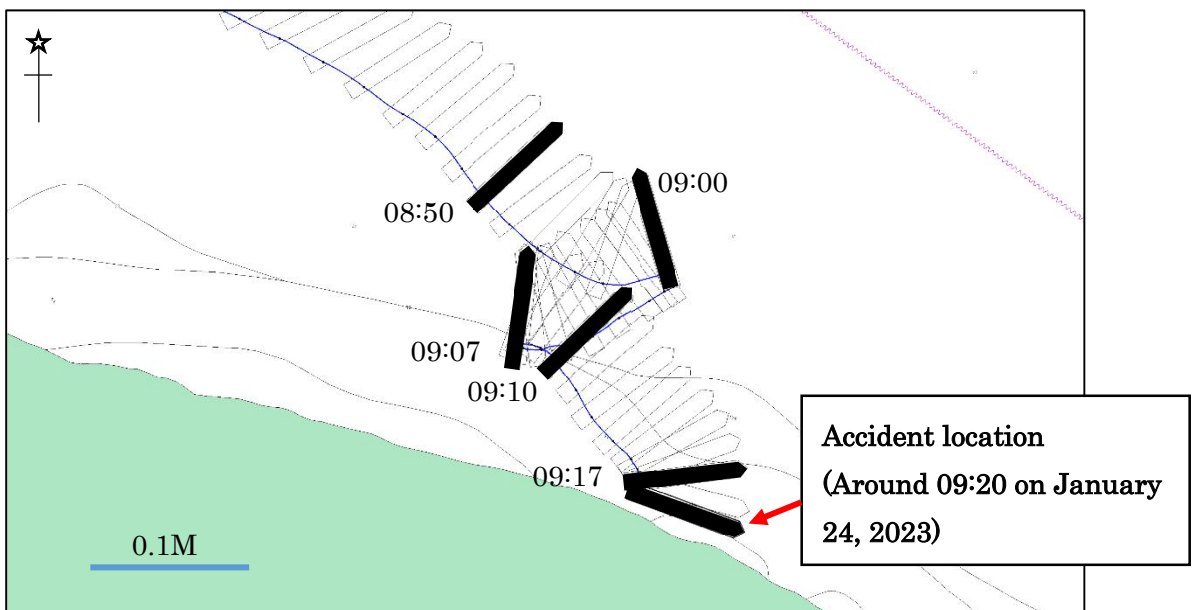
Annex Figure 5 Estimated Navigation Route (Enlarged)

Officer A observed that the wind and waves, whose effects on the Vessel were not particularly felt when he came to the bridge, were gradually gaining strength and that the Vessel’s distance to the Shallow Reef had become approximately 3 to 4 M. He therefore thought the main engine would be needed soon, and, at around 06:00, he ordered the engineer on engine room watch (hereinafter referred to as “Engineer A”) to start the main engine and asked the Master, who was resting in his cabin, to come to the bridge.
