Railway Accident Investigation Report

Train Derailment Accident between Urasa station and Nagaoka station
of the Joetsu Shinkansen of the East Japan Railway Company

November 30, 2007

Aircraft and Railway Accidents Investigation Commission

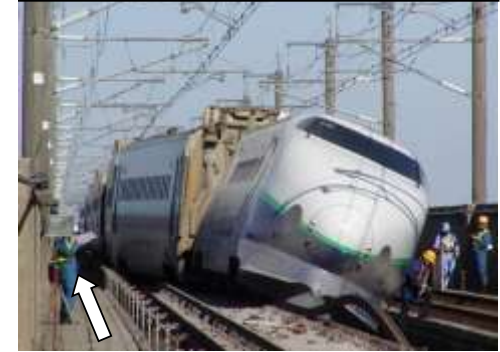
10th vehicle had leaned as right wheels fell into channel for evacuation of melting snow. Photo was taken from around 207,550m on Oct. 24.

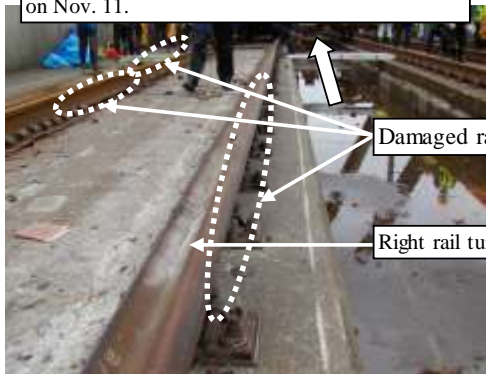
Right rail under vehicle body after removed 9th vehicle. Photo was taken from around 207,590m, on Nov. 11.

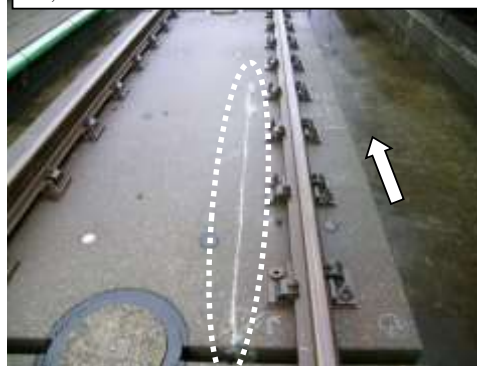
Traces under front bogie of the 1st vehicle after the vehicle was removed. Photo was taken from around 207,824m on Nov. 15.

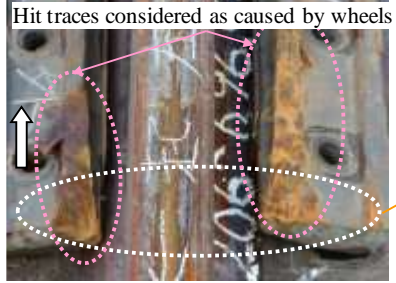
Assembled glued insulated joint bar and left rail in (1), Photo was taken Nov. 12.

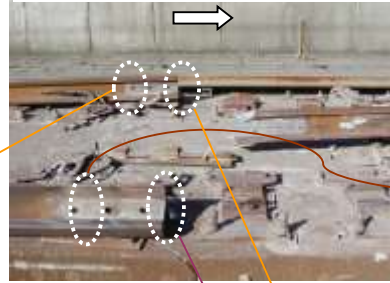
In the insulated joint at around 206,696 m, the glued joint bars of the right and left glued insulated rails^{*4} were removed, and front and rear rails at the joint were separated and broken, furthermore, there were lacks and cracks in a part of right edge of the slab track. Here, there was the hit trace considered as caused by the wheel on the removed glued joint bar. The right rail was broken at around 206,717 m and around 206,741 m. Here, there was the hit trace considered as caused by wheels in the side surface of the bottom of the broken rail.

(1) Separated right & left rails and damage of glued insulated joint, around 206,696m. Photo was taken on Oct. 24.

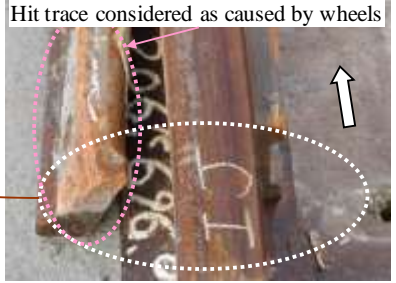
Assembled glued insulated joint bar and right rail in (1), Photo was taken Nov. 12.

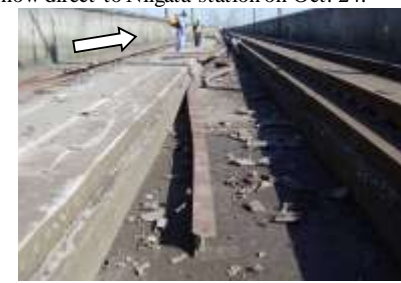
(2) Right rail separated in around 206,705m. Photo was taken from channel for evacuation of melting snow direct to Niigata station on Oct. 24.

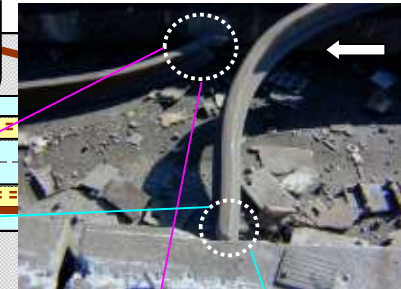
(5) Channel for evacuation of melting snow around 206,741m where right rail was broken. Photo was taken Oct. 24.

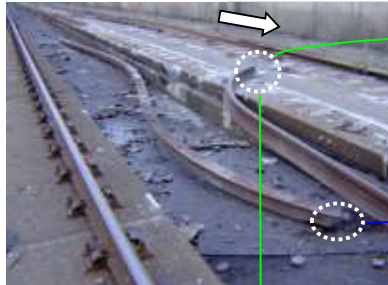
(3) Right rail had broken. Photo was taken from around 206,720m on Oct. 24.

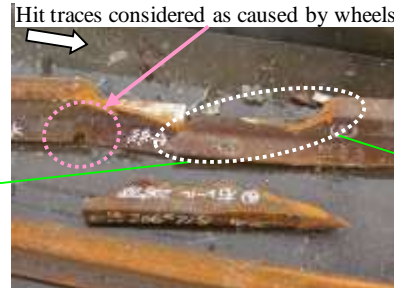
(4) Broken right rail and pieces of rail scattered in around. Photo was taken around 206,717m on Oct. 24.

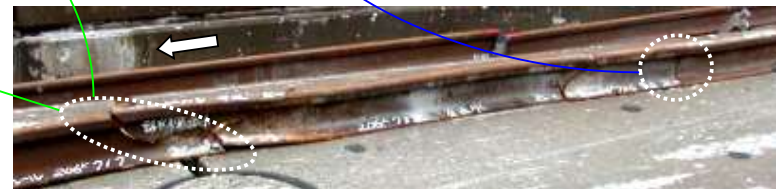
Opposite side of left part of Photo (4), up track side. Photo was taken on Nov. 14.

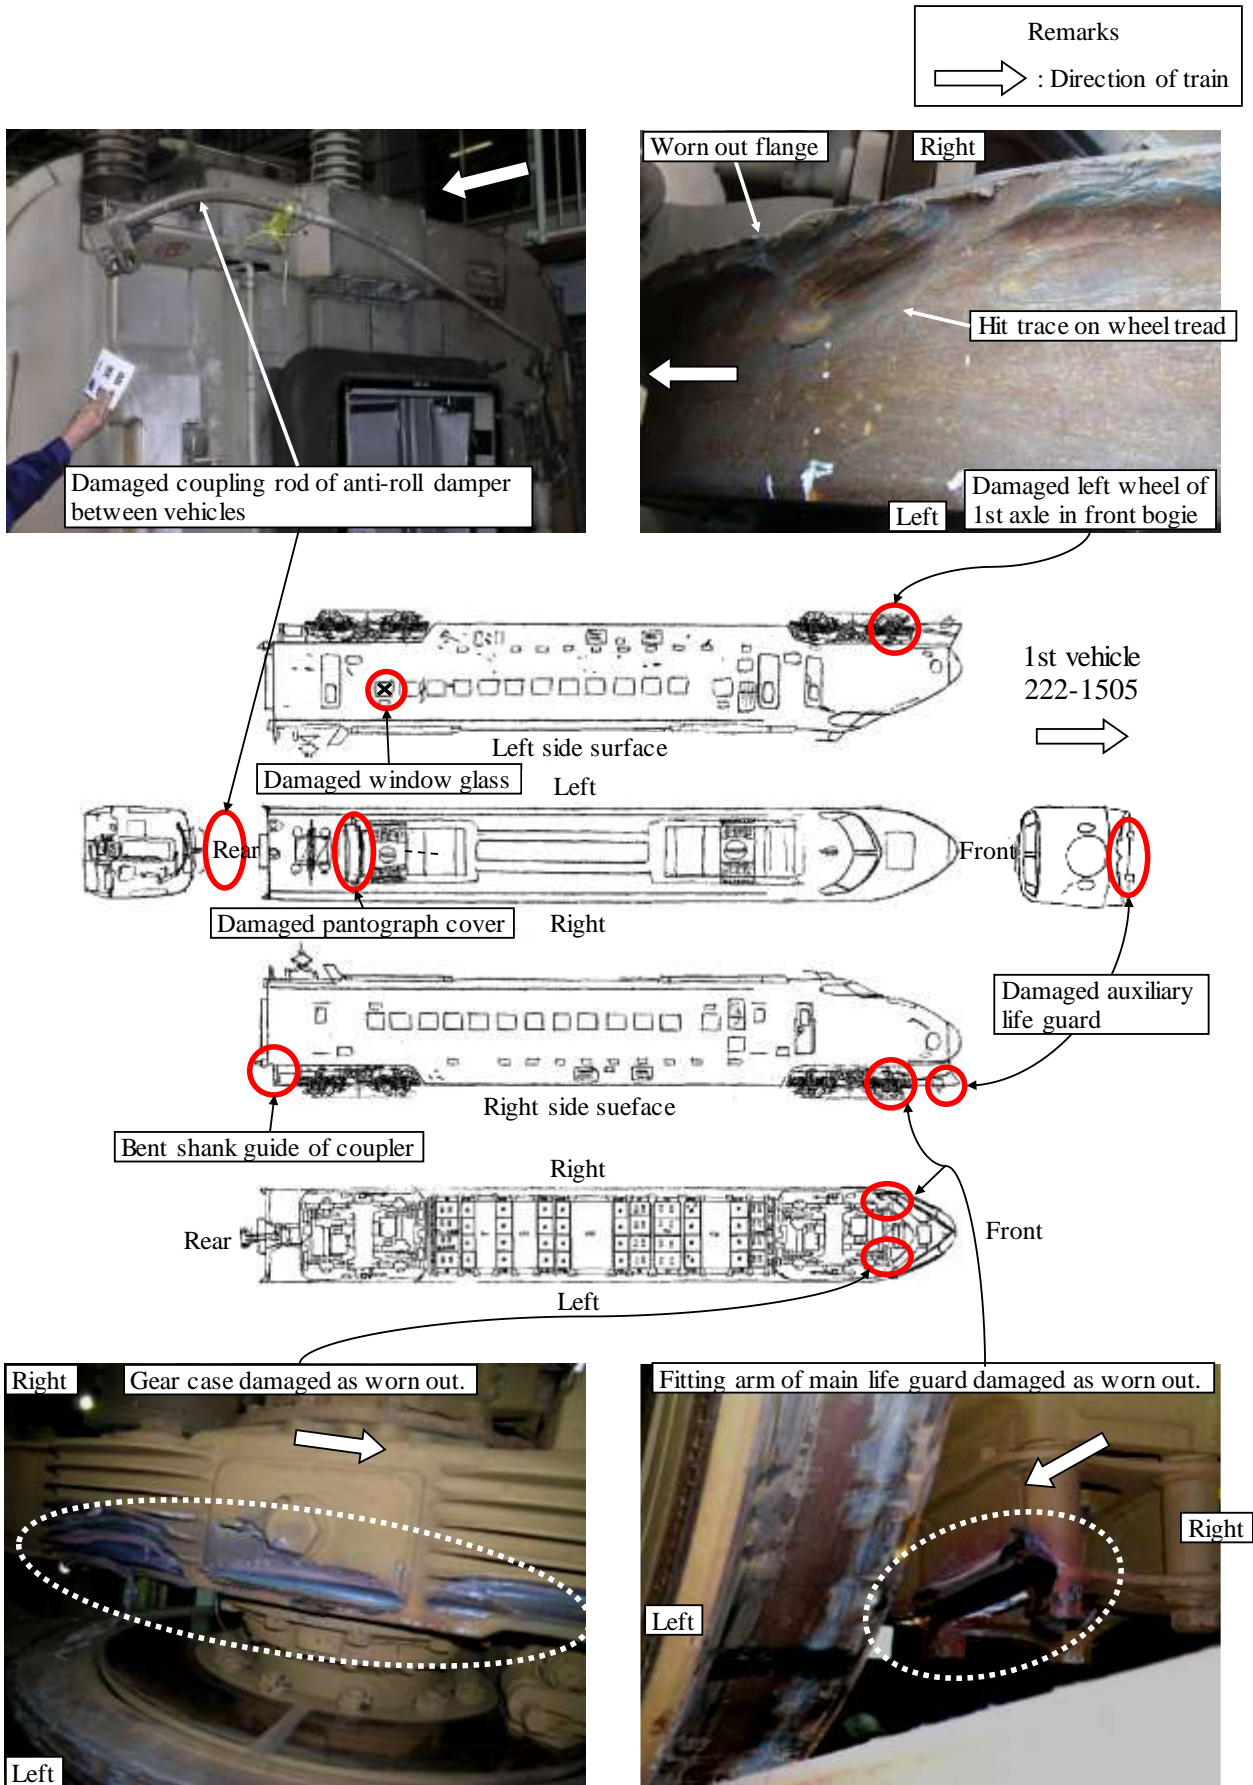
Figure 4. Status of the Major Damages of the Vehicles I (The 1st Vehicle)

- (a) A part of flange of left wheel in the 1st axle of the front bogie was worn away, and there were the hit traces on its outer tread.
- (b) The main life guard and the auxiliary life guard were damaged and there were traces considered as caused by coming into contact with rail, etc., in the brushing rubber of the auxiliary life guard.
- (c) There were damages considered as worn away in the portion, close to right shoulder of right rail, of the fitting arm of the right side main life guard, and in the portion, close to the right shoulder, of left rail of the gear case of the 1st axle in the front bogie, respectively.
- (d) A laminated glass of left side window in the passenger room was damaged.
- (e) The pantograph cover was damaged.
- (f) The coupling rod of the anti-rolling damper device, between the 1st and the 2nd vehicles, was damaged.

- (g) The shank guide of the rear coupler was bent.
- (2) The 2nd vehicle, 215-31 *[Refer to Figure 4-II]*
- (a) There were damages considered as caused by the coupler, in the front end of the vehicle body.

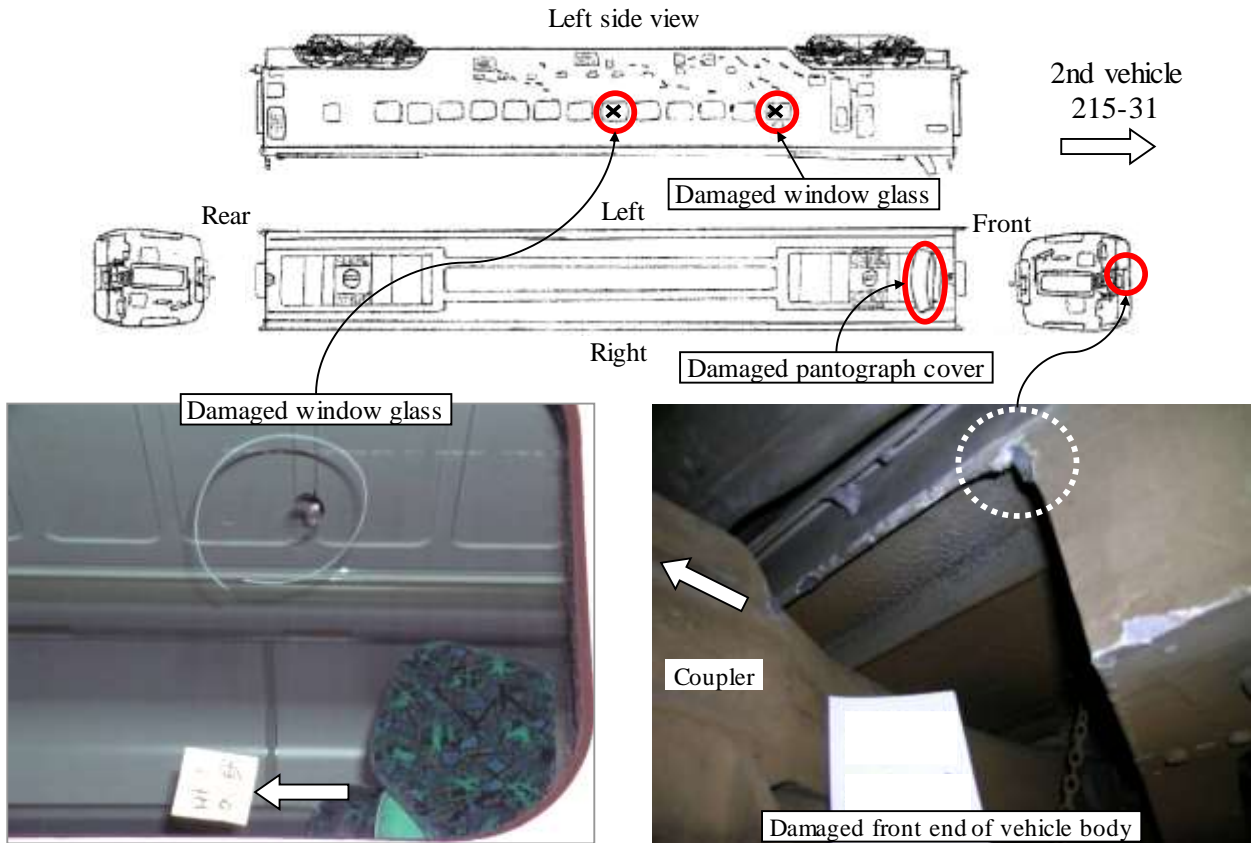
Figure 4. Status of the Major Damages of the Vehicles II (The 2nd Vehicle)

- (b) The pantograph cover was damaged.
 - (c) Two laminated glasses of the left side windows in the passenger room were damaged.
- (3) The 3rd vehicle, 226-1033 *[Refer to Figure 4-III]*

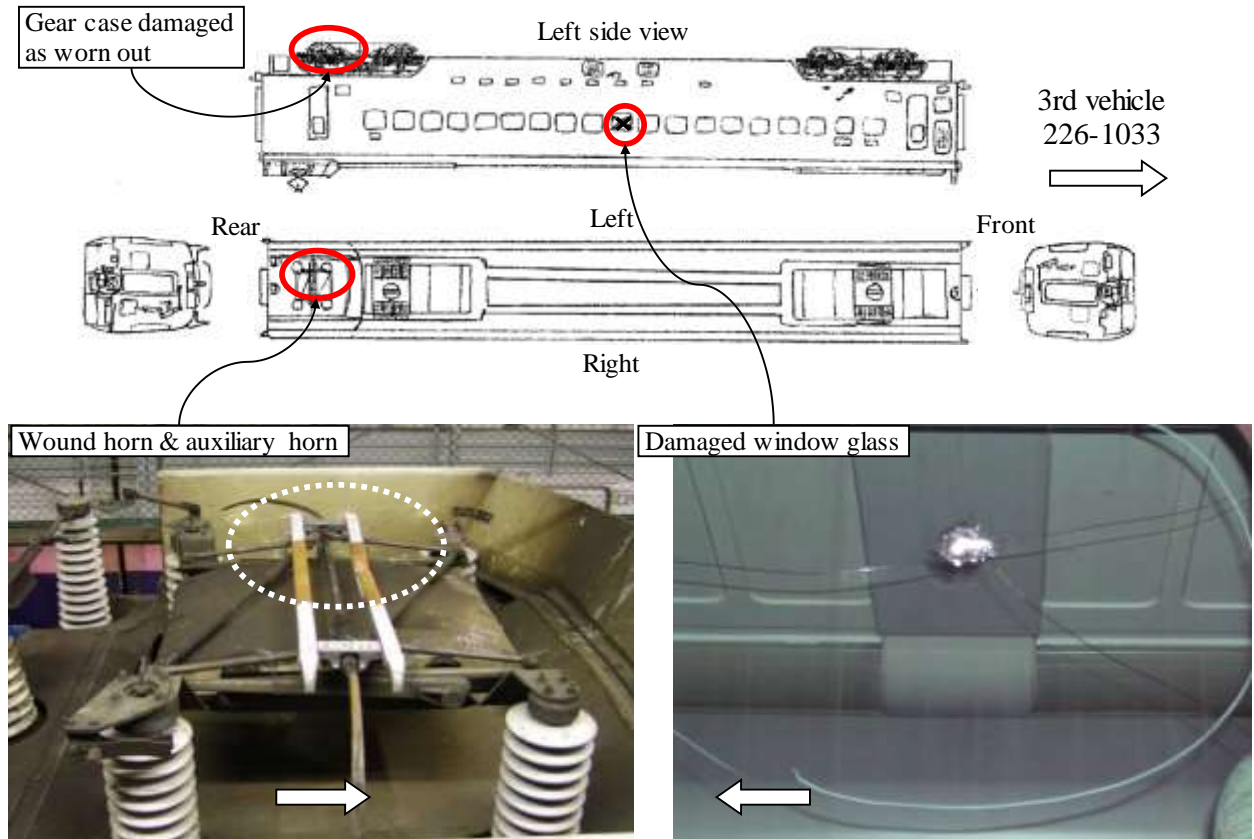
Figure 4. Status of the Major Damages of the Vehicles III (The 3rd Vehicle)

- (a) There were damages as worn away in the portion close to left shoulder of right rail of the gear case of the 2nd axle in the rear bogie.
 - (b) A laminated glass of left side window in the passenger room was damaged.

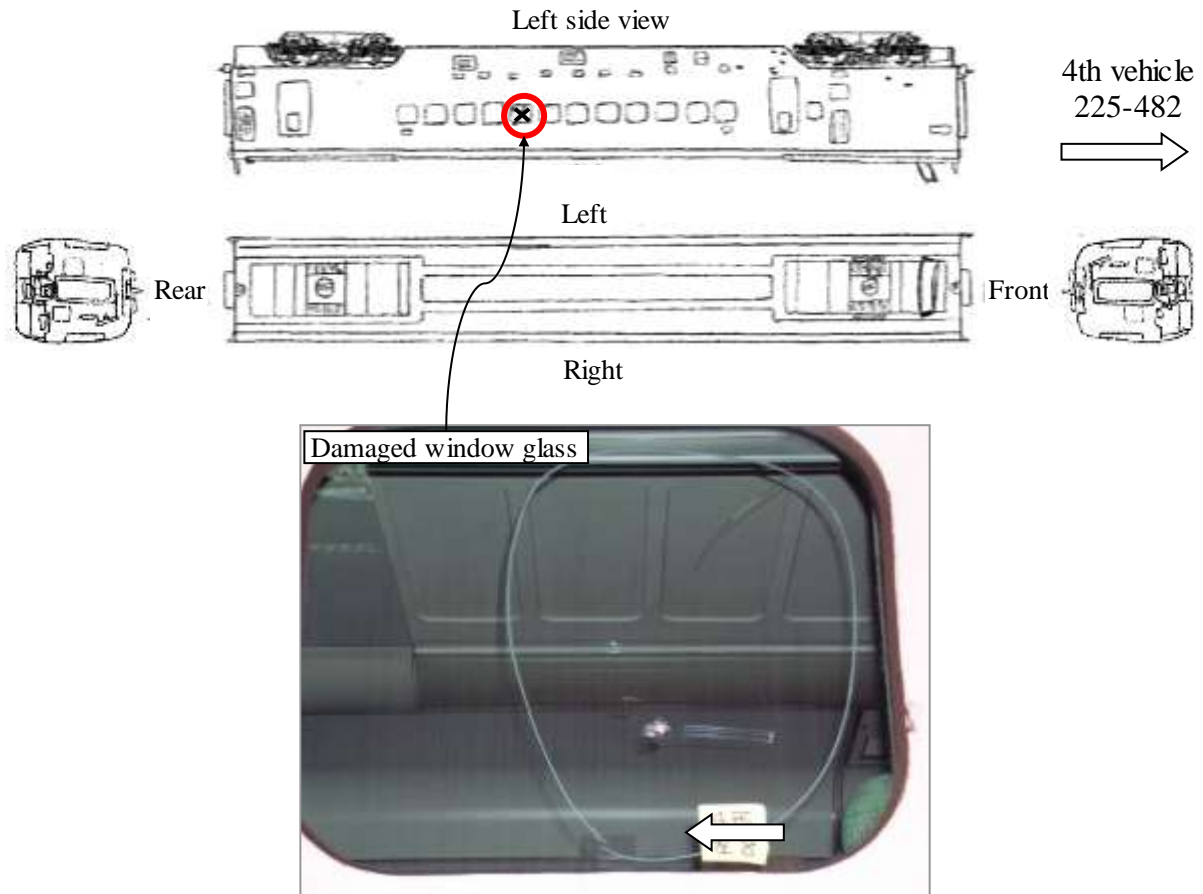
Figure 4. Status of the Major Damages of the Vehicles IV (The 4th Vehicle)

- Each one of the laminated glasses of right and left side windows in the passenger room were damaged.
- (5) The 5th vehicle, 226-1009 *[Refer to Figure 4-V]*

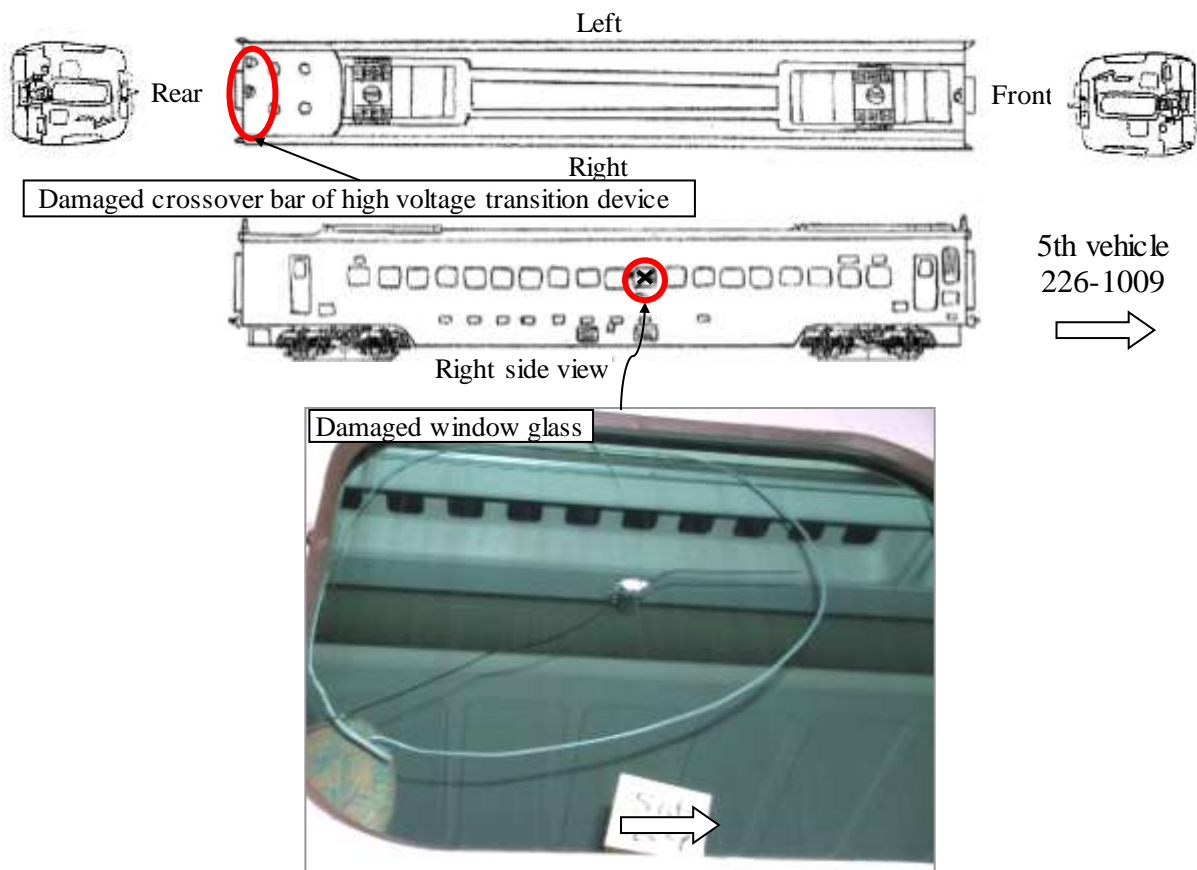
Figure 4. Status of the Major Damages of the Vehicles V (The 5th Vehicle)

- (a) A laminated glass of the window in right side of the passenger room was damaged.
 - (b) The jumper bar of the ultra high voltage jumper coupler in the rear end of the roof-top was damaged.

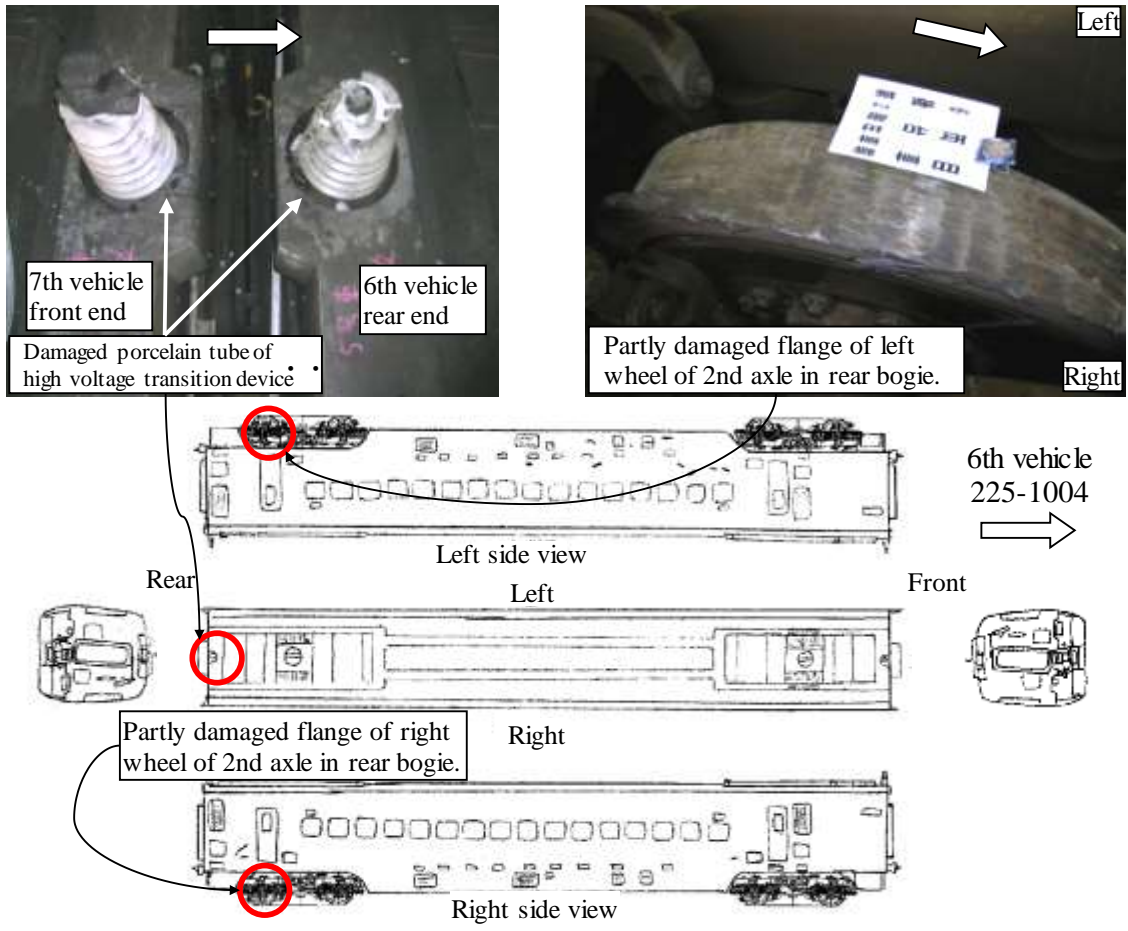
Figure 4. Status of the Major Damages of the Vehicles VI (The 6th Vehicle)

- (6) The 6th vehicle, 225-1004 *[Refer to Figure 4-VI]*
- (a) A part of wheel flanges of left and right wheels of the 2nd axle in the rear bogie were worn away in the same phase in the circumferences of the both left and right wheels.

- (b) The porcelain tube of the ultra high voltage jumper coupler in the rear end of the roof-top was damaged.
- (7) The 7th vehicle, 226-1032 *[Refer to Figure 4-VII]*

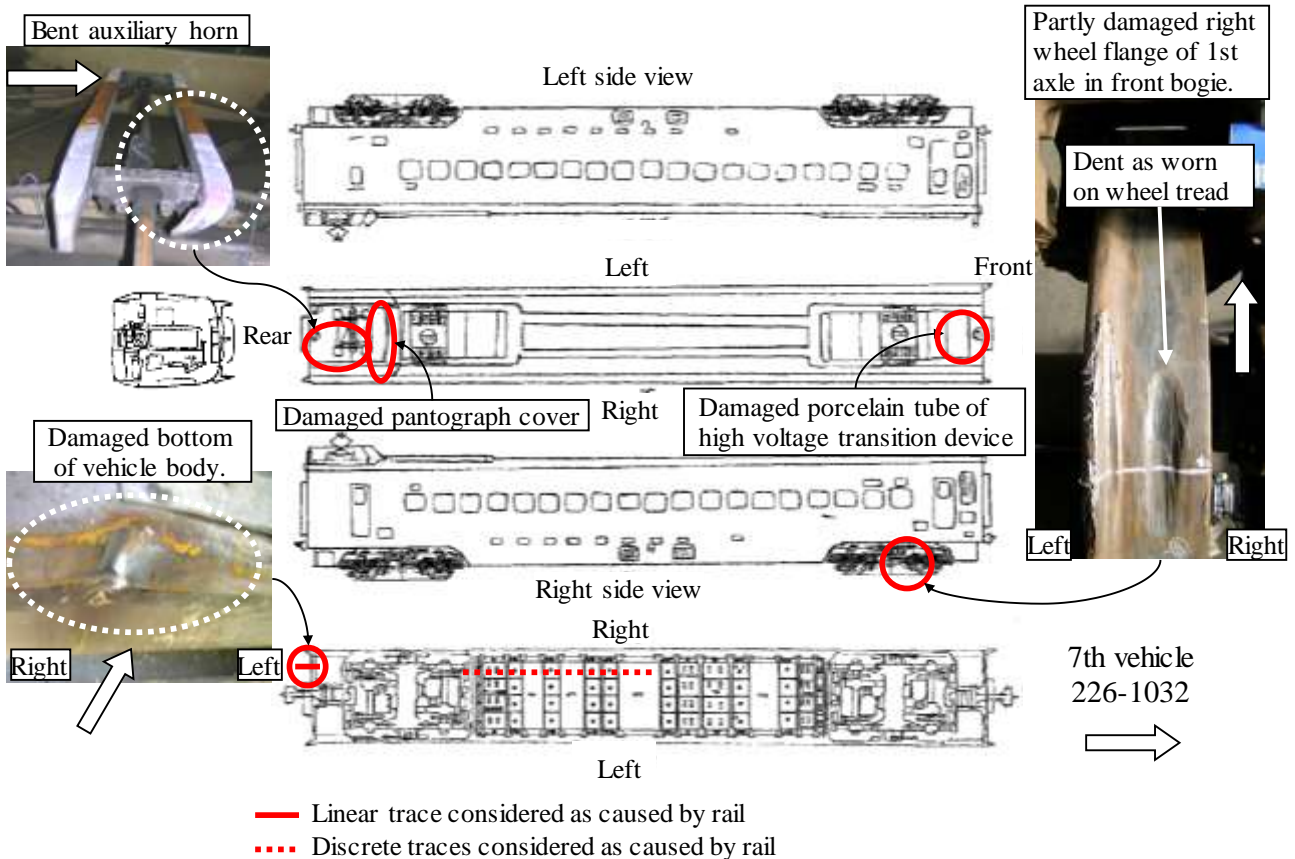
Figure 4. Status of the Major Damages of the Vehicles VII (The 7th Vehicle)

- (a) The porcelain tube of the ultra high voltage jumper coupler in the front end of the roof-top was damaged.
 - (b) A part of the flange of right wheel of the 1st axle in the front bogie were worn away, and there were worn hollows in the tread in outside of the worn flange.

- (c) There were linear damages considered as caused by rail on the bottom surface of the vehicle body.
 - (d) The Pantograph cover was damaged.
 - (e) The auxiliary horn in right side of the pantograph in operation, was bent.

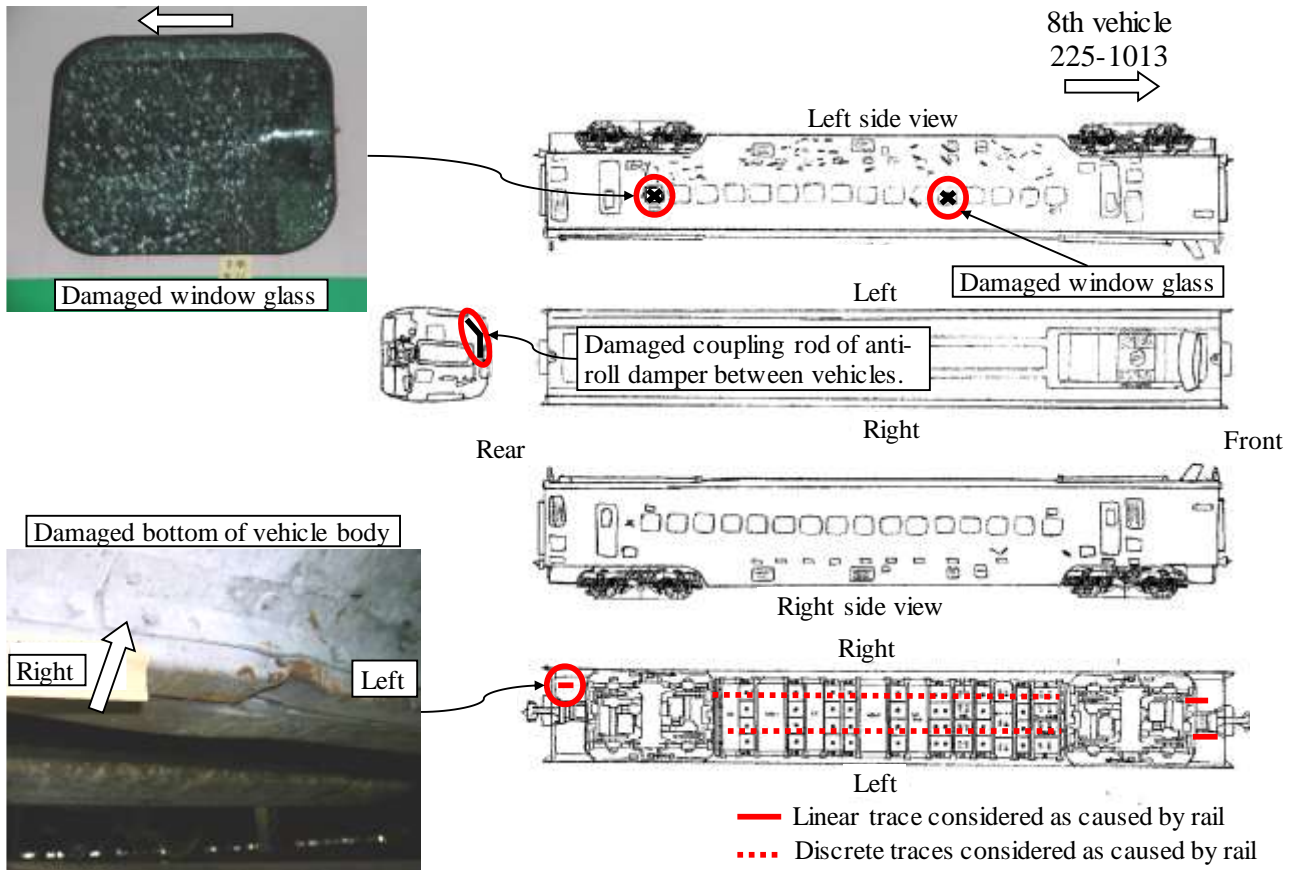
Figure 4. Status of the Major Damages of the Vehicles VIII (The 8th Vehicle)

- (8) The 8th vehicle, 225-1013 *[Refer to Figure 4-VIII]*
- (a) There were linear damages considered as caused by rail, in the bottom surface of the vehicle body.

- (b) Two laminated glasses of the left side window in the passenger room were damaged.
 - (c) The coupling rod of the anti-rolling damper between the 8th and the 9th vehicles were damaged.

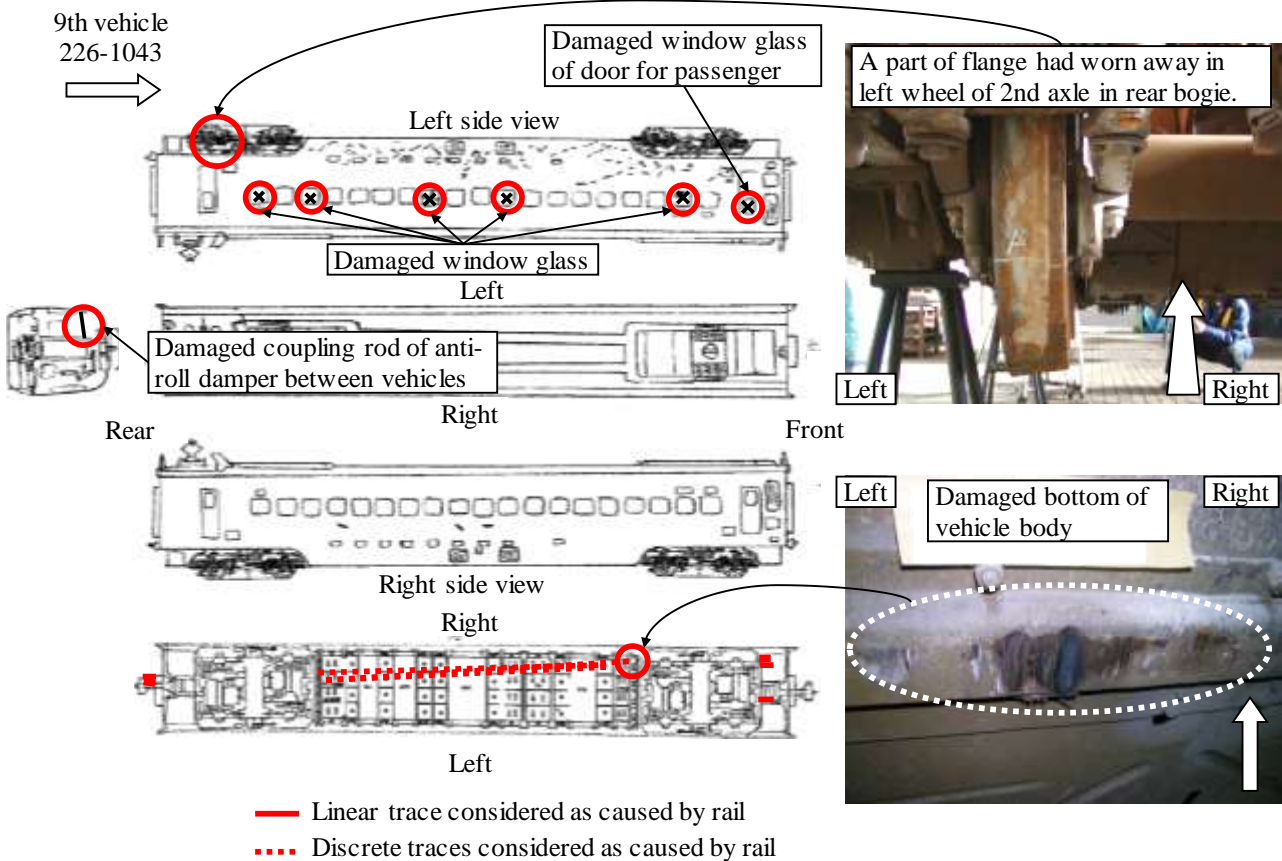
Figure 4. Status of the Major Damages of the Vehicles IX (The 9th Vehicle)

- (9) The 9th vehicle, 226-1043 *[Refer to Figure 4-IX]*
- (a) A laminated glass of the front left door for getting on and off for passengers was damaged.

- (b) Five laminated glasses of the left side windows in the passenger room were damaged.
 - (c) There were the linear damages considered as caused by rail, at the bottom surface of the vehicle body.

- (d) A part of the flange of the left wheel of the 2nd axle in the rear bogie was worn away.
 - (e) The coupling rod of the anti-rolling damper between the 9th and the 10th vehicles was damaged.

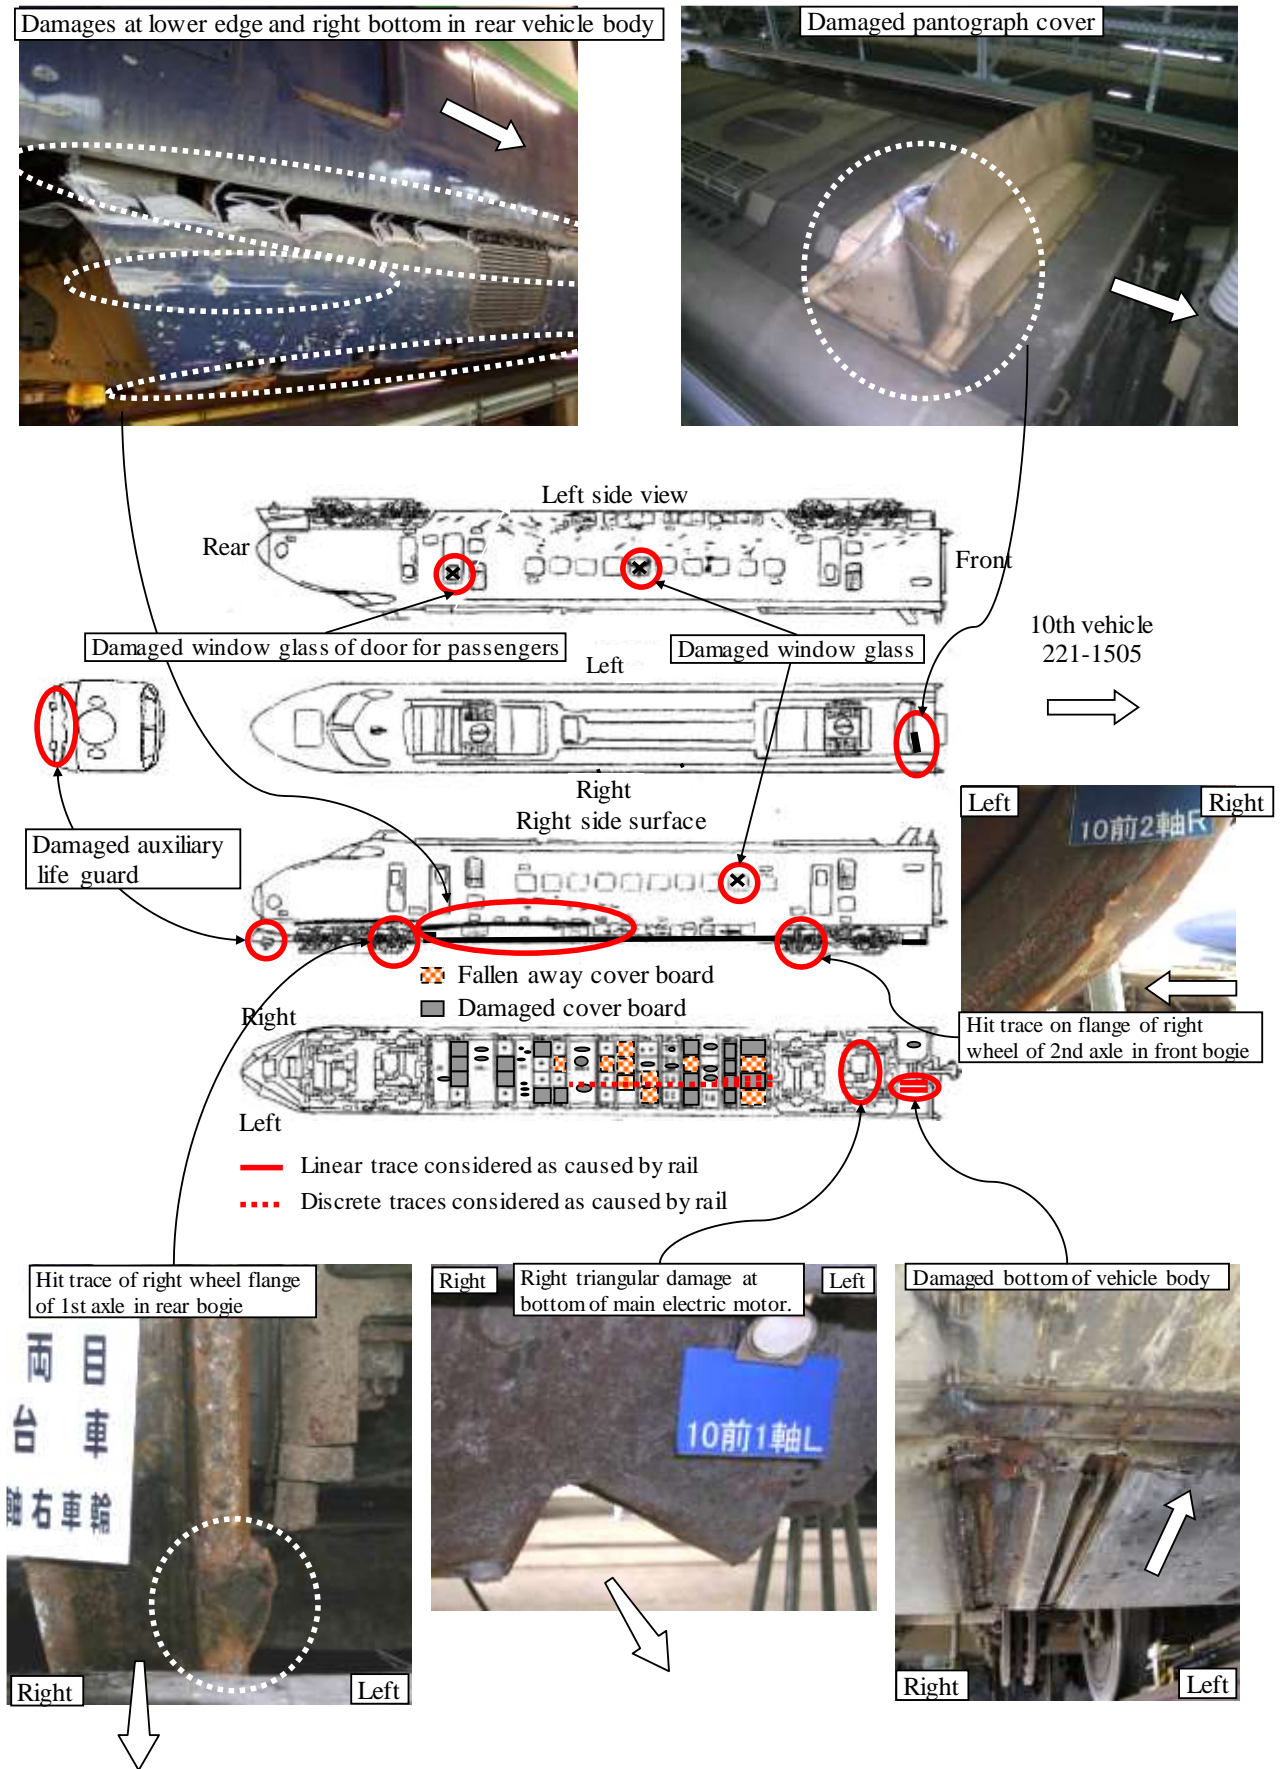
Figure 4. Status of the Major Damages of the Vehicles X (The 10th Vehicle)

- (b) The pantograph cover was damaged.
 - (c) There was the damage as being worn away in almost right triangular cross section orthogonal to direction of train running, in the bottom of the main electric motor of the 1st axle in the front bogie.

- (d) A laminated glass of the window in each right and left side of the passenger room were damaged.
 - (e) A laminated glass of the rear left door for getting on and off for passengers was damaged. The damage was reached to inside of the door.

- (f) There were damages considered as caused by the slab track of the up track in the lower part of right side surface of rear part of the vehicle body, and damages considered as caused by the channel for the evacuation of melting snow between up and down tracks in bottom edge in the right side surface of rear part of the vehicle body, respectively.

- (g) There were linear damages considered as caused by rails in the bottom surface of the vehicle body.
 - (h) Ten cover boards for the bottom of the vehicle body were fallen away, and almost all cover boards including fallen boards were damaged.

- (i) A part of the front cover of right side axle box of the 1st axle in the rear bogie was broken.
 - (j) The main life guard and the auxiliary life guard were damaged.
