~ Accident that the train ran onto the compacted snow and derailed while passing the level crossing located in the curved track ~

Railway operator : Hokkaido Railway Company
 Accident type : Train derailment
 Date and time : At about 05:31, December 6, 2017
 Location : In the premises of Zenibako station, Hakodate Line, Otaru City, Hokkaido

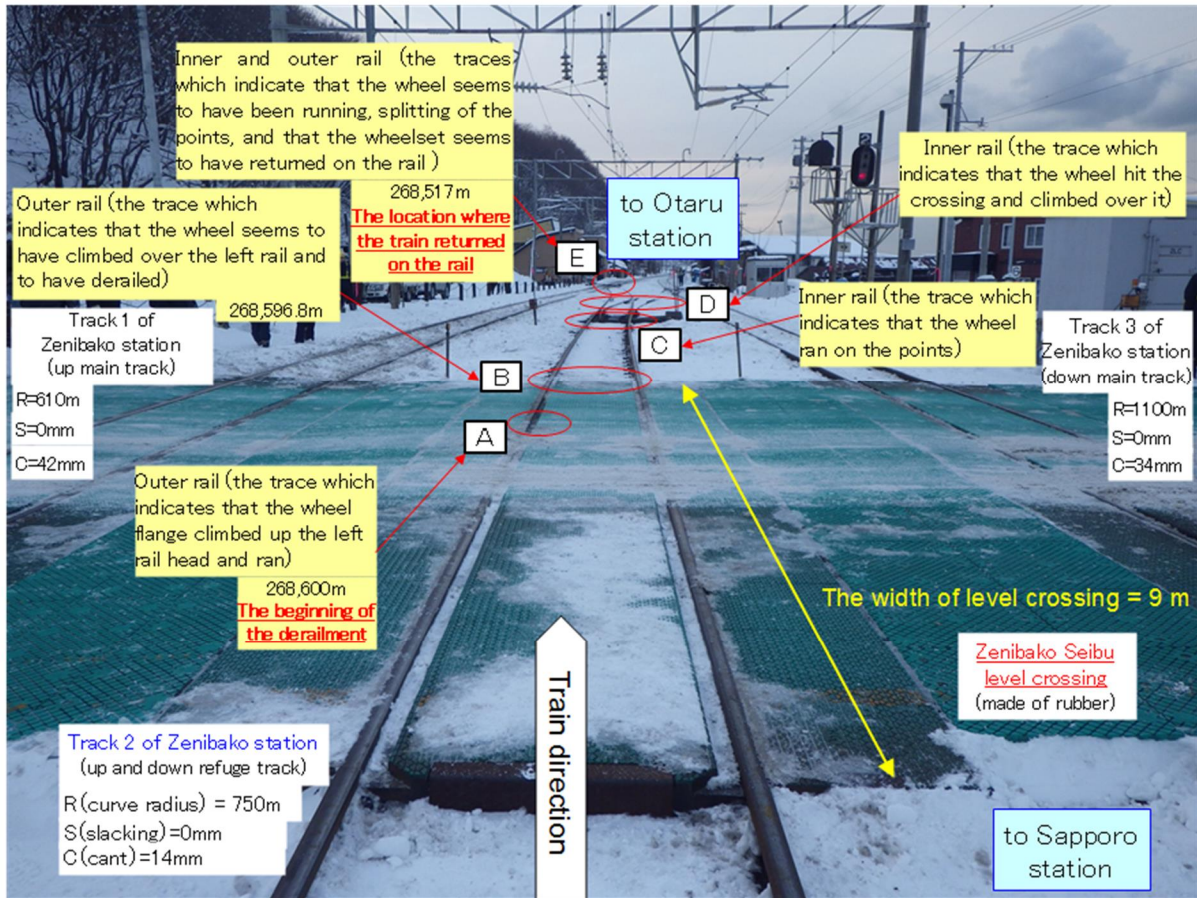
<The situation of the vicinity of the accident site>

- It is probable that the accident occurred as the left wheel of the 1st axle in the front bogie of the 1st vehicle climbed up the left rail, *i.e.*, the outer rail, and derailed to left, while the train

was passing the level crossing in the premises of the station, located in the right curved track in the refuge track for inbound and outbound trains where the frequency of train operation was low.

- It is somewhat likely that the derailment was caused as the wheel flange climbed up the compacted snow which had existed on the rail and the flangeway in the level crossing.

- It is somewhat likely that the compacted snow had been formed as it snowed hard in the previous day of the accident in the situation that the temperature around 0 °C had been continued, and the snow had been trodden hard by the automobiles passing the level crossing road in the long interval between the concerned train and the train operated just before the concerned train. In addition, it is somewhat likely that the compacted snow formed on the rail and the flangeway had been remaining without removed, because the snow removal works had not been implemented before the concerned train passed.

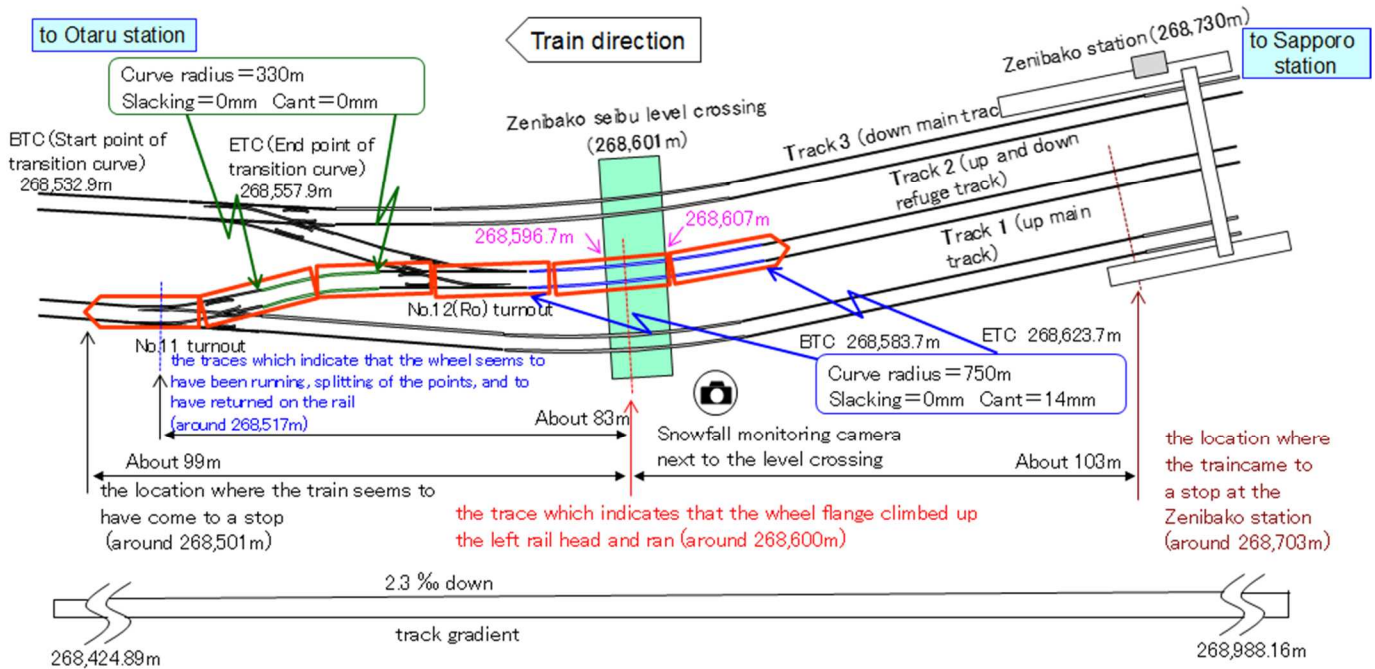
<The situation of the derailment>

At about 05:31, Wednesday, December 6, 2017, while the inbound Deadhead 5854M train, one man operated and started from Teine station bound for Otaru station of Hakodate Line, was running in the No.2 track, the refuge track for inbound and outbound trains, in Zenibako station, at a velocity of about 34 km/h in the cruising operation, the driver of the train noticed an abnormal sound and the indication showing an abnormal situation in the monitor display in the driving desk, then the driver applied an emergency brake and stopped the train.

After checked the vehicles, train operation was resumed, but the indication of the abnormal situation had been displayed repeatedly. Therefore, the train operation was cancelled, and the train was deadheaded to Sapporo Operation Depot. As the traces showing that wheel derailed and continued running, was found in the wheel of the 1st axle in the front vehicle of the 1st vehicle of the train, in the results of the vehicle inspection implemented in Sapporo Operation Depot, the investigation of the track in the premises of the station was implemented. As the results of the investigation, the trace of the derailment of train was found in Zenibako West level crossing and the trace of restoring was found in the No.11 turnout which was located in about 83 m apart from the level crossing in the direction of Otaru station.
