"The accident that the train derailed because the gauge widened significantly while the train was passing through the curved track"

Railway operator : Konan Tetsudo Co., Ltd.
 Accident type : Train derailment
 Date and time : About 18:52, April 14, 2019
 Location : Around 13,280 m from the origin in Owani station, between Chuo-Hirosaki station and Hirokoshita station, single track, Owani Line, Hirosaki City, Aomori Prefecture

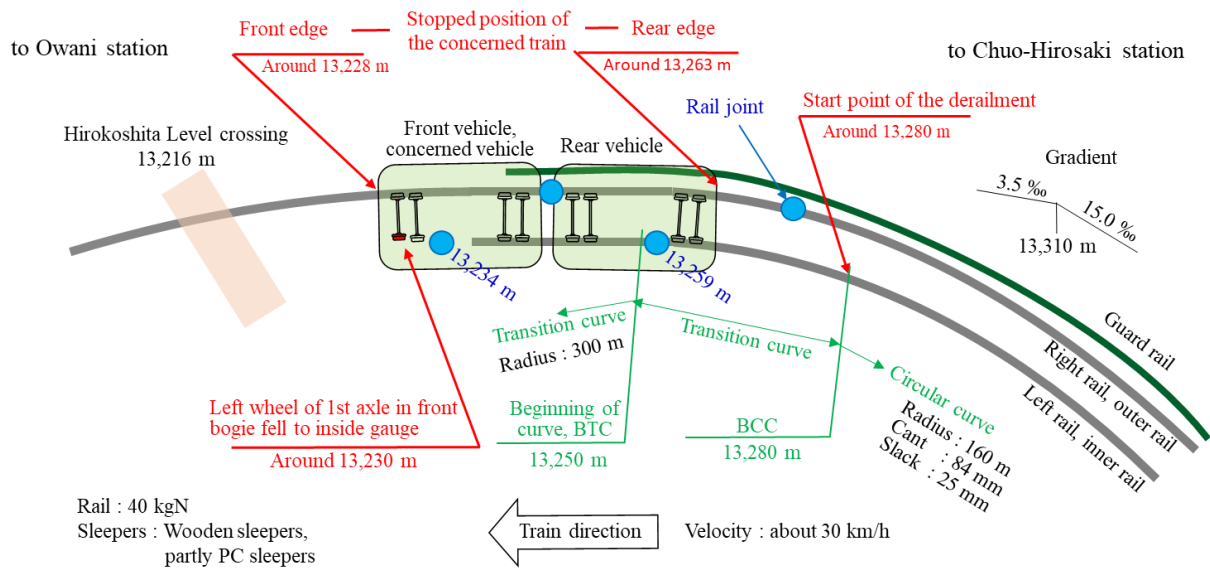
<STATUS OF THE DERAILMENT>

After the train stopped, the driver checked the situation and found that the 1st axle in the front bogie of the forefront vehicle had been derailed.

It is probable that the concerned accident was caused as that the left wheel of the 1st axle in the front bogie of the forefront vehicle fell to inside gauge because the gauge widened significantly while the train was passing through the 160 m radius left curved track.

As for the significantly widened gauge, it is probable that the gauge widened dynamically by the rail tilting, etc., due to the lateral force caused by the running train, because of the large static irregularity of gauge and the continuously existed poor sleepers and the poor rail fastening status in the concerned curved track.

It is probable that the static irregularity of gauge had been large, related with that the maintenance standard value for the irregularity of gauge was larger than the appropriate value because the slack had not been considered.

It is probable that the poor sleepers and the poor rail fastening status had been continuously existed, related with the insufficient repairing works for the sleepers and the rail fastening devices due to the inadequate records and measuring methods in the sleeper inspections.

- (1) The steady implementation of the track maintenance.
- (2) Change of materials of the sleepers.
- (3) Study on the reduction of the slack.
