"The accident that train collided with earth and sand flowed into railway track and derailed"

Railway operator : Aizu Railway Co. Ltd.
 Accident type : Train derailment
 Date and time : About 05:50, November 27, 2019
 Location : Around 24,556 m from Nishi-Wakamatsu station, between Tonohetsuri station and Yunokami Onsen station, single track, Aizu Line, Shimogo Town, Fukushima Prefecture

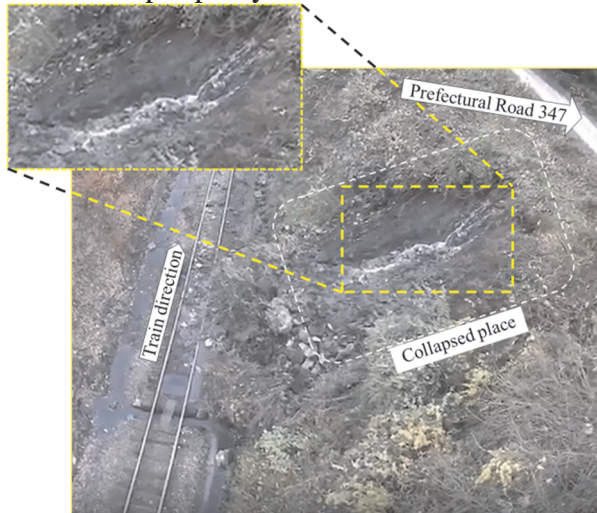
<Status of periphery of the accident site>

At about 05:50, on Wednesday, November 27, 2019, while the one-man operated inbound 2302D train, composed of two vehicles and started from Aizu-Tajima station of Aizu Railway Co., Ltd., bound for Aizu-Wakamatsu station was in the left curved track between Tonohetsuri station and Yunokami Onsen station at the velocity of about 60 km/h, the driver of the train noticed the earth and sand flowed into the track in ahead, and applied the emergency brake but the train ran onto the earth and sand, and all four axles of the front vehicle derailed.

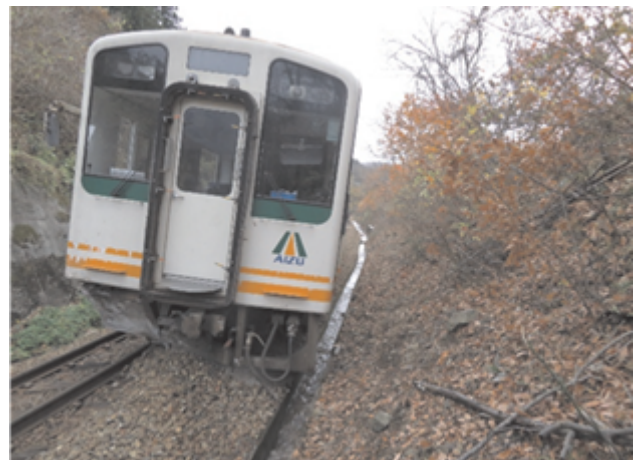
<Status of derailment>

The JTTSB concludes that the probable cause of this accident was that the slope in the railway track side collapsed, and the train ran onto the earth and sand flowed into the railway track and derailed in the accident.

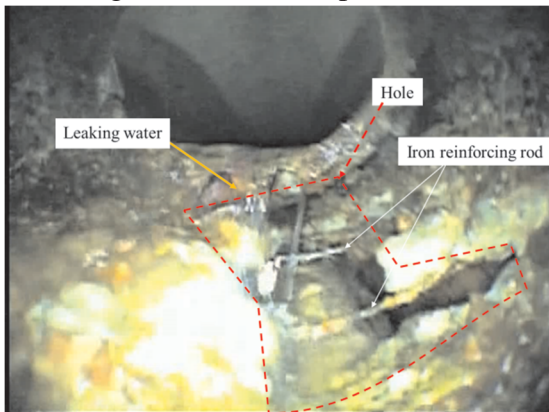
<Image of the fiber scope>

It is probable that the slope collapsed and earth and sand flowed into the railway track because the strength of the waterway, which had been laid underground of the Fukushima Prefectural Road 347 located in upper part of the collapsed slope, deteriorated over the years, and broken caused the leaking water, that soaked into the collapsed slope, composed of the colluvium layer, and made unstable status due to the increased water content.

It is likely that the waterway broke as deteriorated strength due to the deterioration over the years, related by that the management of the waterway had not been conducted properly.

In order to prevent the similar accident in the accident site, it is necessary for the manager of the waterway to manage the waterway properly such as to repair the waterway installed in upper part of the slope in order to keep in the healthy status.
