"The accident that train collided with earth and sand, etc., accumulated in the catch net for falling rocks as a result of a slope collapse, and derailed"

Railway operator : West Japan Railway Company  
 Accident type : Train derailment  
 Date and time : About 05:48, March 9, 2020  
 Location : Around 20,060 m from Bitchu-Kojiro station, between Tojo station and Bingo-Yawata station, single track, Geibi Line, Shobara City, Hiroshima Prefecture

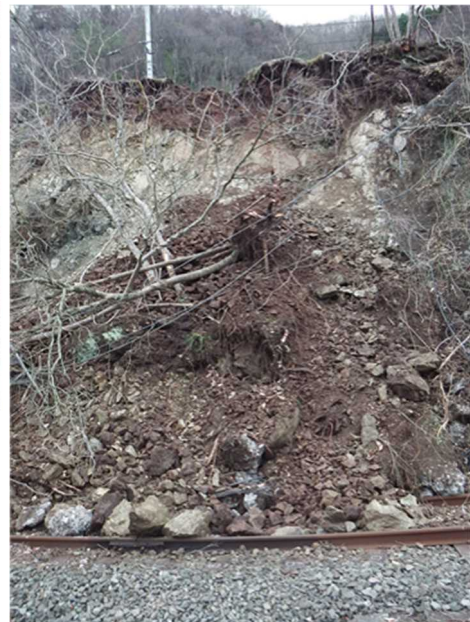
<Status of the collapsed slope >

It is probable that the slope had collapsed because the strength of the fragile inner bedrock in upper part of the slope deteriorated gradually by the progress of the weathering in long period.

Furthermore, the pocket type catch net for falling rocks itself can catch the falling stones, etc., and prevent to be flowed into the railway track, however there is the fear that the accumulated earth and sand were pushed out and hinder the route of the trains, based on the concerned accident. Therefore, it is desirable to conduct the inspection for the place where the pocket type catch net for falling rocks was installed same as this accident site, and take the measures such as the removal of the sprinkled place of unstable loose stones, the covering surface works such as the spraying works, the lattice frame works, the concrete covering works to suppress the collapse of slope due to the encroachment of weathering, etc., according to the necessity.

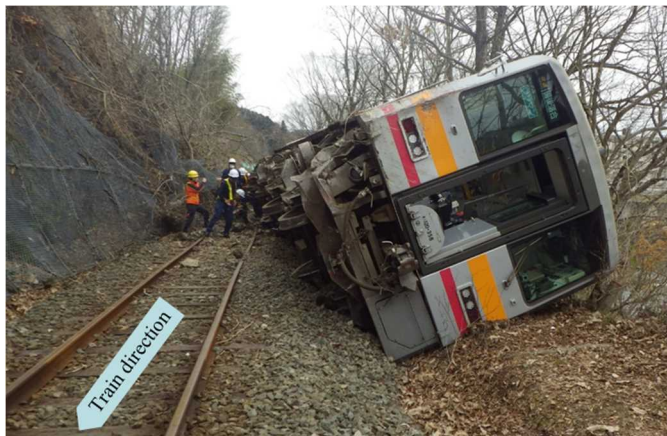
<Status of the derailment >

The train tilted to left side against the direction of travel and the vehicle body turned over, caused the derailment of the whole axles.

The JTTSB concludes that the probable cause of this accident was that the fallen rocks and earth and sand, etc., which were caused by the collapse of the slope and accumulated in the pocket type catch net for falling rocks and pushed out resulted to hinder the route of the train, and the approaching train collided with them, turned over, and resulted the derailment of all axles, in this accident.
