"The accident that train ran onto the plural ballasts and derailed while running in the level crossing"

Railway operator : East Japan Railway Company
 Accident type : Train derailment
 Date and time : About 15:53, May 8, 2020
 Location : Around 91,537 m from Chiba station, between Awa-Kamogawa station and Awa-Amatsu station, single track, Sotobo Line, Kamogawa City, Chiba Prefecture

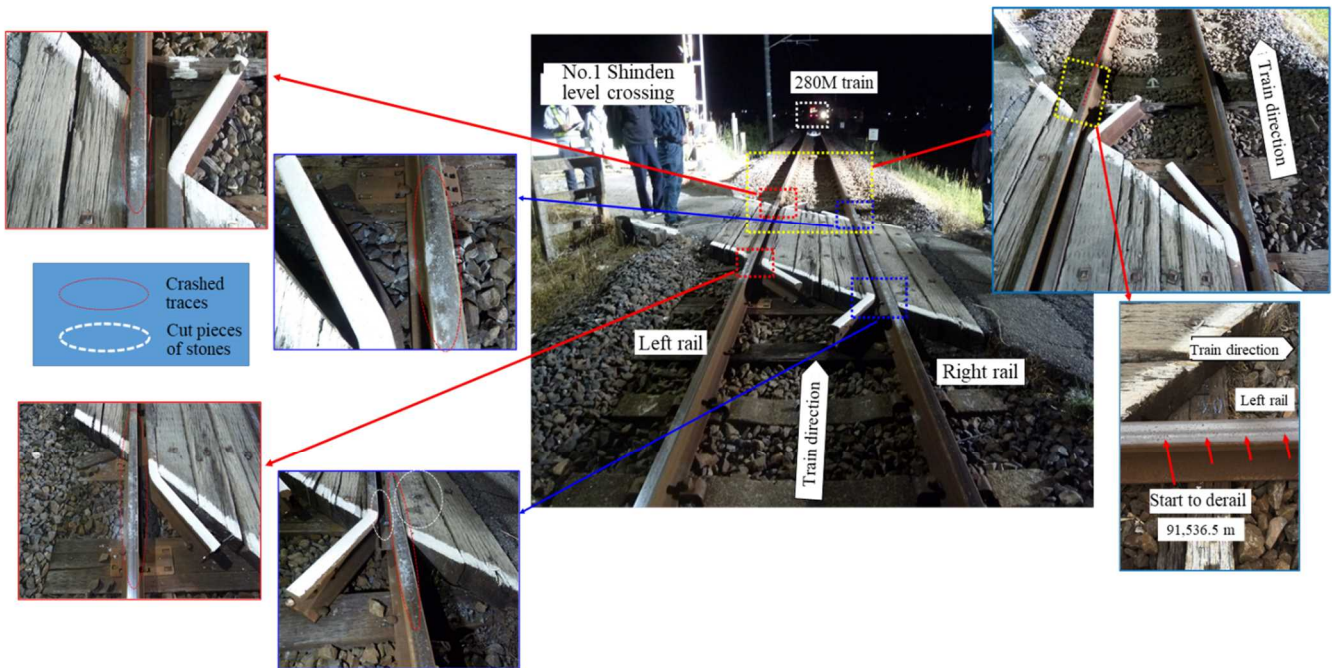
<Status of No.1 Shinden level crossing after the accident>

The JTTSB concludes that the probable cause of this accident was that, while the train was running in No.1 Shinden level crossing, the 1st and the 2nd axles in the front bogie of the 1st vehicle ran onto the plural ballasts in around the top surface of rail in the level crossing and derailed to left side of the direction of travel, in this accident.

It could not be determined the precise reason why the plural ballasts had been existed in around the top surface of rail in the level crossing, although there was the possibility as to be placed intensively.

- (1) The placed stones have the possibility to cause the train derailment accident depending on the placed positions and the numbers, therefore, it is considered as necessary for the railway operators to cooperate with the police, the local self-government, etc., in order to prevent such placed dangerous stones from happening.
- (2) It is desirable to study on the installation of the device to remove obstacles in the part close to the top surface of rail in the vehicle body or the bogie, in the range that the safety running of the vehicle can be secured, in order to remove obstacles such as the ballasts, etc.
- (3) It is desirable to study on the installation of the guard angles in the neighborhood of the level crossing, and the installation of the device to prevent deviation to the vehicles in order not to deviate largely in the neighborhood of the level crossing when derailed,

because there is the possibility to cause the train derailment accident depending on the size of the obstacles, etc., in the level crossing.
