"The accident that train derailed by the significantly widened gauge while passing in curved track"

Railway operator : Toyama Chihou Tetsudou Inc.
 Accident type : Train derailment
 Date and time : About 08:56, July 26, 2020
 Location : In the premises of Higashi-Shinjo station, Main Line, Toyama City, Toyama Prefecture

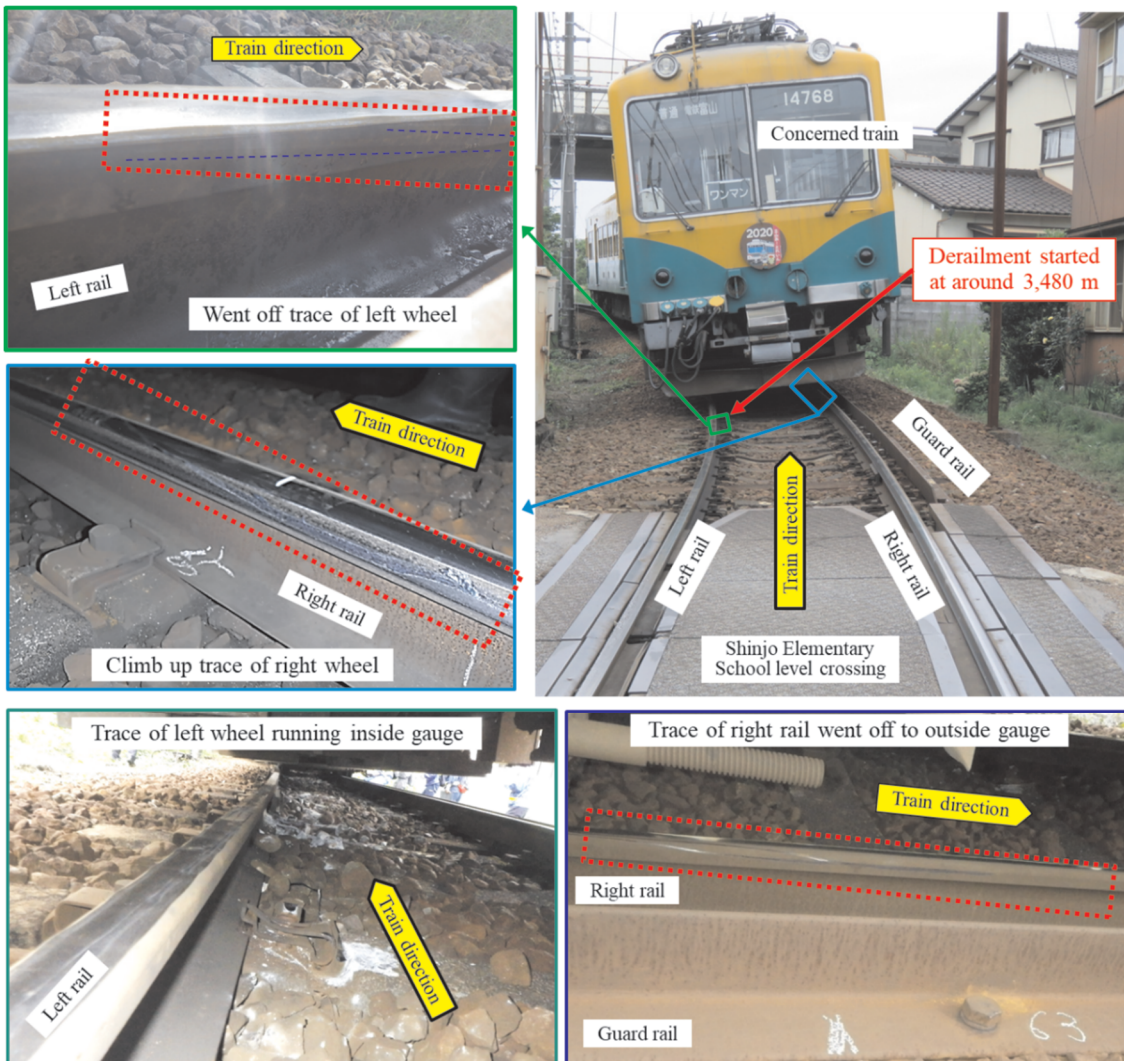
<Status of the derailment>

After the train stopped, the driver checked the vehicle and found that the 1st axle in the front bogie of the front vehicle derailed to right, and all axles in the front bogie and the 1st axle in the rear bogie of the rear vehicle derailed to right.

The JTTSB concludes that the probable cause of this accident was that the gauge widened significantly while the train was passing in the left curve of 181 m radius, and the left wheel of the 1st axle in the front bogie went off inside gauge.

It is probable that the gauge widened significantly because the gauge widened dynamically due to the lateral movement and the tilting of rail caused by the the lateral force accompanied by the train running, as the poor rail fastening devices existed continuously in the curved track, where the static irregularity of gauge had been exceeding the maintenance standard value.
