"The accident that the train collided with the fallen trees and derailed"

Railway operator : East Japan Railway Company Ltd.
 Accident type : Train derailment
 Date and time : About 21:35, July 5, 2021
 Location : Around 8,465 m from Ichinoseki station, between Mataki station and Rikuchu-Kanzaki station, single track, Ofunato Line, Ichinoseki City, Iwate Prefecture

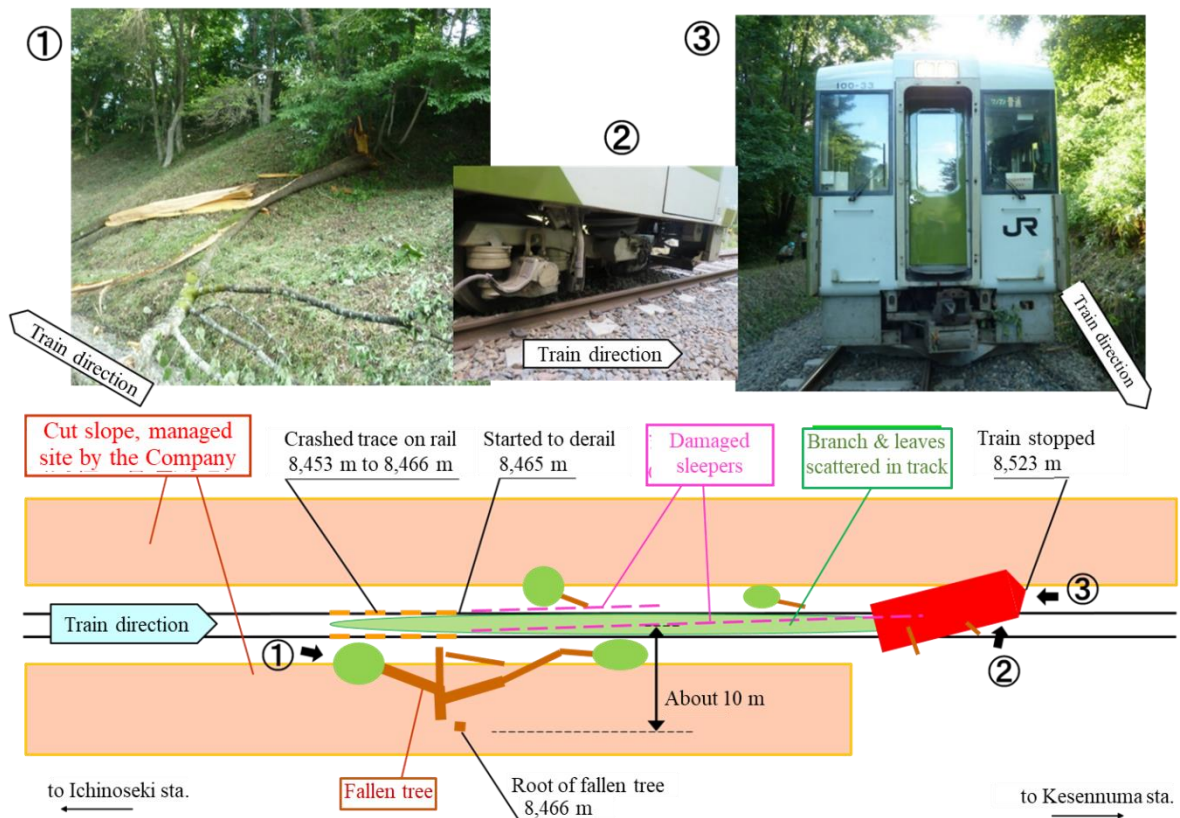
The driver of the train, while the train was running in the section between Mataki station and Rikuchu-Kanzaki station in the dark circumference at the velocity of about 67 km/h, found the fallen trees in ahead and operated the emergency brake, but it was too late, the train collided with the fallen trees and all 2 axles in the front bogie derailed to left side of the travelling direction.

General situation of the accident site and periphery

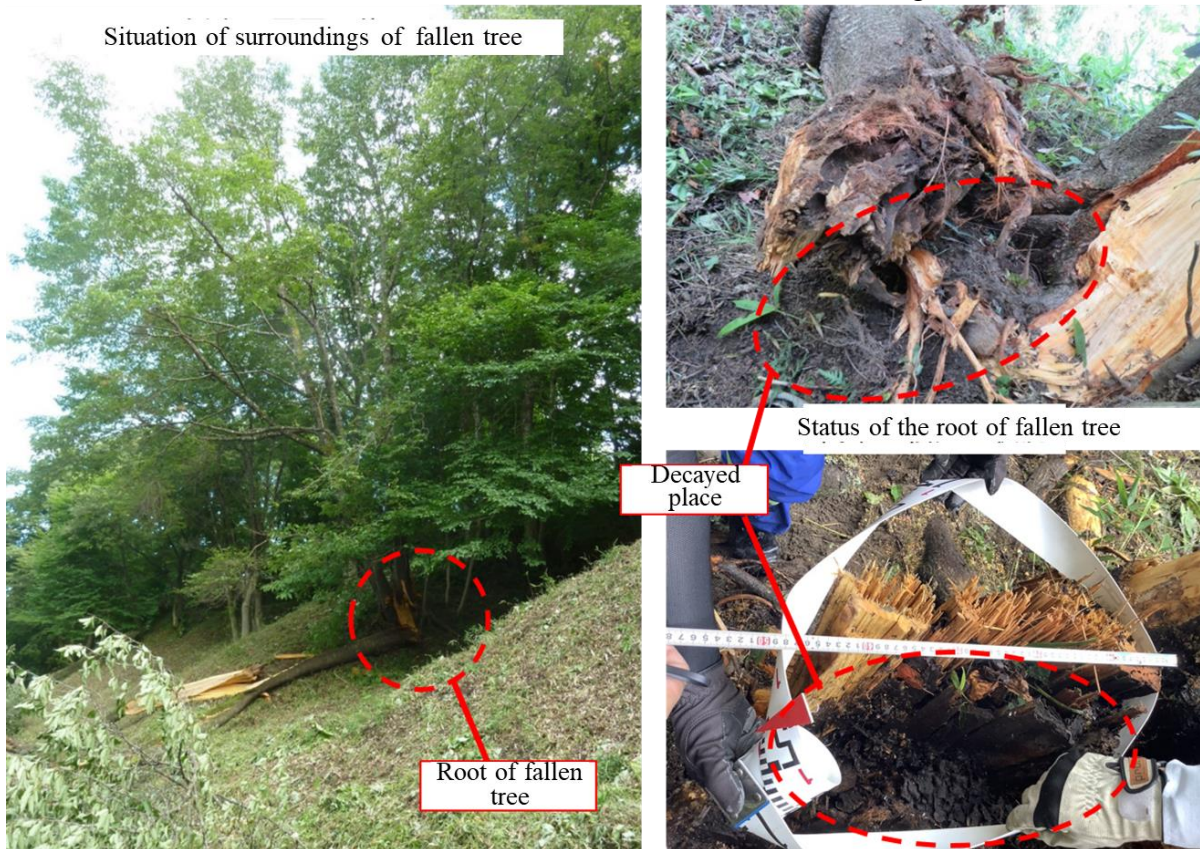
It is highly probable that the fallen trees had been invaded the structure gauge and hindered the route of the train, because the trunk of the tree, which had been grown up in the cut slope in right side of the direction of the train, broke at around the root where hollowed partly due to the progress of the deterioration, and collapsed toward the railway track.

Status of the root of the fallen tree and surroundings

It is considered as necessary to investigate more precisely on the part between trunks for the case of the trees as plural trunks grew up from the single root same as the concerned fallen tree, and to review the manual such as to add the case of the concerned fallen tree, etc., and let known well.

It is desirable to conduct the precise investigation by the hammering test using wooden hammer or the intrusion of steel rod, etc., depending to the necessity, in addition to the visual observation by the good use of the specialist of the trees, in the management of trees.
