RAILWAY ACCIDENT INVESTIGATION REPORT

**Railway accident with train derailment in the premises of Takamiya station,
single track, Toga Line, Hikone City, Shiga Prefecture
OHMI Railway Co., Ltd.**

| Date and Time | About 21:17, February 7, 2022 |
| Location | In the premises of Takamiya station, single track, Taga Line, Hikone City, Shiga Prefecture |

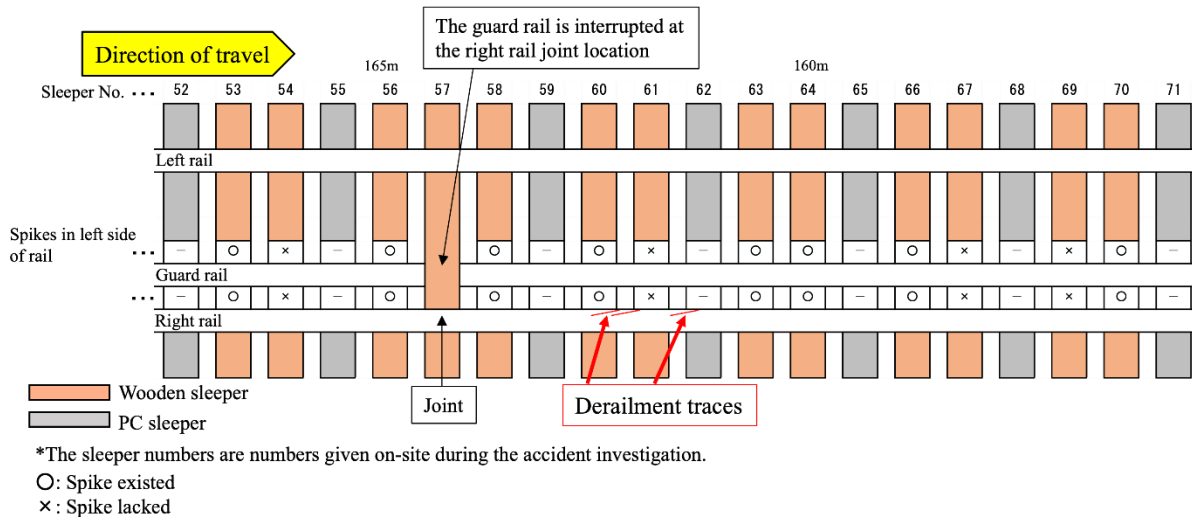
Figure 3: Fastening Guard Rails

(8) A 40 kgN guard rail is installed inside the gauge of the right rail along the entire length of the Curve. The guard rail is fastened to wooden sleepers by one dog spike each on the inside and outside. [Refer to Figure 1] However, as shown in Figure 3, there were spots where it was not fastened with dog spikes.

In addition, according to the “guide to controlling the track management shown in the photos^{*6},” the method for laying guard rails and fastening them to sleepers is said to be “fastening the guard rail to each sleeper with dog spikes, etc.”

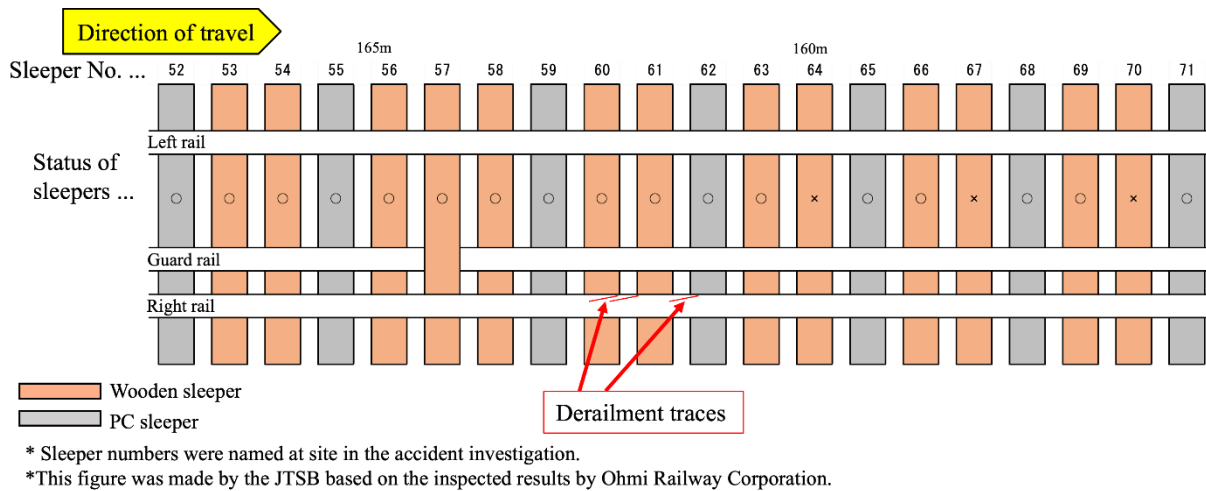
Figure 4. Sleeper Inspection Results

The inspection results for near the site of the accident are shown in Figure 4. According to this same figure, there were 3 defective sleepers found near the site of the accident.

With regard to sleepers near the derailment starting point, as mentioned in 2.3.3.3 (2) (i), a periodic inspection was conducted on September 9, 2021, and three defective sleepers were found near the site of the accident. However, as mentioned in 2.3.3.4 (2) (ii), in the investigation conducted on February 9, 2022, after the accident, a series of spots were found near the derailment starting point that were suspected to be defective sleepers.

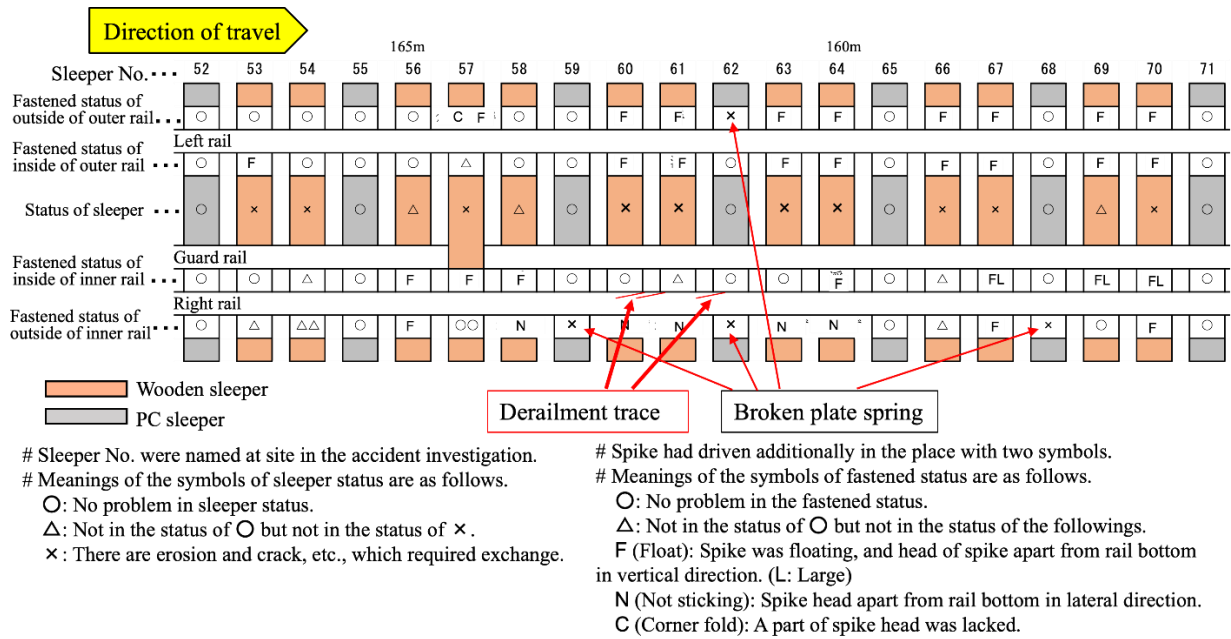
Figure 6. Sleeper status and Rail Fastening status

Also, as shown in Figure 6, a large number of instances of defective sleepers and floating dog spikes were observed in the wooden sleepers, especially in the vicinities where derailment traces were observed, and the sleepers were in a continuously defective state along with the poor fastening of adjacent PC sleepers. Floating dog spikes, pushed-out dog spikes, and broken plate springs are shown in Figure 7. Also, the cut surface of a plate spring is shown in Figure 8. As shown in Figure 8, rust was observed in the cut surface of the plate spring for No. 59. On the other hand, a cut surface that was believed to have been recently cut was observed for No. 62.

Also, there were no clear differences between the inner and outer rails in terms of rail fastening status.

However, as mentioned in 2.3.3.4 (2) (ii), a large number of instances of poor rail fastening condition were discovered in a series of PC sleepers and wooden sleepers near the derailment starting point during the investigation after the accident. Also, based on rust observed in the cut surface of the plate spring, it is likely that the plate spring may have broken prior to the accident. The Company stated that, among the various inspection items checked during the walking inspection tour, it may not have been possible to check the status of individual fastening devices, and the broken plate spring may have been overlooked. Also, as mentioned in 2.3.3.3 (2) (i), they stated that no inspection methods or judgment criteria had been established for rail fasteners, so the condition of the rail fastener could not be judged correctly.

Therefore, when inspecting track members, such as during a sleeper inspection, and when conducting a permanent way inspection tour, etc., the Company needs to check for things like wooden sleeper corrosion, floating dog spikes, cracked PC sleepers, and broken fastening

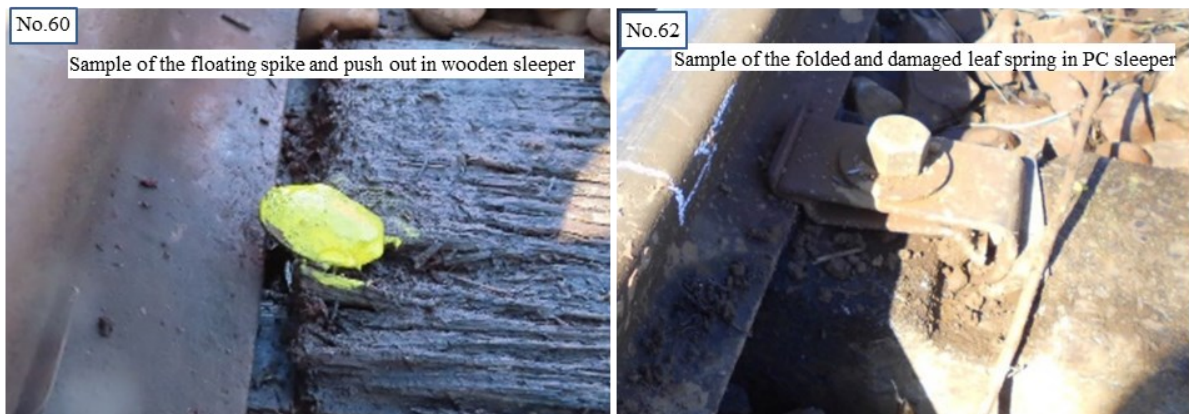
Figure 7. Dog Spike and Spring Plate Status

- (i) The amount of wear on the rails was 9 mm on the side of the left rail (outer rail) near 162 m. This is within 15 mm, which is the standard value for maintenance for rail wear specified in the Company’s “Civil Engineering Facility Implementation Standards.”
- (ii) The results from the investigation of sleeper status and rail fastening status near the site of the accident are shown in Figure 6. The sleeper numbers in the same figure are ones that were given to on-site sleepers during the accident investigation. As shown in the same figure, the plate springs on the outside of the left rail and the outside of the right rail for No. 62 for the PC sleeper fastening device were broken, as were the plate springs on the outside of the right rails for No. 59 and No. 68.

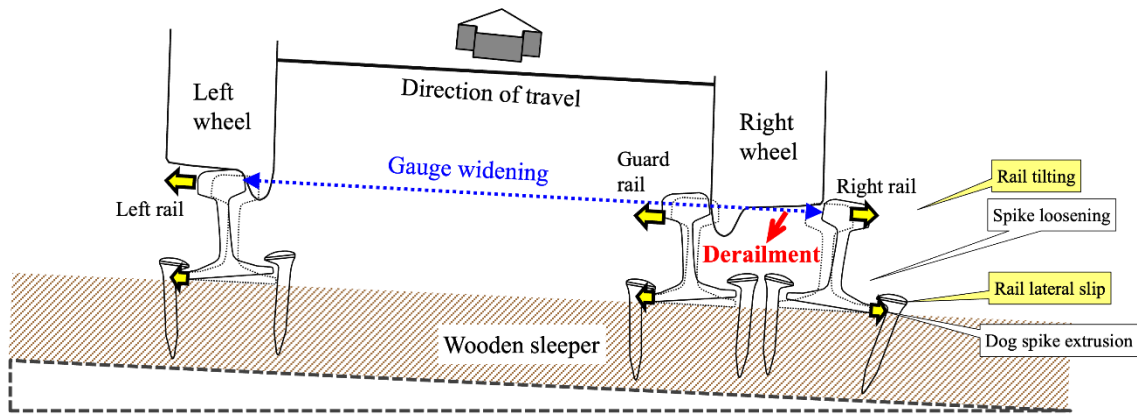
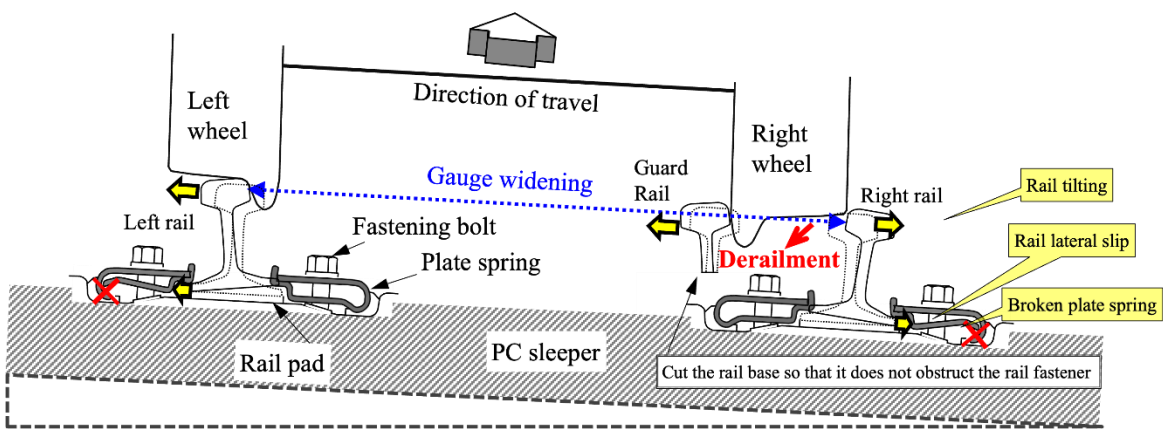
Figure 11. Illustrated Image of Derailment by Gauge Widening in the Accident

The JTSB conclude that it is more likely that the phenomenon mentioned in 3.1.2–3.1.4 where the right wheel of the Train fell into the gauge of the right rail near 162 m, *hereinafter referred to as “derailment by gauge widening”*, had been caused by dynamic gauge widening from rail tilting^{*18} from lateral force while the train is running and rail lateral movement, which will be cover later in 3.3.3(1), *hereinafter referred to as “rail tilting, etc.”*, The image of derailment by gauge widening in the accident is illustrated in Figure 11. Also, more detailed information on gauge widening will be explained later in 3.3.4.

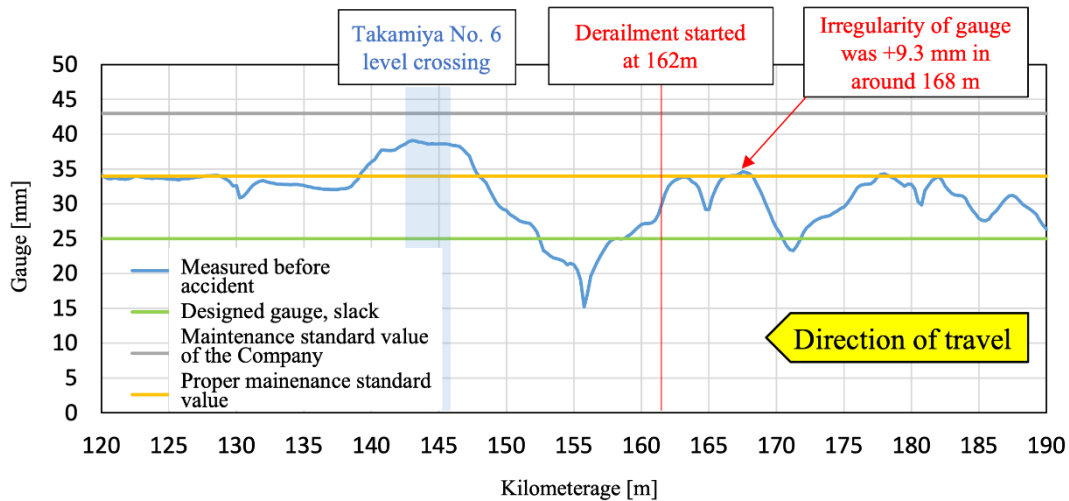
Figure 12. Irregularity of Gauge on the Curve

As mentioned in 2.3.3.3 (1), with the exceptions of irregularity of line alignment near 166 m and irregularity of gauge on the gauge reduction side near 156 m, all the measured values for track irregularity obtained before the accident on the Curve were within the standard value for maintenance.

However, regarding the irregularity of gauge on the gauge widening side, if the appropriate standard value for maintenance mentioned in 3.3.1 (1) had been applied, irregularity of gauge excluding the slack near 168 m would have been +9.3 mm, which would have reached the standard value for maintenance. *[Refer to Figure 12]*

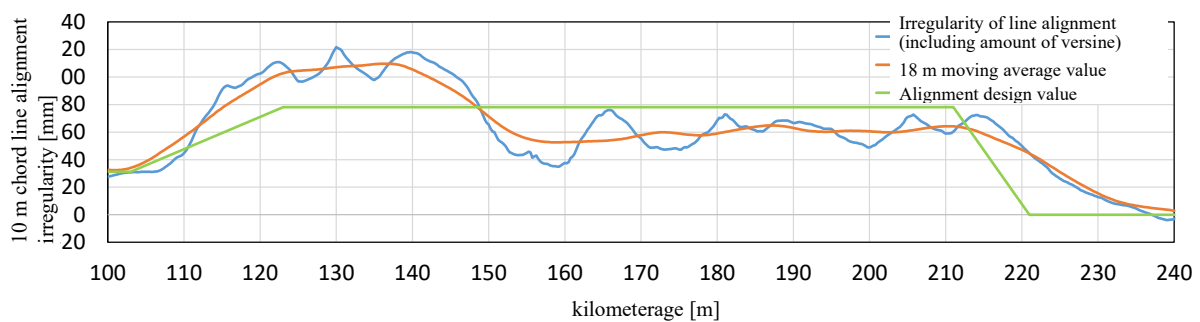
Figure 13. 18 m moving average value and design value for irregularity of line alignment

amount of curve versine near 120 m–140 m is about 105 mm, which is an alignment that’s identical to a curve with a radius of about 120 m. Also, the amount of curve versine near 150 m–210 m is about 60 mm, which is an alignment that’s identical to a curve with a radius of about 200 m. In this way, in order to perform appropriate curve management based on track irregularity from the moving average method, if there is a large difference between the design values and obtained values for curve radius and cant, it’s preferable to modify the curve profile and manage it according to that curve profile.

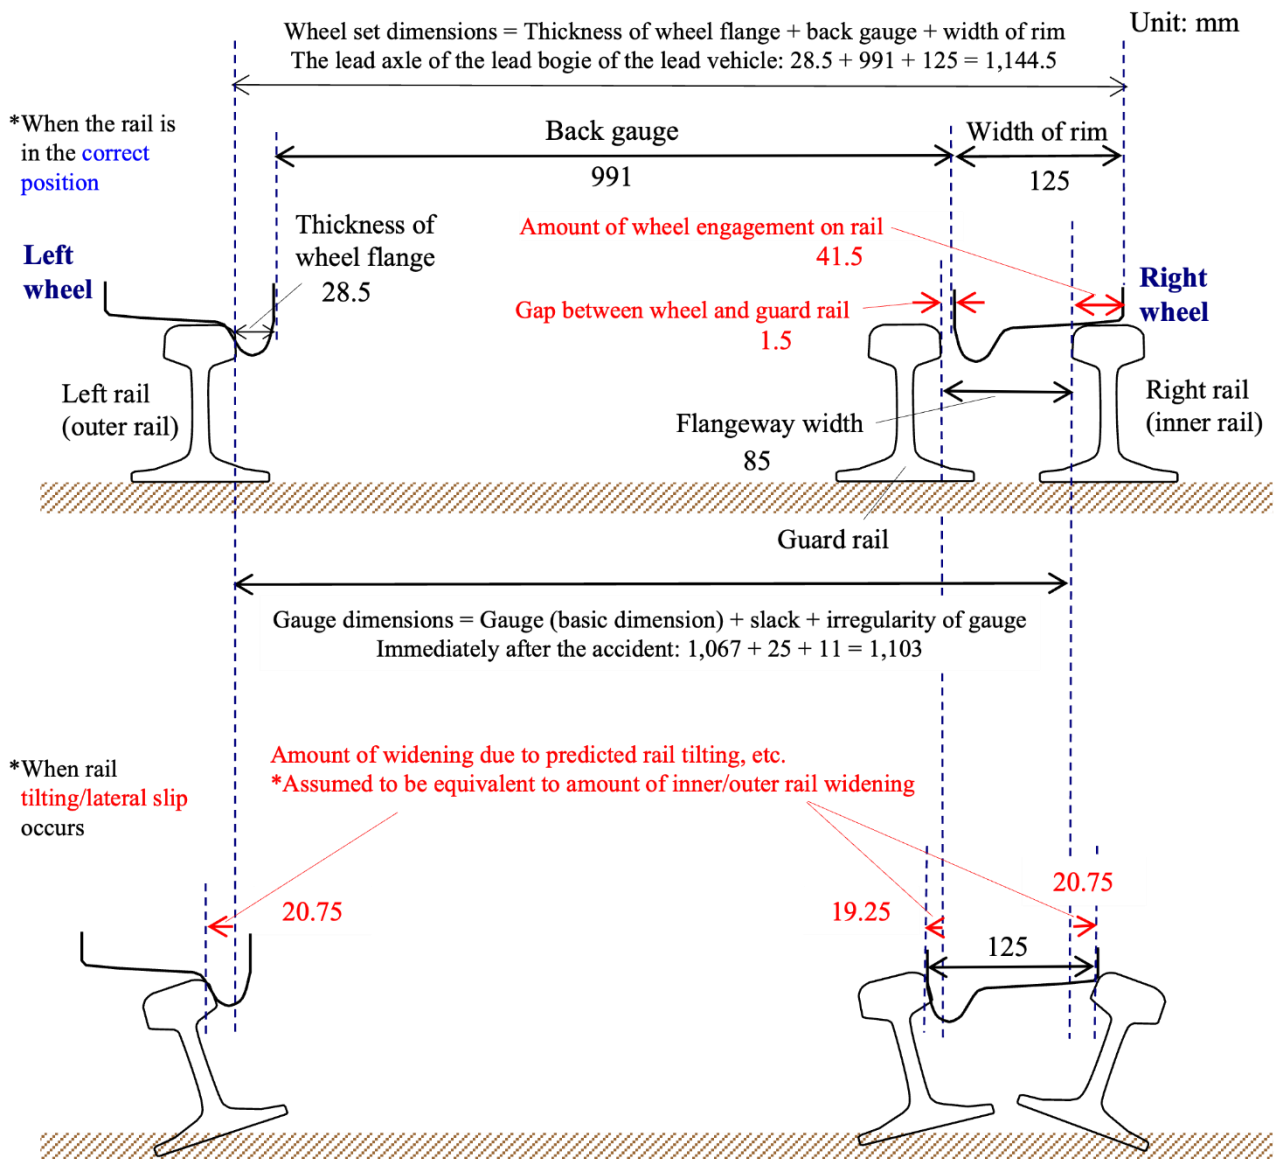
Figure 14. Estimated Gauge Widening Status

In addition, while the amount of widening for each of the inner and outer rails is unknown, as mentioned in 2.3.3.4 (2) (ii), there were no clear differences between the inner and outer rails in their fastening status near the derailment starting point immediately after the accident, etc., so assuming that the amount of widening was roughly the same for each, it is more likely that this amount may have been about 20.75 mm ($= 41.5/2$) apiece for the inner and outer rails.

Based on this, it is possible that the amount of flangeway width widening from right side (inner rail side) guard rail tilting, etc. may have been 19.25 mm. *[Refer to Attached Material 2]*
