RAILWAY SERIOUS INCIDENT INVESTIGATION REPORT

Vehicle damage, Suminoe Vehicle Inspection Division,
Nankai Electric Railway Co. Ltd.

November 26, 2020

Railway Serious Incident Investigation Report

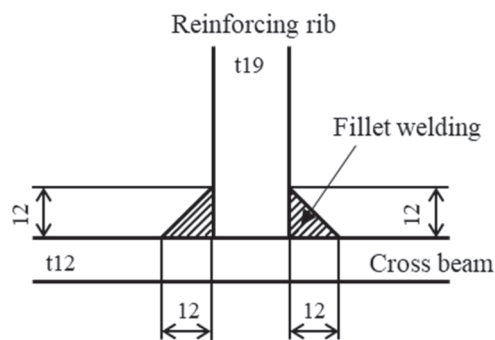
Figure 4. Welded part of reinforcing rib welded without groove processing

There was a possibility that the workers who received the explanation on the work contents from the work manager welded without groove processing after temporary installed as in the case of usual reinforcement work during the reinforcing rib installation work. In addition, there was a possibility that the bogie with cracks in Table 2 was also welded without groove processing during the reinforcing rib installation work.

The welded part of the reinforcing rib welded without the groove processing is as shown in Figure 4.

As described in 2.5.3.3, in a welding work site that did not know that the groove processing was performed by air gouging, after temporarily attached the reinforcing rib, welding was performed without performing the groove processing, as a result, it is highly probable that the welding defect generated at the welded part between the cross beam and the reinforcing rib.

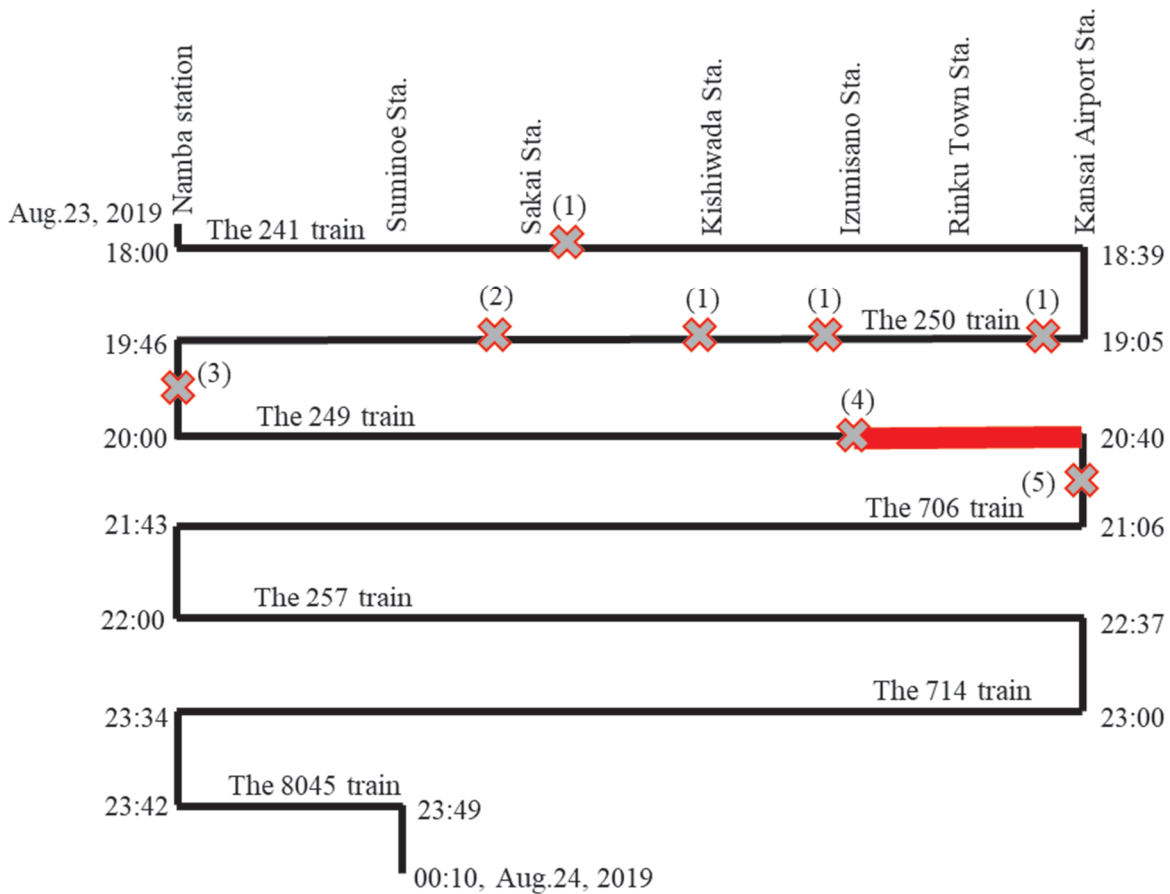
- (1) The conductor noticed the metallic sound as squeak corresponding to motion of vehicle from under the gangway footplate of the coupled part of the 2nd and 3rd vehicles when patrolled the cabins.

- (2) The conductor reported to the dispatcher using train radio that "There is a defect in the vehicle. Loud sound as metals rubbing each other is heard from under gangway footplate of the connecting part of the 2nd and 3rd vehicles while running. Please contact with the relevant sections".

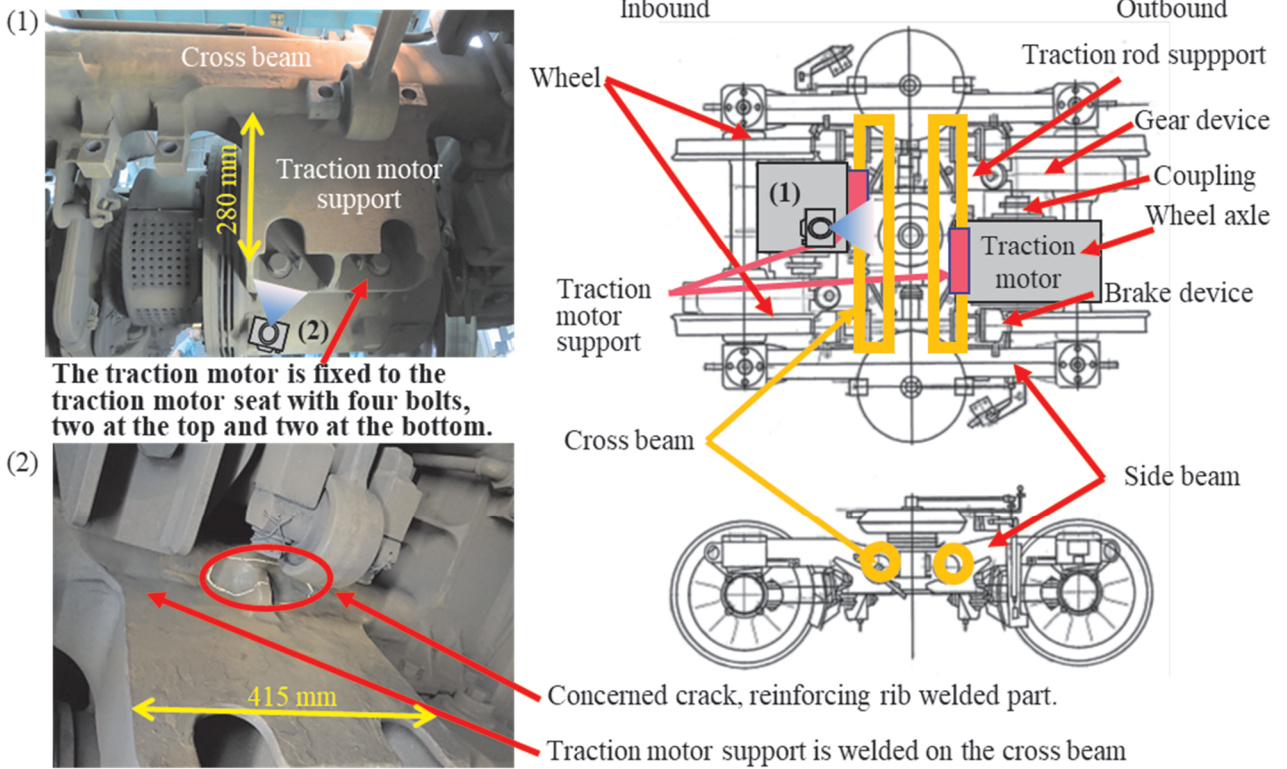
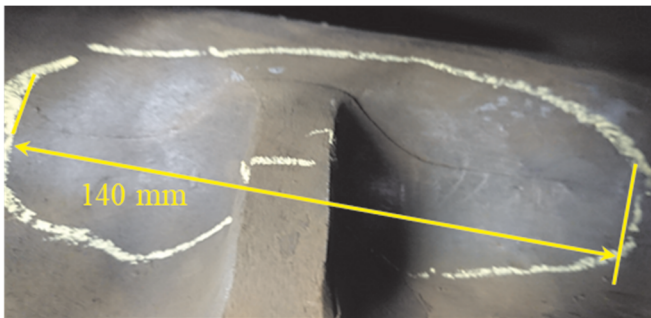
Attached Figure 3. Structure of the Bogie and Damaged Status

- (1) The crack was generated at the welded part between the backside of the traction motor support in the cross beam and the reinforcing rib, and was about 140 mm in length and about 1 mm in width.
- (2) When observed the broken surface of the crack, multiple ratchet marks^{*11} were found as extended outward.

As described in 2.4.2 and 2.4.3, it is highly probable that the crack in backside of the traction motor support was generated from the welding defect in the upper part of the reinforcing rib in the welded part between the cross beam and the reinforcing rib, based on the followings.

- (1) Welding defect such as poor fusion were confirmed in the welded part between the cross beam and the reinforcing rib.
- (2) The beach marks found on the broken surface of the crack were found in both the broken surfaces in the reinforcing rib side and the cross beam side.
- (3) Plural ratchet marks could be seen on the broken surface of the crack and extended outward.

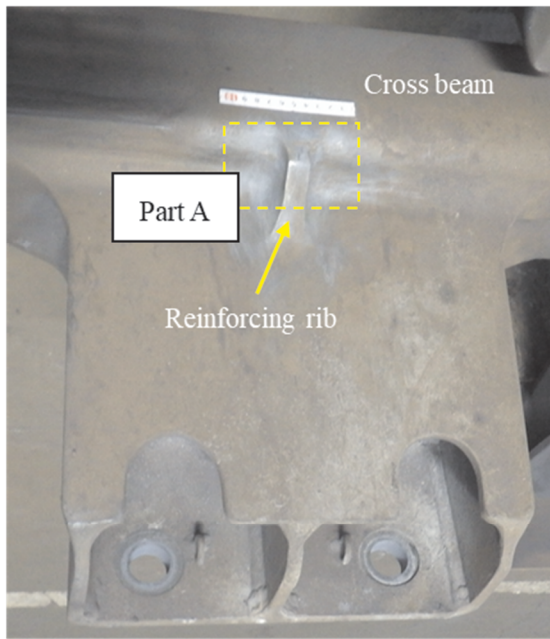
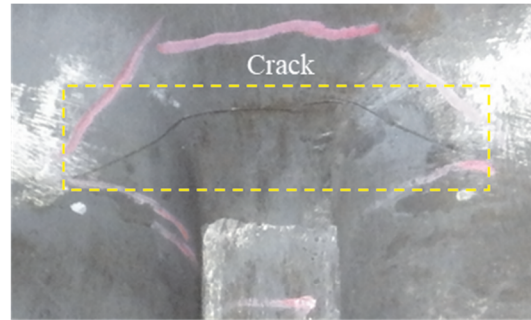
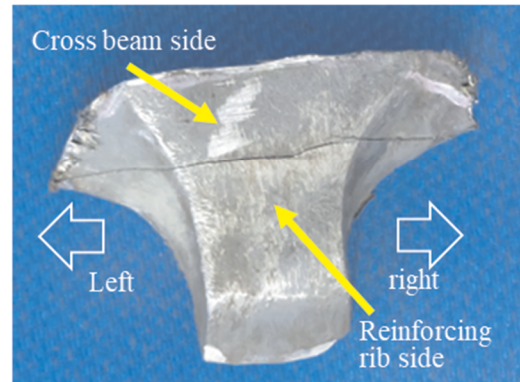
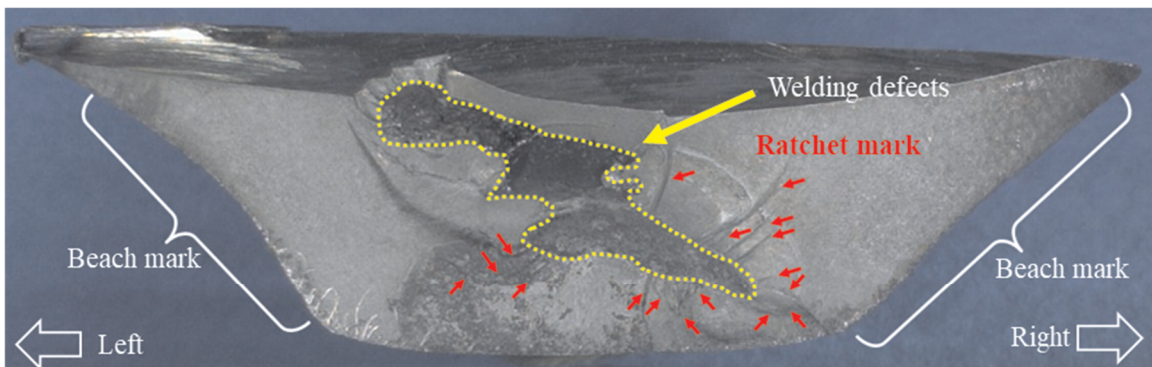
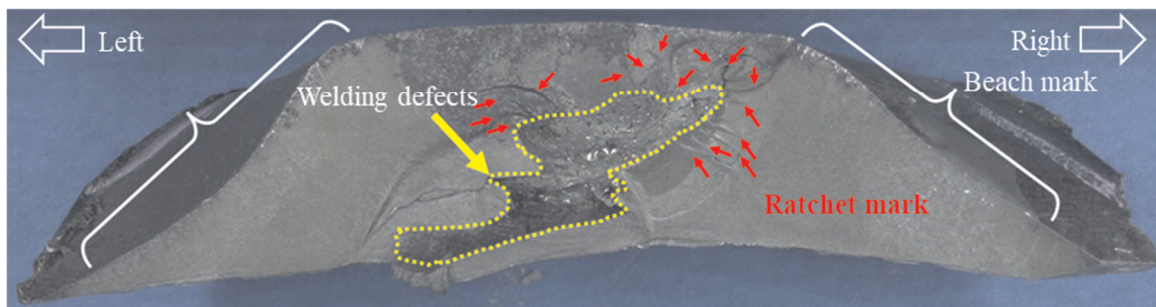
Attached Figure 4. Situation of the Broken Surface of the Crack, 2nd vehicle of the 5th trainset

The crack in the 2nd vehicle of the 5th trainset was cut and investigated in detail, the damaged status of the crack was as follows.

- (1) The broken surface of the crack was observed and the beach marks^{*15} were found in both the damaged surface of the reinforcing rib side and the damaged surface on the cross beam side. In addition, it was confirmed that plural ratchet marks extended outward.
- (2) The welding defects^{*16} such as the blowhole^{*17} and the incomplete fusion^{*18}, etc., were found at the welded parts between the cross beam and the reinforcing rib.
- (3) It was confirmed that there was a gap between the cross beam and the reinforcing rib.
- (4) The EDX analysis was carried out to analyze the substances adhered to the broken surface of the crack, but components related to the paint such as titanium, Ti, could not be confirmed definitely.

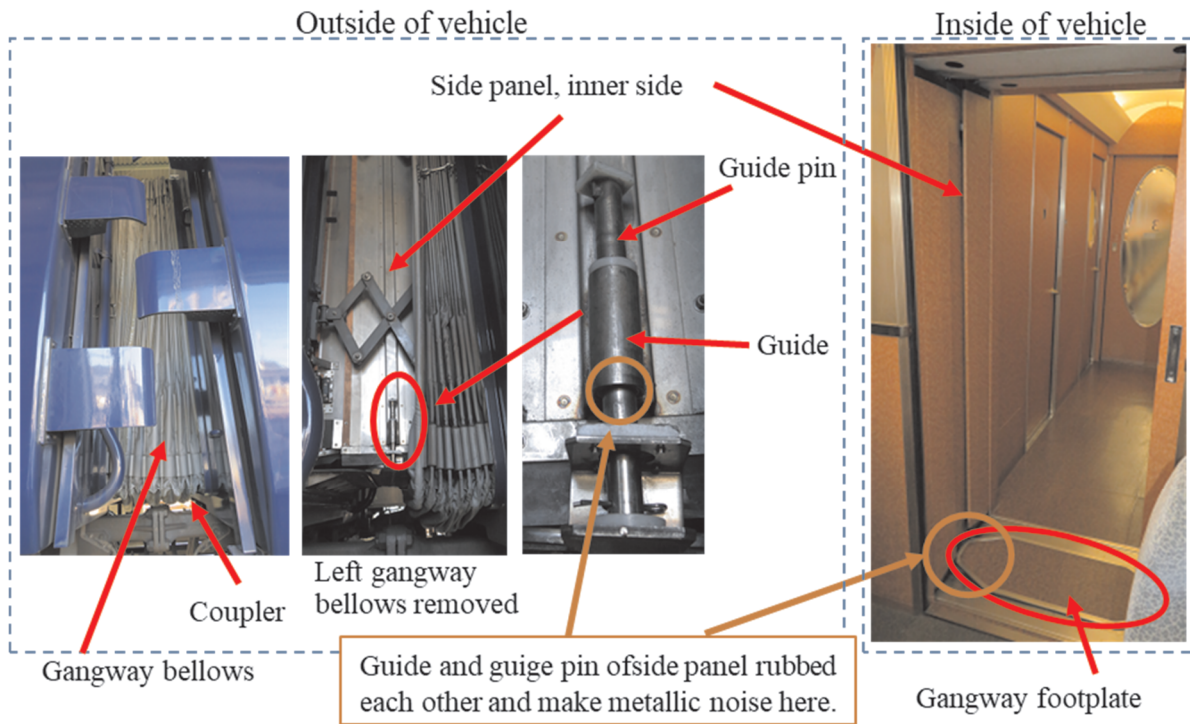
Attached Figure 5. Status of Abnormal Sound Generated Place

When a survey was conducted by boarding a commercial train in order to identify the location of the abnormal sound, it was found that a metallic noise was generated at the coupling part of the vehicles when vehicles moved up and down while running in the curved section.
