Kazuhiro Nakahashi, Chairman,
Japan Transport Safety Board

On the opinion concerned with the prevention of the train derailment accident
caused by the gauge widening

On the prevention of the train derailment accident by the widening gauge

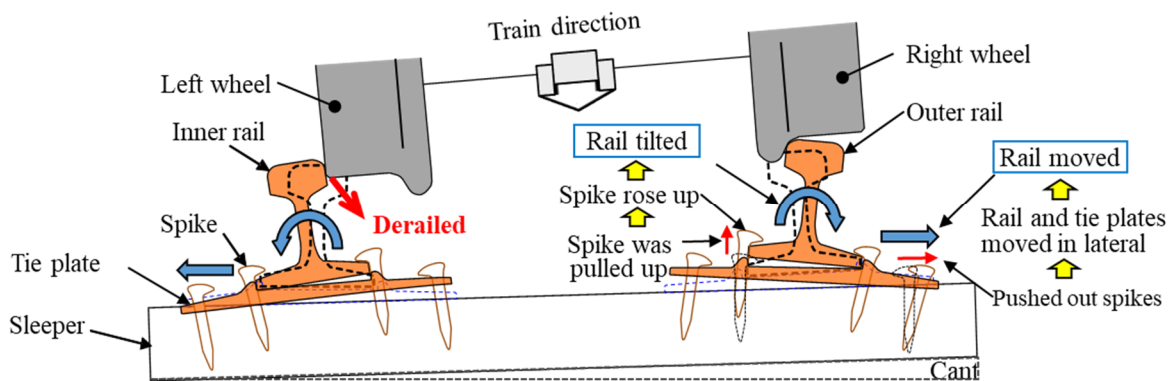
It is important to suppress the dynamic widening gauge by the tilting of rail, etc., by managed the sleepers and the rail fastening devices properly, in order to prevent the

accident that the vehicle derailed to inside gauge due to the widening gauge. [Refer to Figure 1]

Figure 1. Sample of the derailment to inside gauge due to the widening gauge

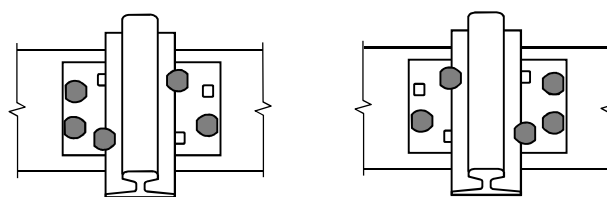
In addition, it is necessary to pay attention on the number of the spikes and the driving method, etc., when the tie plates which affect the tilting of rail, etc., are used. The sample of the standard to drive the spikes for the tie plate^{*3} was shown in Figure 2, as the reference.

B type and E type tie plates, the case for curved track of the radius less than 500 m

Figure 2. Sample of the standard driving spikes for the tie plate

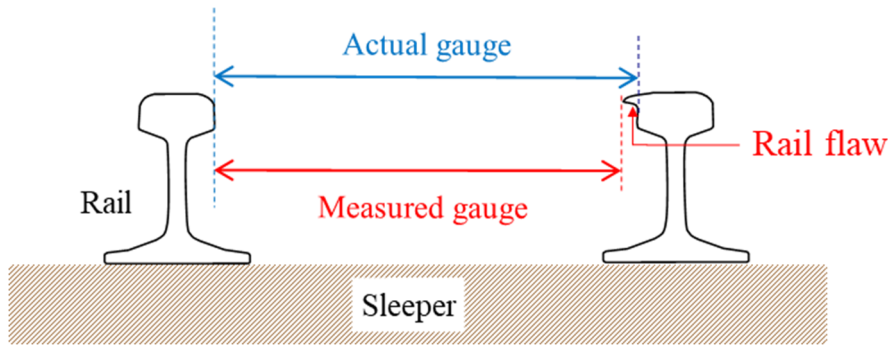
When the rail flaw generated in the rail corner side, the metal surface layer of the rail top deforms and becomes to the status as being pushed out toward inside gauge. On the other hand, the gauge is defined as "the shortest distance between the rail heads at the height within 14 mm, or 16 mm, from top surface", and measured based on this definition. Therefore, when the rail flaw was existed, the gauge is measured from the tip of the rail flaw, then the measured gauge becomes smaller than the actual gauge by the size of the rail flaw, refer to Figure 3. This is the evaluation in the dangerous side against the gauge, and there is the case to cause the derailment to inside gauge, as the rail flaw had folded and damaged. Refer to Figure 4.

Figure 3. Measurement of the gauge when the rail flaw was existed.

Therefore, it is desirable to implement the proper management such as to remove the rail flaw depending on the necessity, when the occurrence of the rail flaw was confirmed in the periodic inspection of rail or the track patrol, etc.

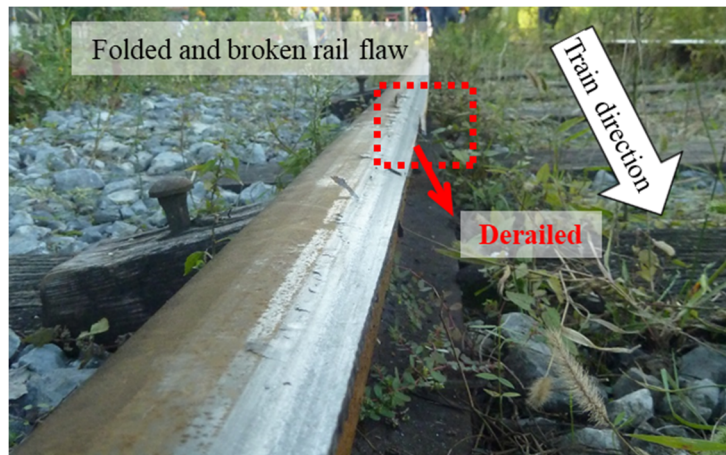
Figure 4. Sample of the derailment to inside gauge as the rail flaw was folded and damaged.

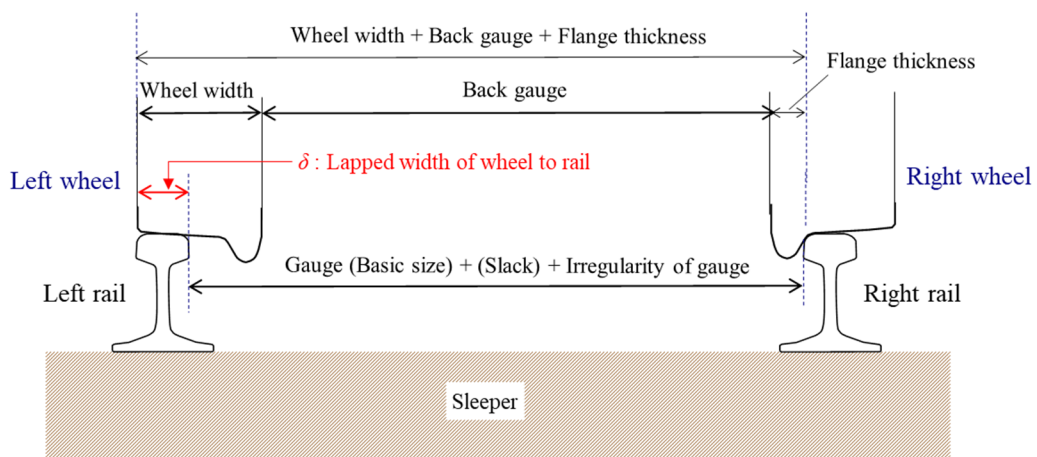
Note that the standard value for track maintenance of the irregularity of gauge shown in Table 1, was decided as the track irregularity including the slack did not to exceed the limit value of the irregularity of gauge shown in Figure 6. Furthermore, the static values are set as the value corresponded to the upper limit value of the distribution in the relationship of the static irregularity of gauge and the dynamic irregularity of gauge shown in Figure 7, and decided considering as to convert the dynamic irregularity of gauge, against the static irregularity of gauge as the standard value, in the safety side as possible.

Figure 6. Limit value of the irregularity of gauge

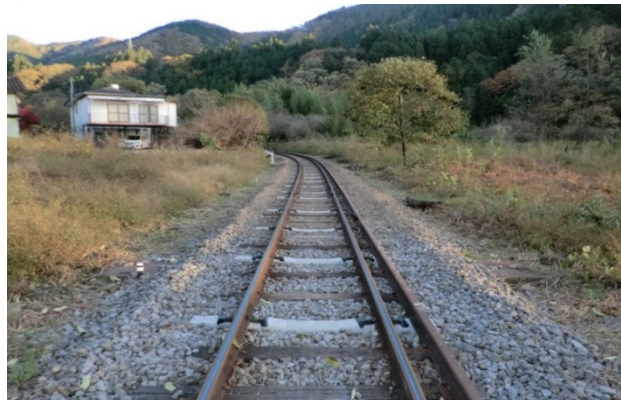
Figure 8. Example of partly changed PC sleepers

Note that it is effective to replace sleepers partly which exchanges sleepers in the ratio of one in several sleepers when it is difficult to exchange all sleepers from the cost problem, etc. Refer to Figure 8. In this case, it is desirable to determine the ratio of the sleepers made of concrete, etc., for exchange, considering the conditions of the running vehicles and the track shape, etc.
