KOKU-KU-KI-267

No. TCD-8201C-1-2022

Japan Civil Aviation Bureau
TAIKUSEI-KAIZEN-TSUHO
Airworthiness Directive

1. Applies to: Kawasaki BK117 series helicopters equipped with a Goodrich rescue hoist assembly having a Part Number (P/N) as listed in Table 2.1 of this AD.

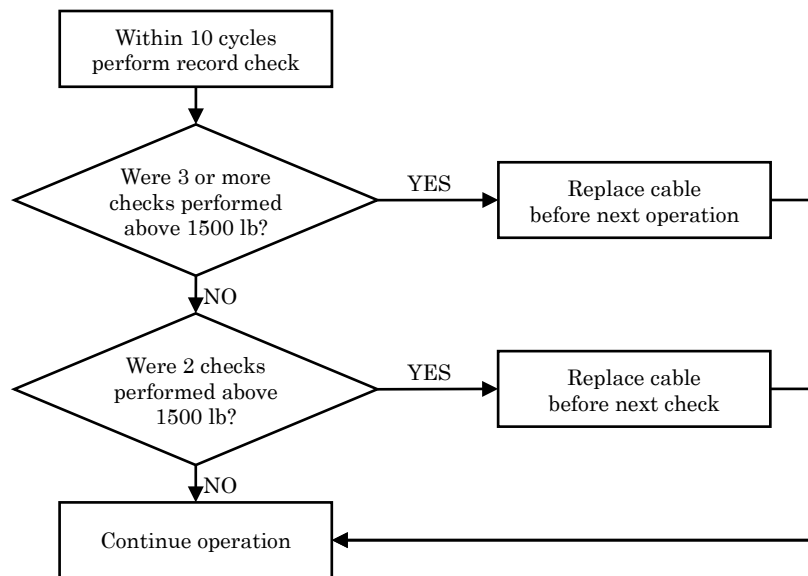
2.1 Within 10 hoist operating cycles from June 17, 2016 (the effective date of AD No. TCD-8201C-2016), accomplish a records check to determine whether, during any previous hoist load check/test, a cable was load-tested (average of 5 pulls) at 1500 lb [680 kg] or more. If any cable is identified to have exceeded this limit during two or more hoist load checks/tests, replace the affected cable with a serviceable cable within the time interval shown in paragraph 2.1.1 or 2.1.2 of this AD. For replacement of a cable, see Figure 1 of this AD.
