7. Examples of accident investigations, focused on the factors related to that the approaching train could not be noticed, shown in Table 4, in page 22 to 23.

(i) Bad visibility of train from once stop position at the level crossing

Case 1. Occurred at about 12:46, Tuesday, September 27, 2016 [No.22 in Table 3]

Level crossing accident where visibility of train from level crossing is limited and train passed in high speed.

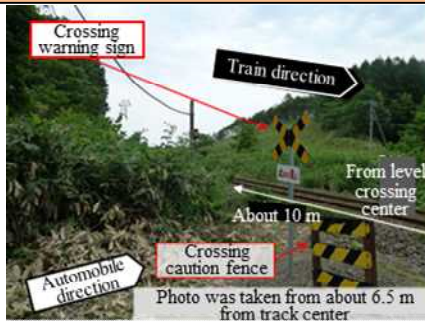
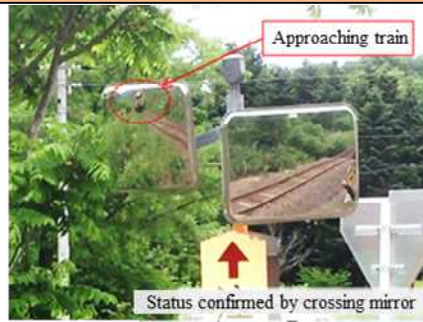
Photo 1. Sight of train viewed from the driver of bicycle

It is somewhat likely that the automobile entered to the level crossing in the situation that the train was approaching related to that the driver seated in the automobile was hard to see the approaching train. However it could not be determined precise situations because the driver of the automobile was dead.

Confirmed by the train operated at the same time as the accident train in the next day of this accident.

Railway operator has studied various measures to prevent accident in class four level crossing such as to install the level crossing mirror and the stop sign, etc., since the occurrence of this accident, and promoted by established the full-time system from April 2017. It is desirable to attempt to improve safety by promoting these measures continuously.

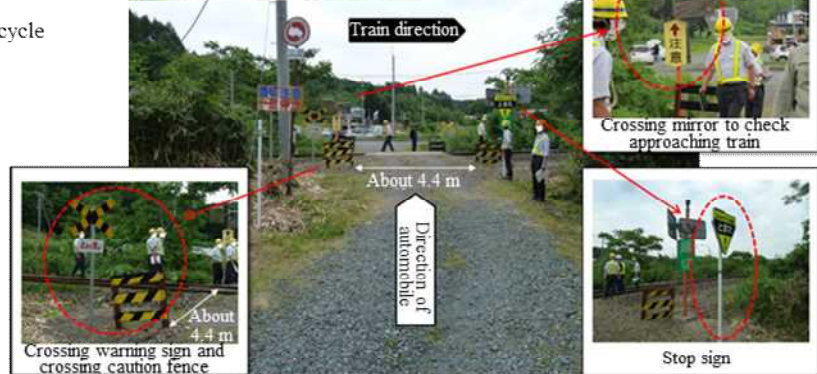
Photo 2. Status of the level crossing and surroundings

It is probable that there is the characteristic that the driver of automobile is hard to confirm the train compared to the pedestrian because the driver confirmed the approaching train from the position of the driver's seat, although the circumferences of level crossings, where the accident with automobile had occurred, are not uniform.

Furthermore, considering that the level crossing accident in which the driver of automobile crossing the accident level crossing was dead had occurred in the past, it is expected for the relevant parties such as the local relevant persons and the railway operator, etc., to restart the discussion in early stage and study on the abolishment, etc., and implement measures. It is considered as a measure to improve safety by prohibiting the passage of automobiles through a year, till to complete the above measures.

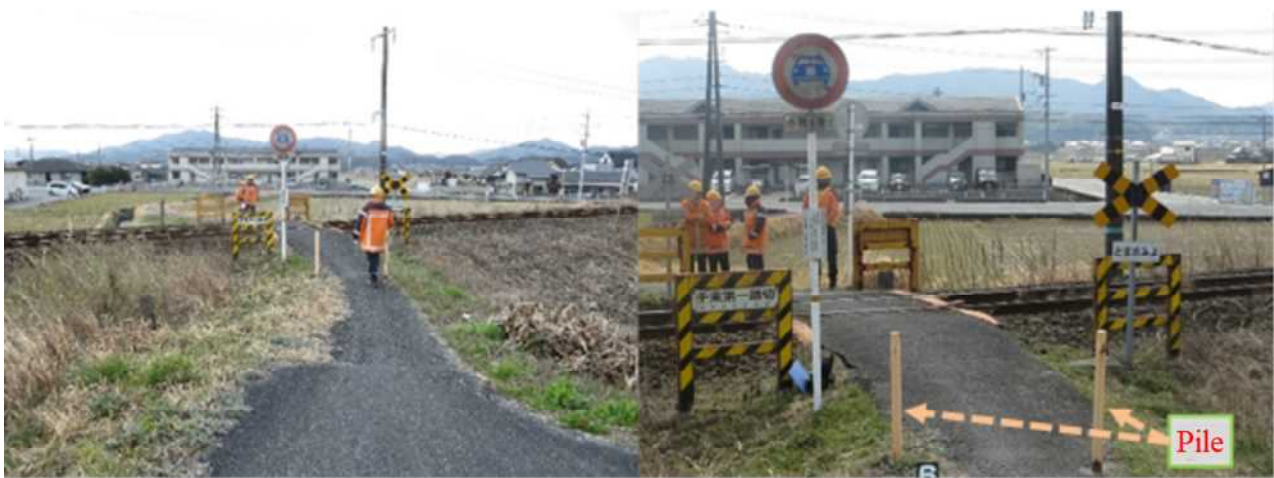
Photo 1. Status of level crossing viewed from the entered bicycle

It is probable that the passerby did not stop just before the level crossing in the situation that the train was approaching, and entered the level crossing without confirming the approaching train well. However, it could not be determined the reason why the passerby entered the level crossing, because the passerby was dead.

Class four level crossing without crossing gate nor road warning device should be abolished or prepared the level crossing protection devices. It is desirable to implement continuously the study on the abolishment or the change to class one level crossing, for this accident level crossing.

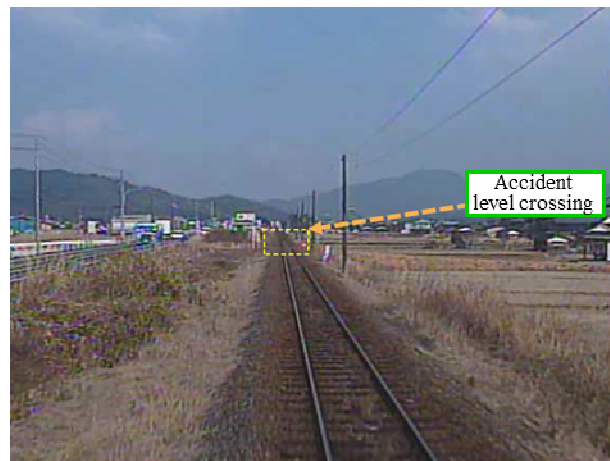
Photo 3. Image in the image recording device of the accident train, before about 100 m

Summary : The driver of the local train, composed of one vehicle, noticed a passerby riding bicycle about 20 to 30 m before the level crossing, and applied the emergency brake, but the train collided with the passerby. The passerby was dead in this accident.

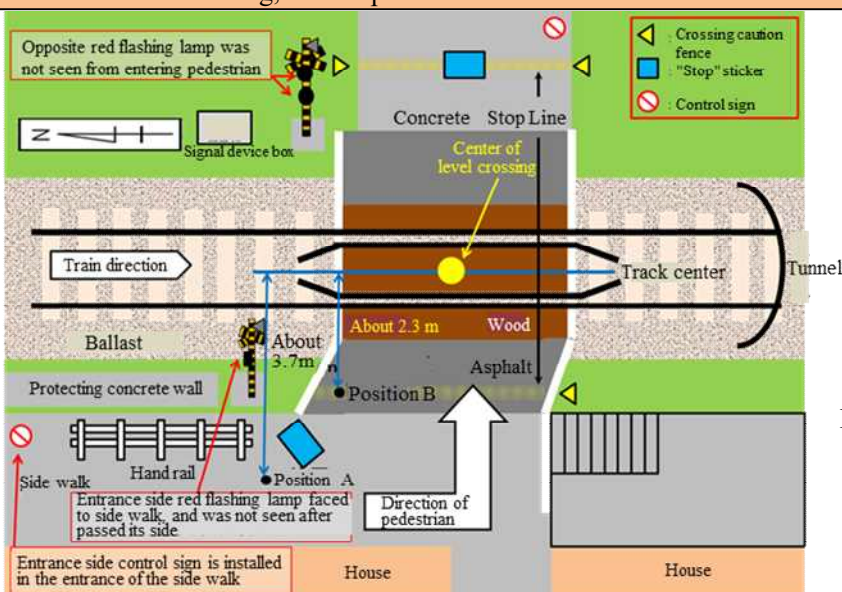
Figure. Status of level crossing and periphery and layout of level crossing protection devices, etc.

Probable causes : It is probable that the accident occurred as the train contacted with a pedestrian because the pedestrian entered class three level crossing equipped with road warning device, in the situation that the road warning device was operating according to the approaching train.

It is somewhat likely that the pedestrian entered the level crossing in the situation that the road warning device was operating responded to approaching train, related with the situation that the pedestrian had been lost hearing sense. Also, it is somewhat likely that the pedestrian could not recognize red flashing lights when the pedestrian entered the level crossing, but the precise situation could not be determined because the pedestrian was dead.

The accident level crossing was class three level crossing equipped with road warning device, however, it is desirable to install omnidirectional red flashing lamp, to enable the passersby certainly recognize the operation of road warning device accompanied to the approaching train. Furthermore, it is expected for the relevant parties to cooperate with each other to improve the safety from the present status, as to install crossing gate in addition to road warning device, to deter the passersby from mistaking to enter the level crossing, In addition, it is desirable to maintain the measures applied to the accident level crossing in the proper status.
