JTSTB (Japan Transport Safety Board) DIGESTS

No. 43 (Issued in September 2023)

Digests of the Analyses of Railway Accidents

Accident Prevention Measures in Local Railways

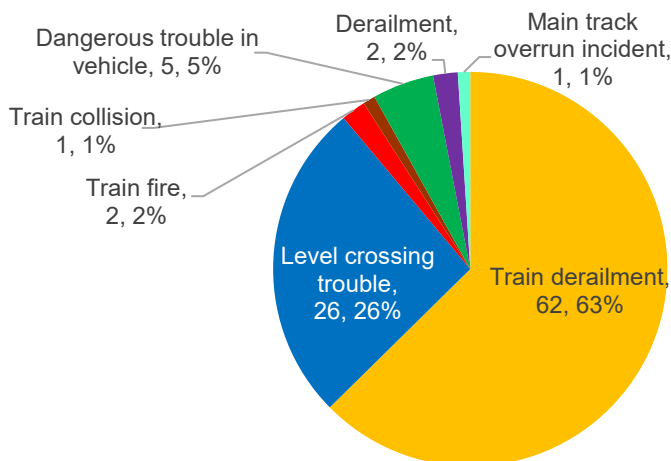
Figure 2: Classification of accidents, etc. in the local railways by category

When we categorize 99 accidents by category (Figure 2), the most common cause is train derailment, accounting for about 63% of all accidents, followed by level crossing accident (approximately 26%). Since these two accident categories account for about 90% of all accidents, we can say that they are the principal accident categories in local railways. Therefore, we analyze more detail thereon.

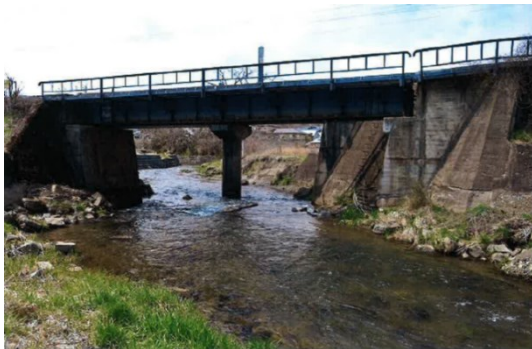
Figure 17: No.4 Kitakami River Bridge
(Full view from the upstream side)

In the upstream and downstream sides of No.4 Kitakami River bridge, the river width was widened by the river improvement works carried out in the past. However, the river width was reduced near the concerned bridge compared to the upstream and downstream sides, because the position of the bridge abutment has not been changed. Therefore, the flow velocity near the bridge accelerates when the water level rises, and the riverbed has lowered. As a result of conducting the overall and individual inspections of the concerned bridge, the riverbed lowering near the bridge pier as well as partial scouring of the bridge abutment were observed. It was found out that reinforcement works are necessary.

When selecting a construction technique, riverbed protection blocks were selected taking into account the nearby environment, because the work can be done in a narrow space, these blocks can prevent bridge piers and abutments from being washed out and the riverbed from being lowered, and the company has an experience in this construction technique. Since the bridge piers and newly-installed concrete riverbed protection blocks have been connected, a possibility of wash-out decreases significantly. In addition, the scouring and riverbed lowering are prevented by covering the entire river width with these new blocks.

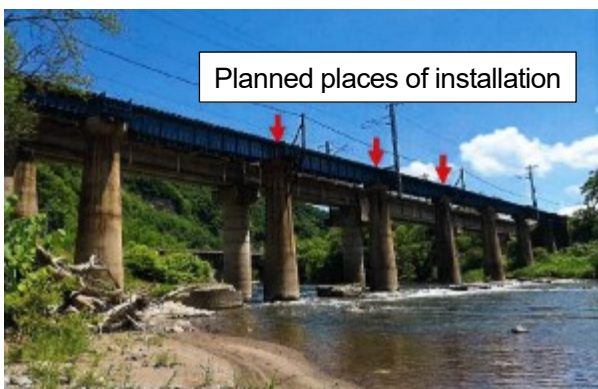
Figure 19: No.8 Mabechi River Bridge (Full view from the downstream side)

Moreover, the riverbed has lowered at No.8 and No.10 Mabechi River bridges from the time when they were constructed. Therefore, riverbed protection blocks were newly installed at No.8 Mabechi River bridge (FY2013) and at No.10 Mabechi River bridge (FY2016) to control the riverbed lowering. Since then, as a result of conducting the overall and individual inspections of both bridges, it was confirmed that there is no problem in their soundness. However, there was a risk that the bridge piers are washed out or inclined due to insufficient embedment caused by the riverbed lowering when the river level rises. Therefore, it was necessary to examine a possibility of introducing inclination detection devices (See Figure 25).

Since the devices capable of automatically transmitting observational data from inclinometers on-line have been installed, it is now possible to check data on a real-time basis and efficiently control operations. Moreover, it is now possible to check the stability of bridge piers with the inclinometers when resuming the train operation after it has been restricted (stopped) due to the rise in water levels. In addition, it is possible to view data on restrictions and disasters in the past.
