Investigated accident case 2

Collision between two cargo ships, both southbound, in restricted visibility because of thick fog, in the vicinity of the northwestern end of the Kanmon Passage No. 2

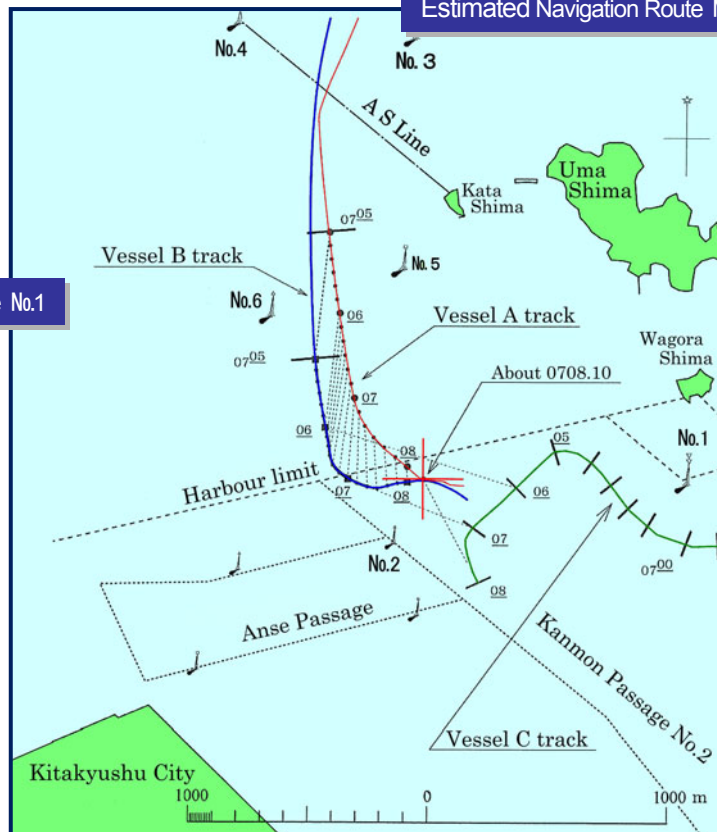
Estimated Navigation Route No.2

This accident occurred in the vicinity of the northwestern end of the Kanmon Passage No. 2, in restricted visibility due to thick fog. It is probable that, when Vessels A and B were proceeding southward, in tandem, in the waterway west of Mutsure Shima Island, and Vessel C was sailing northwestward through the Kanmon Passage No. 2, with the intention to enter the Anse Passage, each of them detected, by radar, the presence of the other two vessels, but did not maintain an appropriate radar lookout and continued sailing, without taking notice that they were developing a close-quarters situation, which resulted in the accident.
