Analysis of Train-Overturn Derailments Caused by Excessive Curving Speed

A. Matsumoto;
Japan Transport Safety Board (JT S B)

Y. Michitsuji, Y. Tobita; Ibaraki University

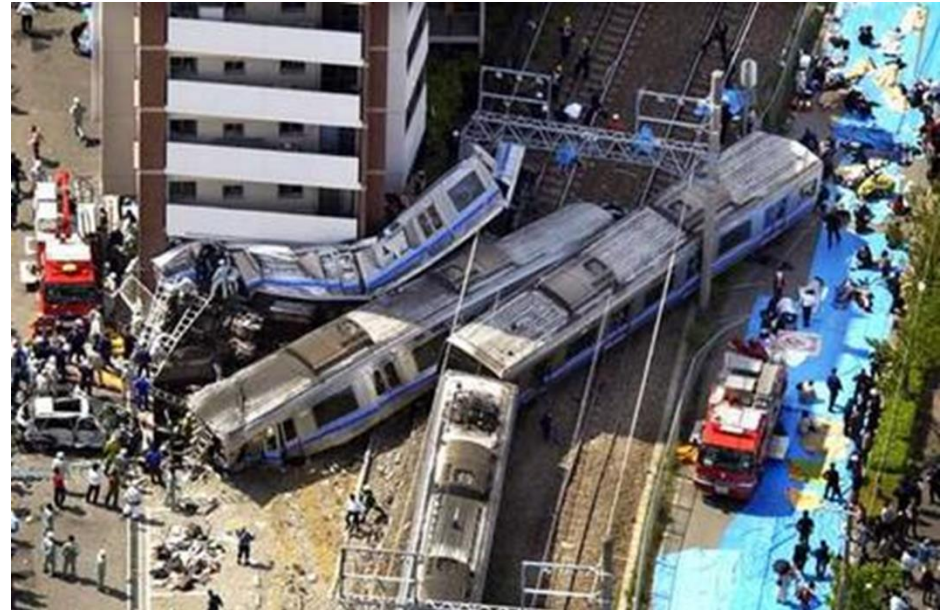
1) Fukuchiyama line accident of JR West near Osaka in 2005; Japan

- *Commuter train set of 7 EMUs for narrow gauge track
- *Leading 2 vehicles overturned, next 2 vehicles heavily deviated from track
- *Leading 2 vehicles terribly crashed to a building at track side
- *Leading 4 vehicles heavily buckled

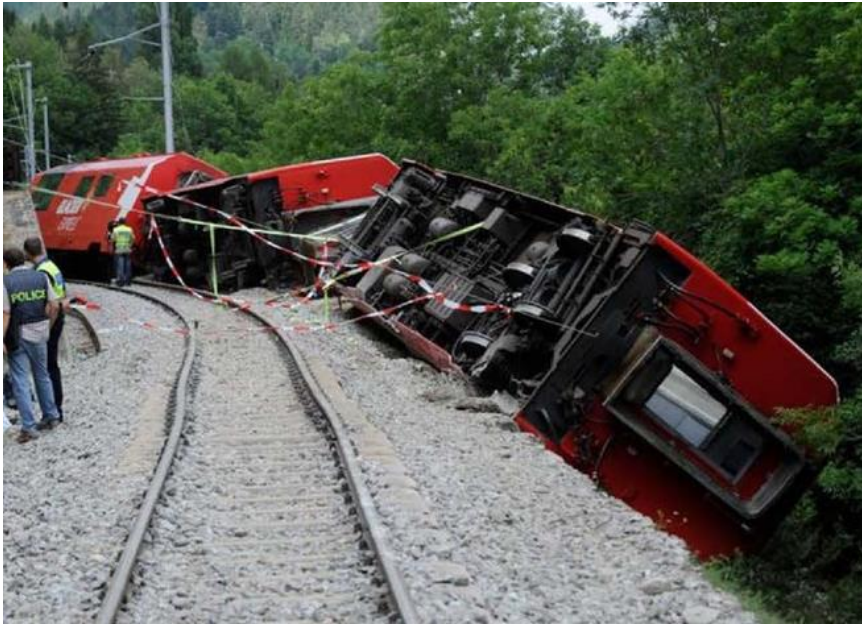
2) Glacier express accident in 2010; Switzerland

- *"Glacier Express"; sightseeing train of 1 EL +6 PCs for meter gauge track
- *3 trailing PCs including "panorama car" overturned and fell down from embankment

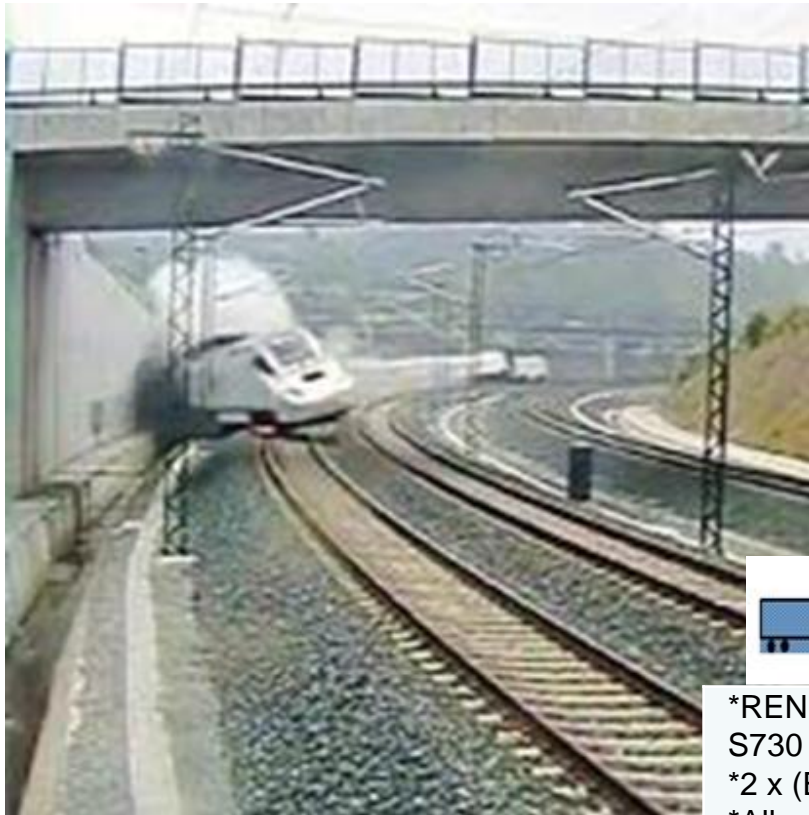
3) Renfe high speed train accident in 2013; Spain

- *RENFE high speed gauge-changing train for hybrid powering; type S730
- *2 x (EL + power unit) + 8 mono-axle & articulated (Talgo-type) PCs
- *All vehicles overturned and fell down to concrete retaining wall
- *Especially 2 power unit vehicle named "technical end coaches" leaned early, which were recognized in the monitor video from wayside

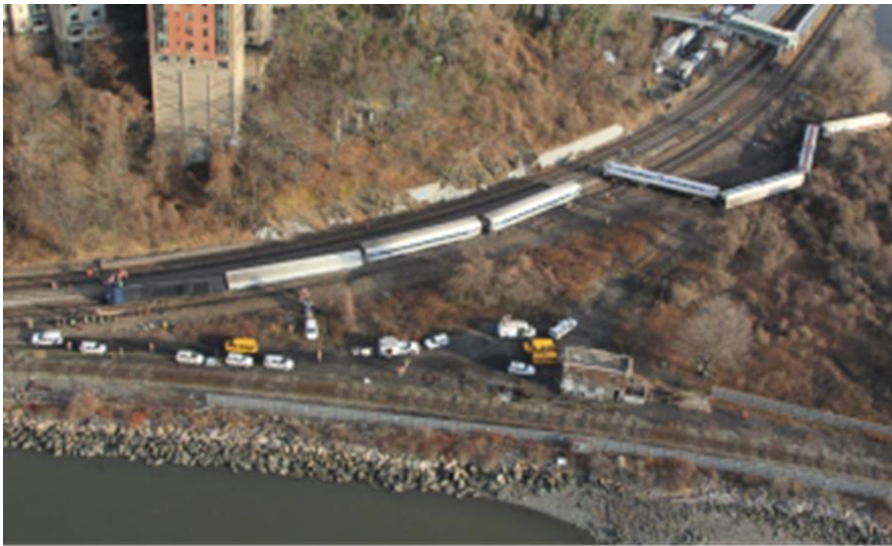
4) New York Metro North Railroad accident in 2013; USA

*Commuter train of 7 PC + 1 EL in push-pull operation

*Leading 4 vehicles overturned or heavily deviated from track

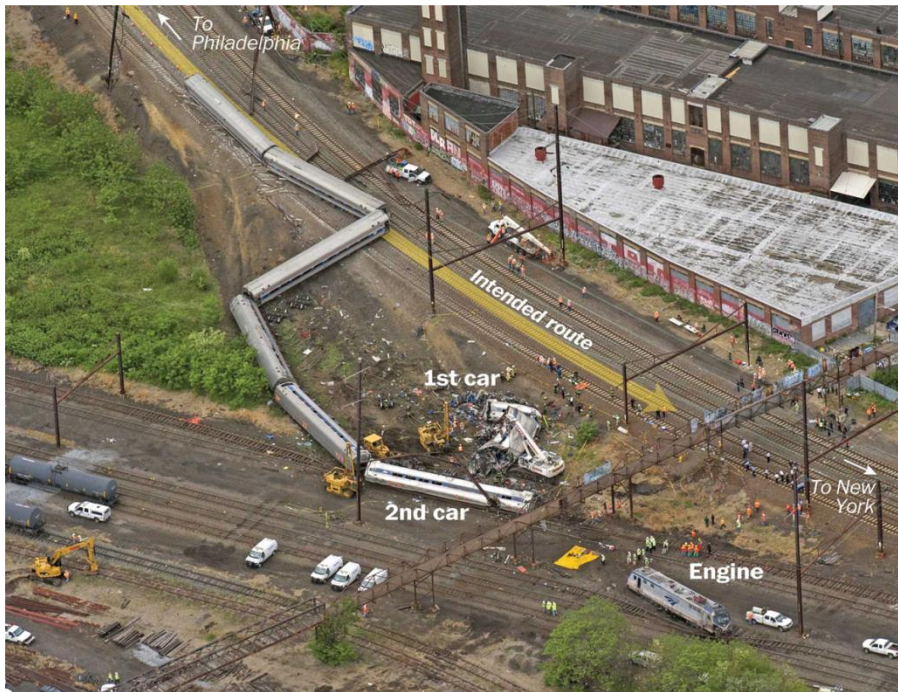
5) Amtrak high speed train accident near Philadelphia in 2015; USA

- *AMTRAK high speed train of 1 EL and 7 PCs
- *Leading 5 PCs overturned or heavily deviated from track
- *Leading EL deviated heavily from track, but not overturned

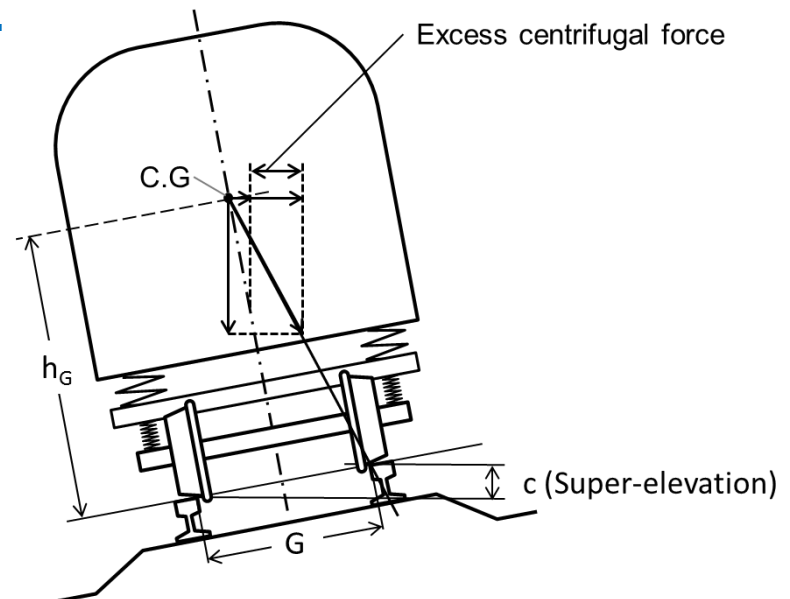
3.1 Basic mechanism of train overturning

The vehicle is overturned when the curving speed exceeds the speed limit, where the resultant force vector composed by the centrifugal force, the gravity and the inertial force of lateral vibration goes toward outside of the track from the gravity center of the vehicle.

Therefore “Overturn” is different phenomena from “flange climb”, and the lateral contact forces between wheel and rail rarely influence to the overturn movement of the vehicle.

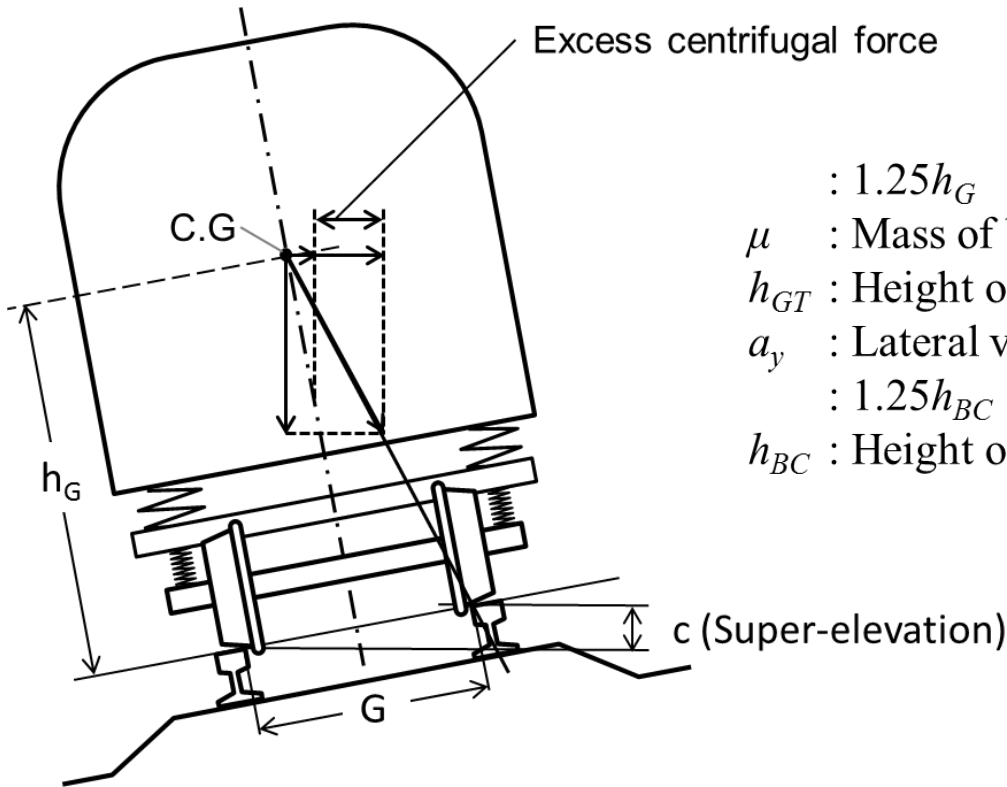
Kunieda's formula

- $1.25h_G$
- μ : Mass of bogie/Half mass of car body
- h_{GT} : Height of center of gravity of the bogie
- a_y : Lateral vibrational acceleration of the car body
- $1.25h_{BC}$
- h_{BC} : Height of center of wind force from the rail top

$$D = \frac{2h_G^*}{G} \left(\frac{v^2}{R \cdot g} - \frac{c}{G} \right) + \frac{2h_G^*}{G} \left(1 - \frac{\mu}{1 + \mu} \cdot \frac{h_{GT}}{h_G^*} \right) \cdot \frac{\alpha_y}{g} + \frac{h_{BC}^* \rho \cdot u^2 \cdot S \cdot C_D}{m \cdot g \cdot G}$$

Unbalanced centrifugal acceleration

Lateral vibration acceleration

Side wind force

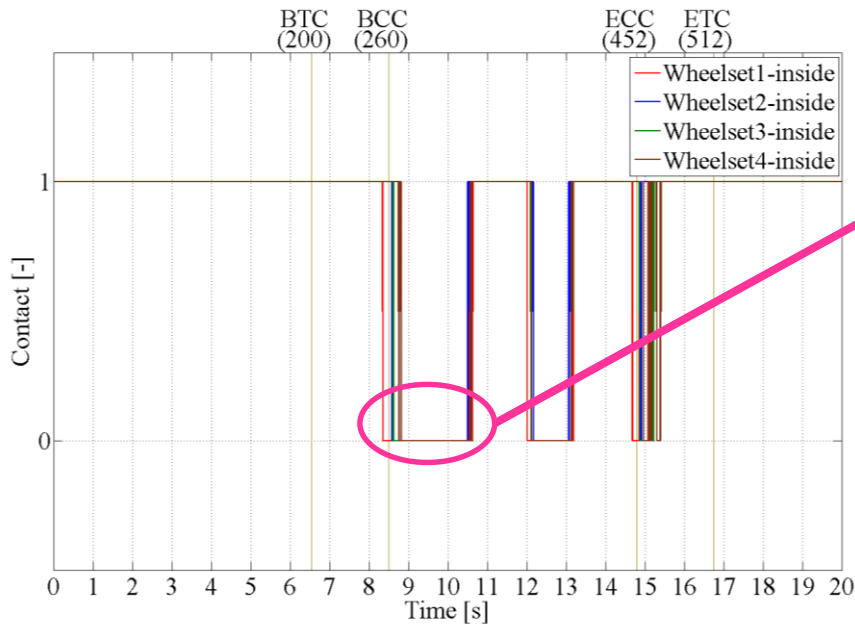
Criterion for judgment of overturning in the simulation

Four inside wheels doesn't contact with rail more than 1 sec.

Overturning

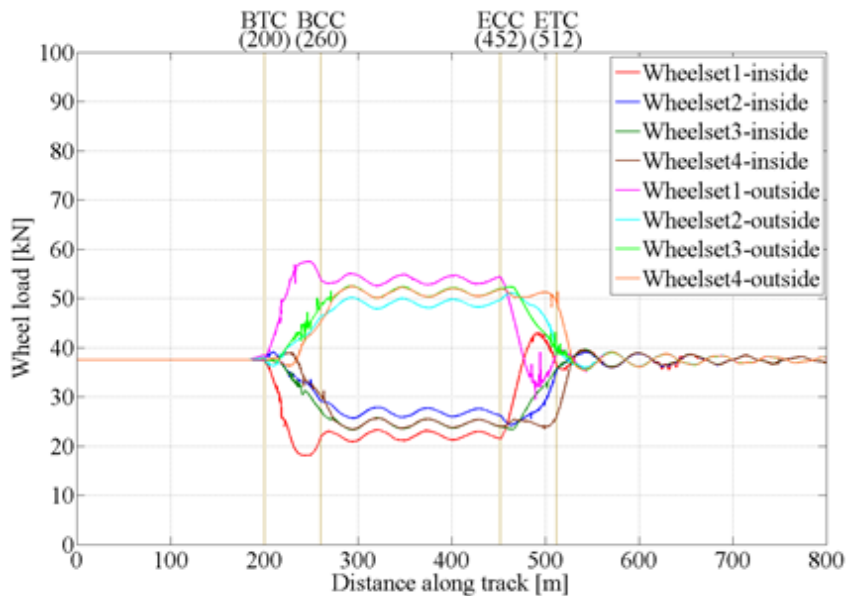
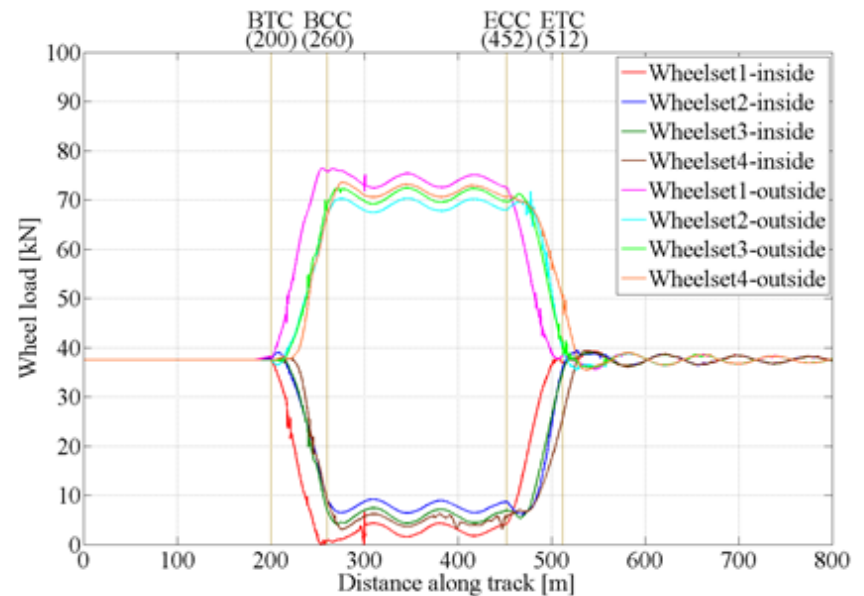
Figure 9: Simulation results.

(a) $V=80$ km/h

(b) $V=109$ km/h

Condition	Kunieda's formula	MBD simulation
Narrow gauge (1.067 m)	105.7 km/h	109 km/h
Standard gauge (1.435 m)	118.7 km/h	121 km/h
Wide gauge (1.667 m)	127.0 km/h	130 km/h

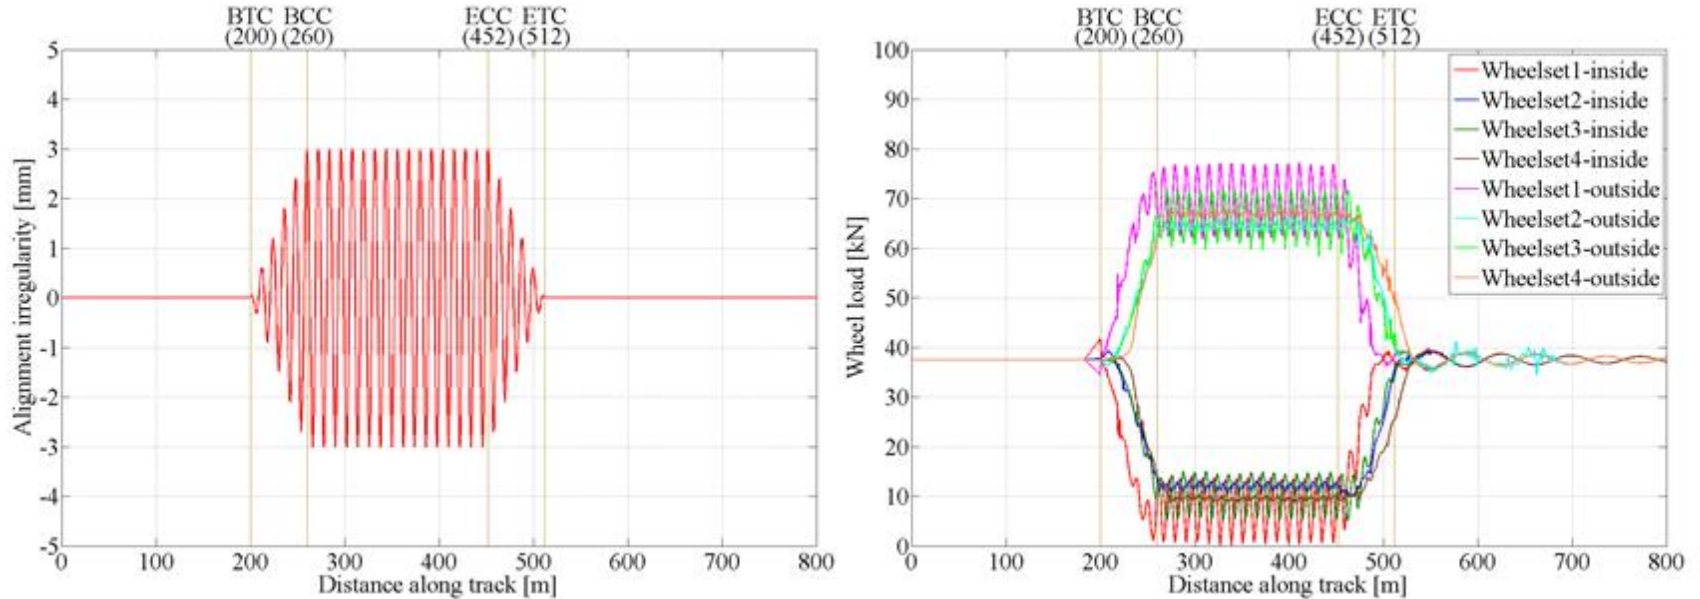
Figure 10: Simulation results with track irregularities.

(a) Alignment irregularity

(b) $V=103$ km/h

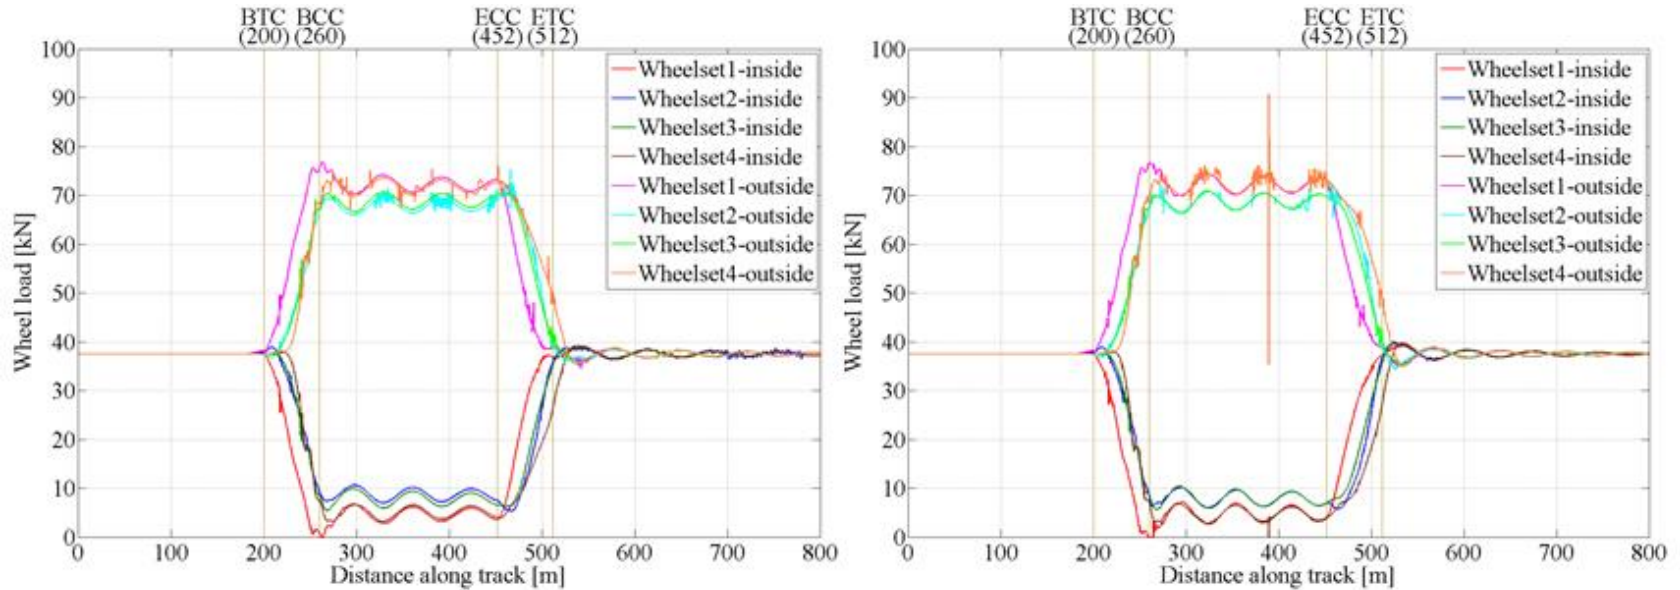
Figure 11: Simulation results.

(a) Gauge=1.435 m at V=121 km/h

(b) Gauge=1.667 m at V=130 km/h

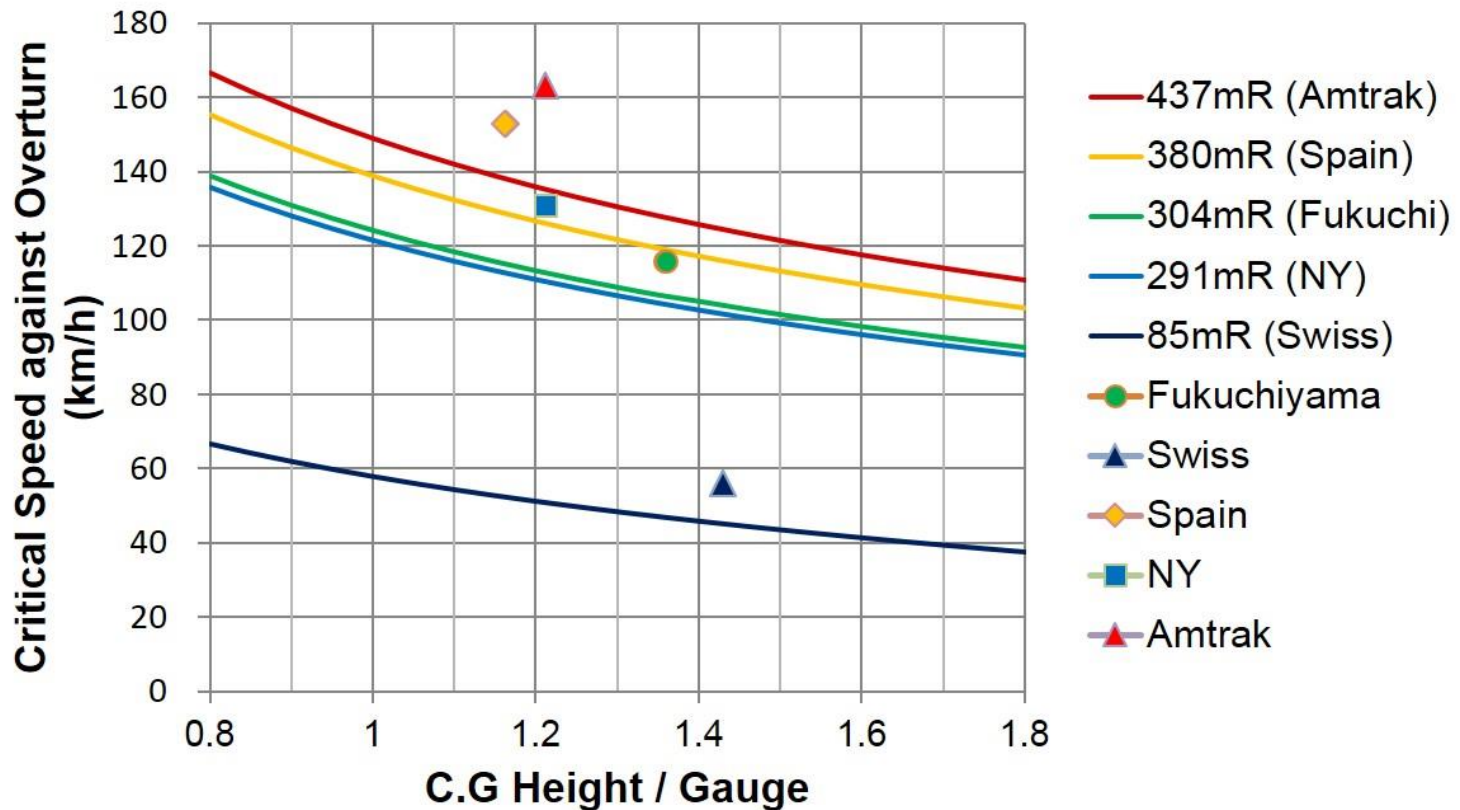
Figure 12 Overview of train overturn accidents.

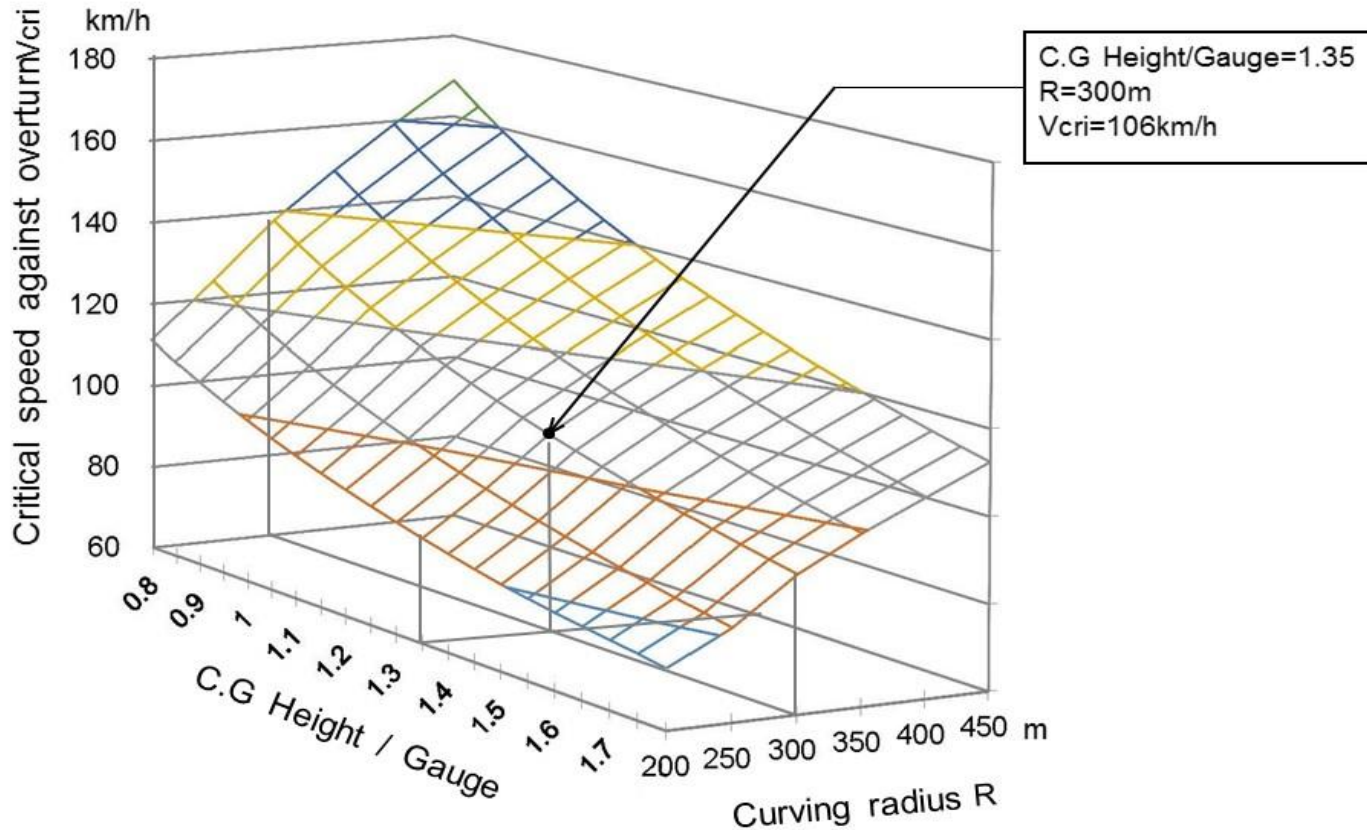
Figure 13 Overview of train overturn critical speed.

The relationship between the critical overturn speeds and various parameters has been considered. **The critical speed is heavily influenced by the ratio of “C.G height of the vehicle” to “track gauge width”.** The overview of the critical speed changes against “**C.G Height/Gauge-ratio**” and “curving radius” are shown in the three dimensional graph.

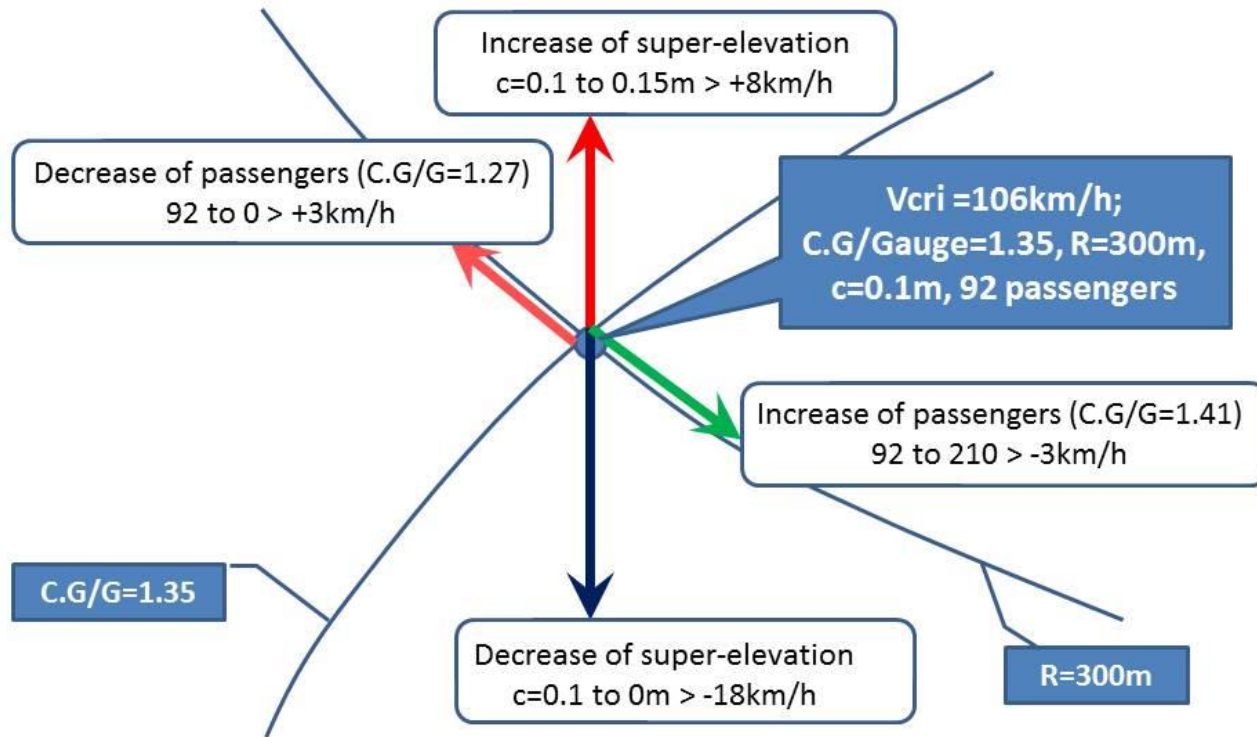
Figure 14 Influenced factors to train overturn critical speed.

The second most important factor is **the C.G height of vehicles**. The ratio of C.G height to gauge width deeply influences the critical overturn speed. **High C.G center height is an obvious disadvantage against overturn.**
