Ensuring Rescue Routes to Support Emergency Activities During Times of Disaster

Current efforts and assessment

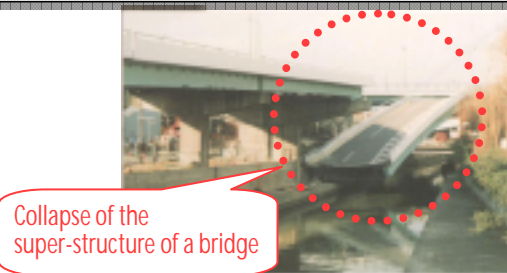
Photo: Collapse of the superstructure of a bridge (Nagata Ward, Kobe City)

System to prevent bridge collapses

Collapse of the super-structure of a bridge

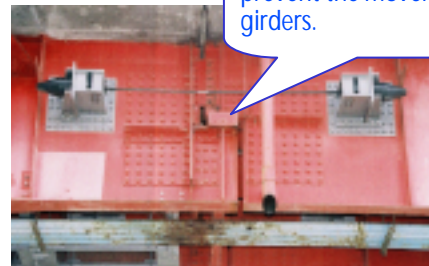
Photo: Aseismic connector (Wanatsu district, Nagaoka City)

Aseismic devices operate to prevent the movement of girders.

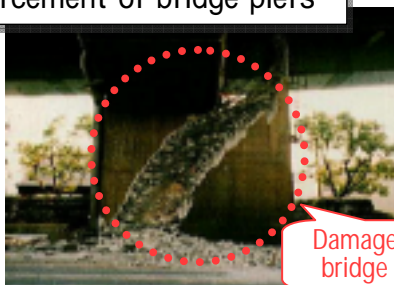
Photo: Damage to a bridge pier (Higashi-Nada Ward, Kobe City)

Reinforcement of bridge piers

Damage to a bridge pier

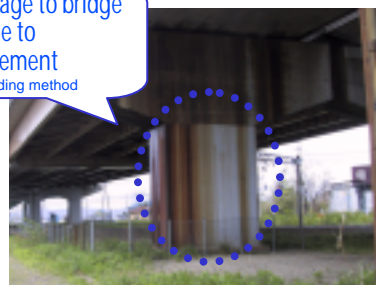
Photo: Bridge piers (Tokamachi district, Nagaoka City)

No damage to bridge piers due to reinforcement
* Steel winding method

Quakeproofing of bridges along emergency roads has been moving forward since the Hyogoken Nambu Earthquake of 1995 (maximum intensity: 7). Accordingly, the Niigata Chuetsu Earthquake (maximum intensity: 7) resulted in no serious damage to road bridges, and thus roads were able to fulfill their function as routes for emergency transport.
