## 3.10 その他の調査結果

### 3.10.1. 覆工コンクリートに関する調査

### 3.10.2. アンカーボルトの腐食状況確認試験

### 3.10.3. アンカーボルト本体の引張り破断試験

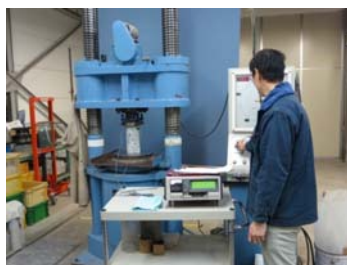
実施状況

- ・コアの大きさ: 直径 125mm、高さ 250mm(最大骨材径 40mm を考慮)
- ・「一般財団法人建材試験センター」で試験を実施
- ・コア採取箇所(合計 15 本)の選定方法
  - #接着系ボルト打音点検(3.9 参照)で良・不良の箇所: 各 2 本
  - #接着系ボルト引抜試験結果(3.6 参照)で C 判定の箇所: 2 本
  - #シュミットハンマー推定値の上位・下位で 2 番目までの箇所: 各 2 本
  - #天井板落下区間で覆工コンクリートの変状が著しい箇所: 5 本

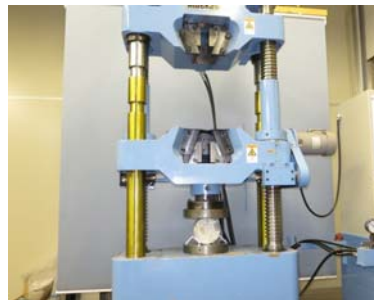
実施状況

⊗ コア採取位置

- ・コアの大きさ: 直径 125mm、高さ 125mm
- ・「一般財団法人建材試験センター」で試験を実施
- ・コア採取箇所(合計 5 本)の選定方法
  - #接着系ボルト打音点検(3.9 参照)で良・不良の箇所: 各 1 本
  - #接着系ボルト引抜試験結果(3.6 参照)で C 判定の箇所: 1 本
  - #シュミットハンマー推定値の最上位・最下位の箇所: 各 1 本

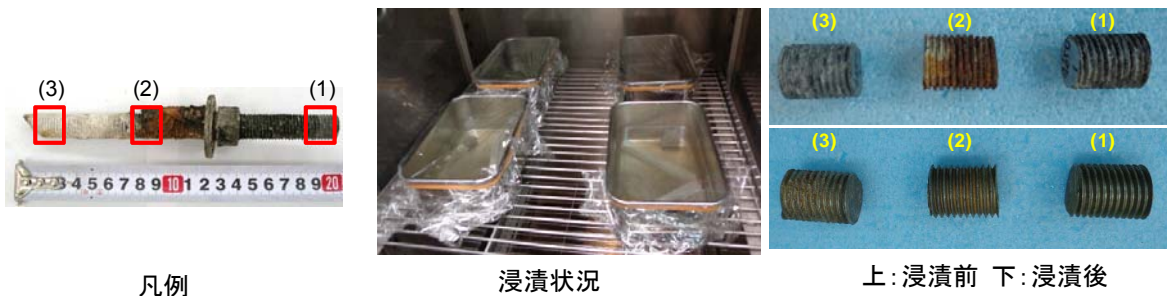
浸漬状況

- ・ 引抜試験で採取したボルトを切り出し、加熱・ブラシ洗浄後、10%クエン酸ニアンモニウム溶液に浸漬して腐食生成物を除去。
- ・ 加熱・ブラシ洗浄後と腐食生成物除去後の試験体重量を比較。

上:浸漬前 下:浸漬後

腐食状況確認試験番号	重量減少率 (%)
①	(1) 1.98
	(2) 2.46
	(3) 1.05
②	(1) 1.54
	(2) 1.82
	(3) 1.73

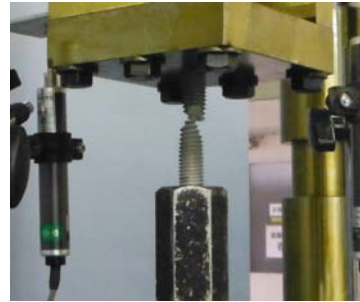
試験B

試験 B：アンカーボルト本体を治具を用いて引張り試験機にかける

引張破断試験番号	引張試験方法	引抜試験結果 (kN)
①	試験 A	10.8
②	試験 A	32.3
③	試験 B	39.7
④	試験 B	23.3

引張破断試験番号	破断荷重 (kN)	降伏荷重 (kN)	降伏応力 (N/mm <sup>2</sup> )
①	80.0	64.8	413
②	79.1	62.9	401
③	81.2	64.4	410
④	78.5	64.4	410

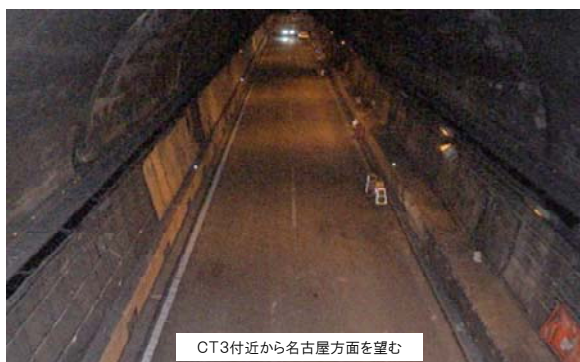
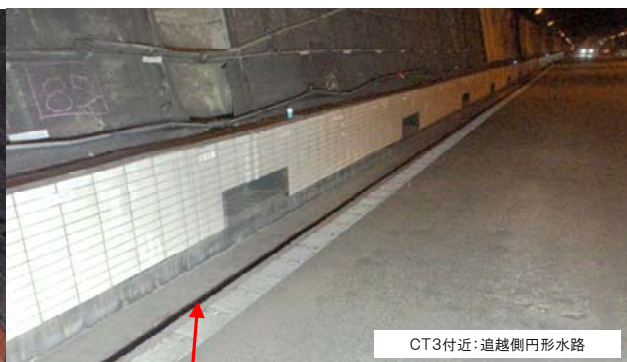
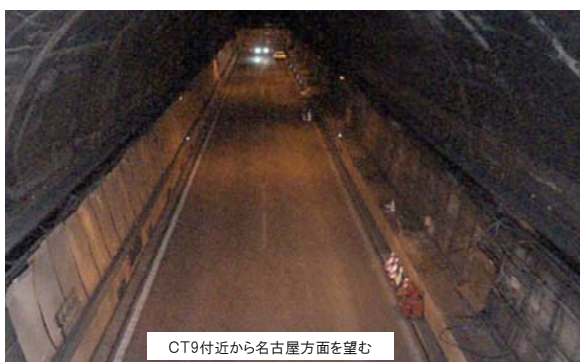
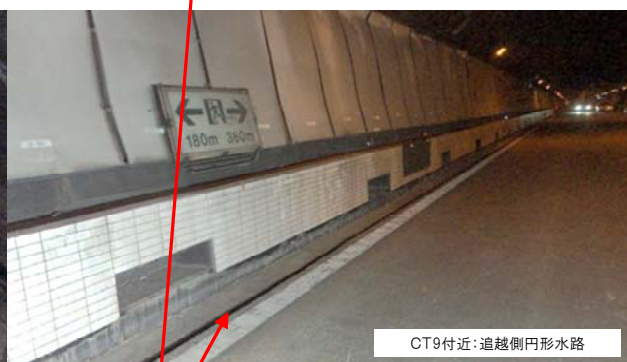
円形水路のゆがみはない

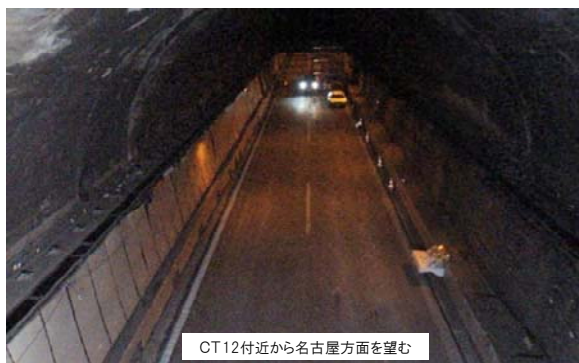
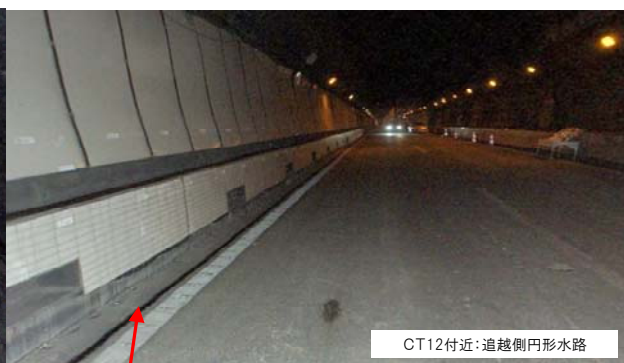
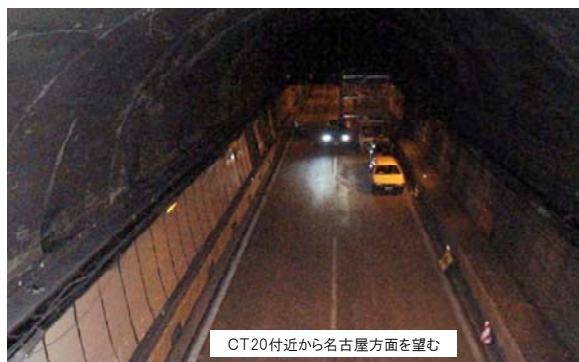
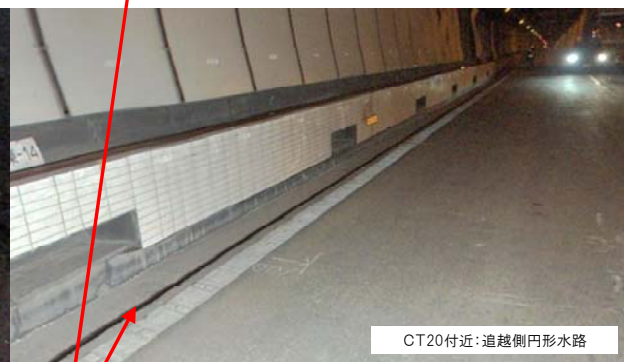
円形水路のゆがみはない

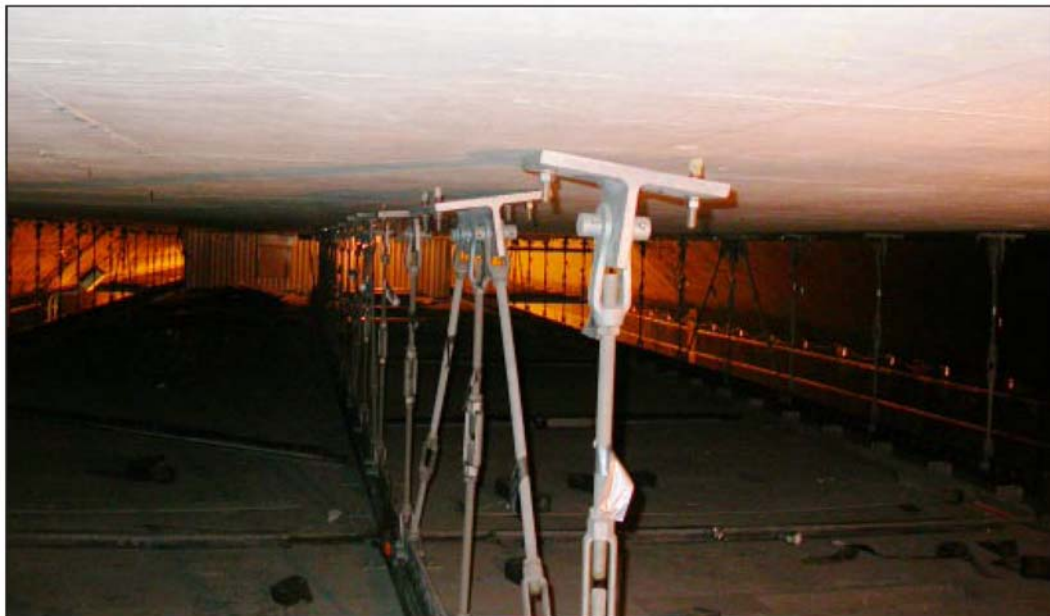
州際道路 90 号トンネル（ボストン）におけるアンカーボルトの変状

■事故の主原因は持続引張荷重に対して抵抗性能の無い速硬型エポキシ樹脂「Sikadur AnchorFix-3」を接着剤として使用していたことであつたとされ、下記に該当する接着剤の製品のリストを公開し、これらの製品を接着系アンカーに使用しないよう注意喚起している。(TA5140.30)

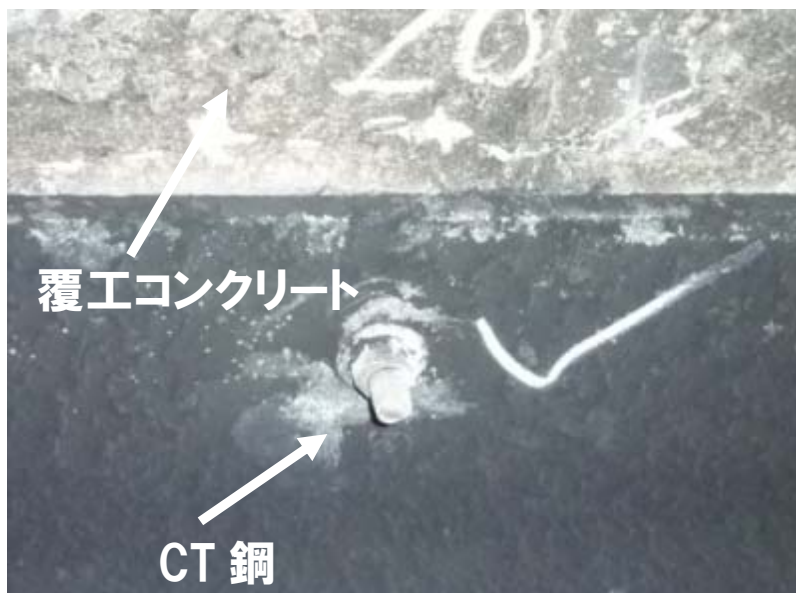
笹子トンネル（上り）における天頂部接着系アンカーボルトの固定状況

撮影日：2012（平成 24）年 12 月 20 日

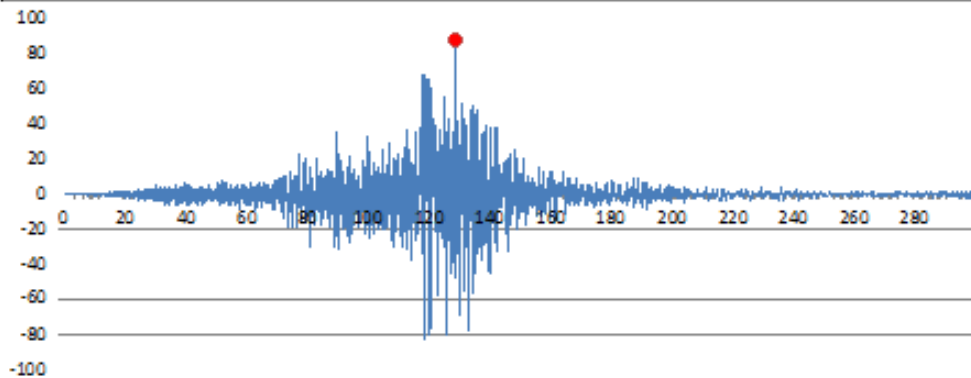
EW

● max 88.8 Gal 発起時刻 128.24 秒

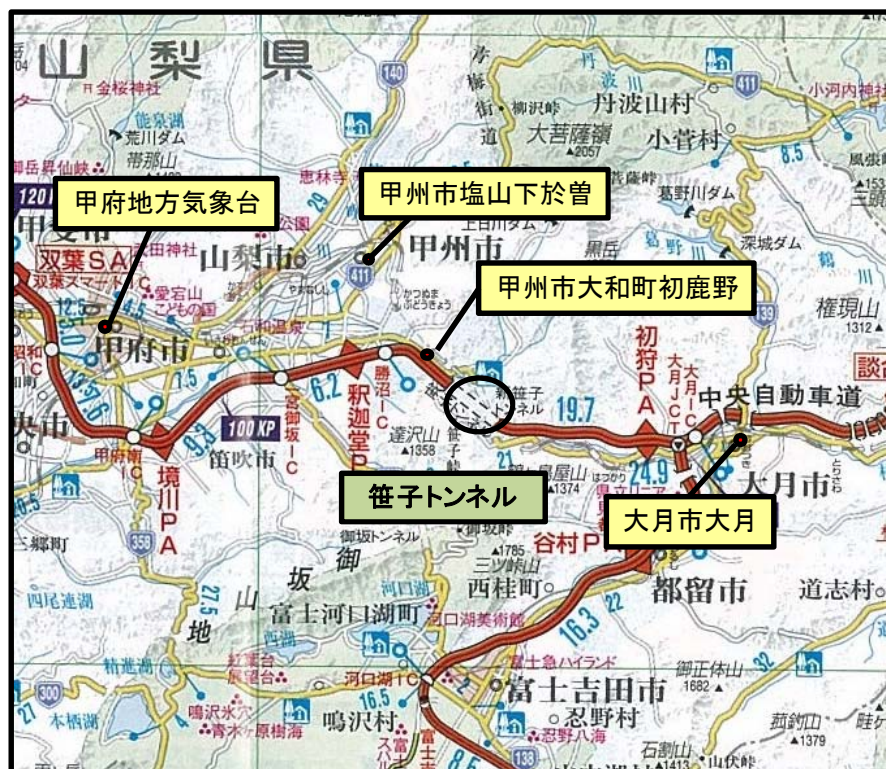
### 3.10.6.3 これまで経験した地震動（1977(昭和 52)年 1 月～2012(平成 24)年 12 月)

甲府市飯田(1977.04～2012.12)										
震度	1	2	3	4	5弱	5強	6弱	6強	7	計
回数	497	171	44	5	1	0	0	0	0	718
甲州市塩山下於曾(1996.10～2012.12)										
震度	1	2	3	4	5弱	5強	6弱	6強	7	計
回数	239	65	8	2	1	0	0	0	0	315
大月市大月(1996.10～2012.12)										
震度	1	2	3	4	5弱	5強	6弱	6強	7	計
回数	119	72	14	4	0	0	0	0	0	209
甲州市大和町初鹿野(2001.06～2012.12)										
震度	1	2	3	4	5弱	5強	6弱	6強	7	計
回数	101	38	6	1	0	0	0	0	0	146

記録上の最大震度は、東北地方太平洋沖地震であり、

- ・ 甲府市飯田および甲州市塩山で震度 5 弱
- ・ 大月市大月および甲州市大和町で震度 4 であった。
