Swift Restoration of Damaged Expressways

Example of Joban Expressway (Mito IC ~ Naka IC)

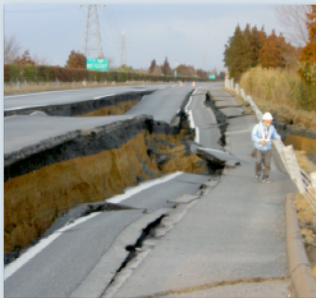
03/11 16:00

Immediately after earthquake hit

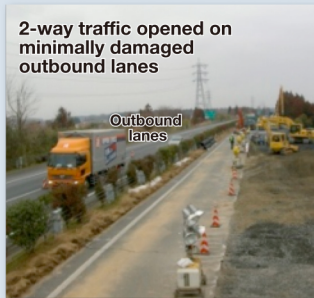
03/12

Temporary recovery

Transit secured for emergency vehicles
Temporary recovery completed

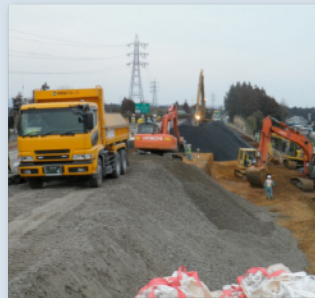
03/14

Emergency recovery

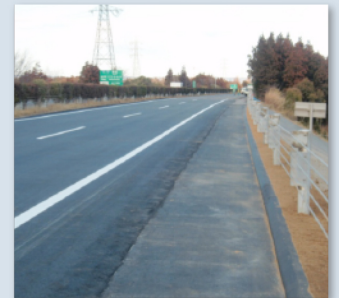
03/17 (6 days after earthquake)

Transit secured for general vehicles
Emergency recovery completed
