航空事故調査報告書

キャセイ・パシフィック航空会社所属
ロッキード式L1011-385-1型VR-HOC

新東京国際空港

平成2年3月24日

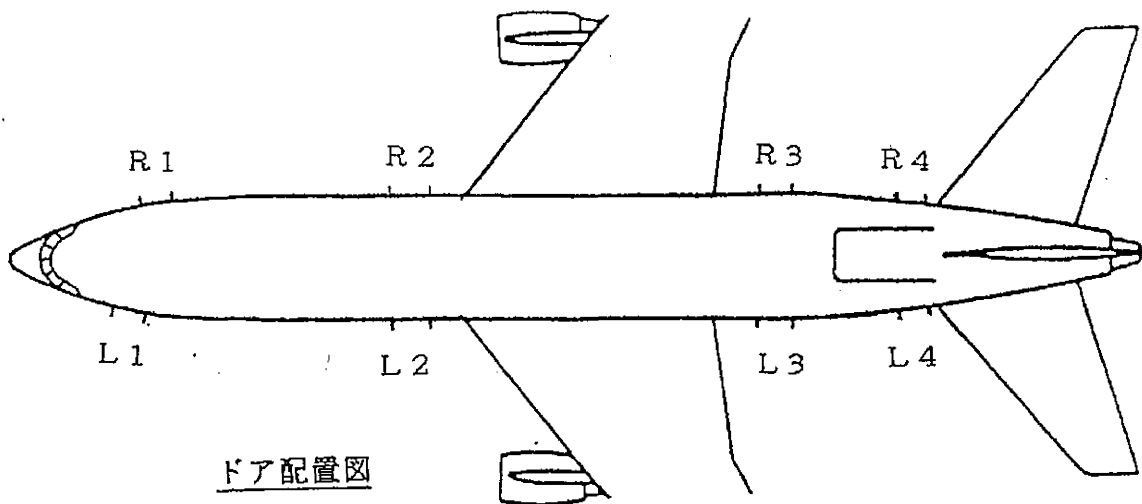
チーフ・パーサは、機長の「右側からの緊急脱出」の指示を「緊急脱出」とのみ聞き、直ちにL1ドアを開いた。しかし脱出スライドは風にあおられて使用できない状態だったため、ドアにセフティ・ストラップを掛けて乗客をR1ドアに誘導した。

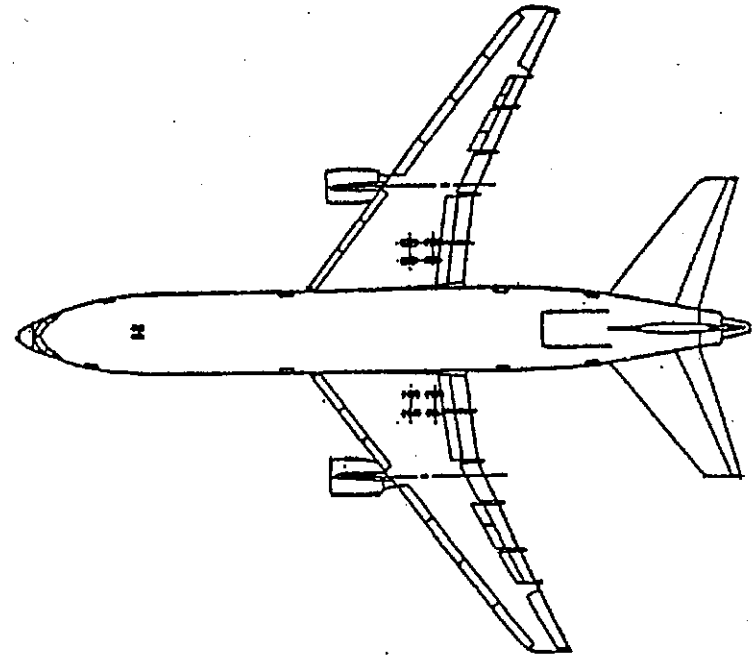
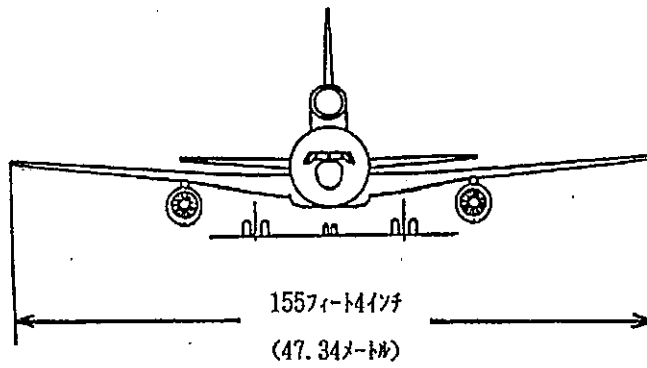
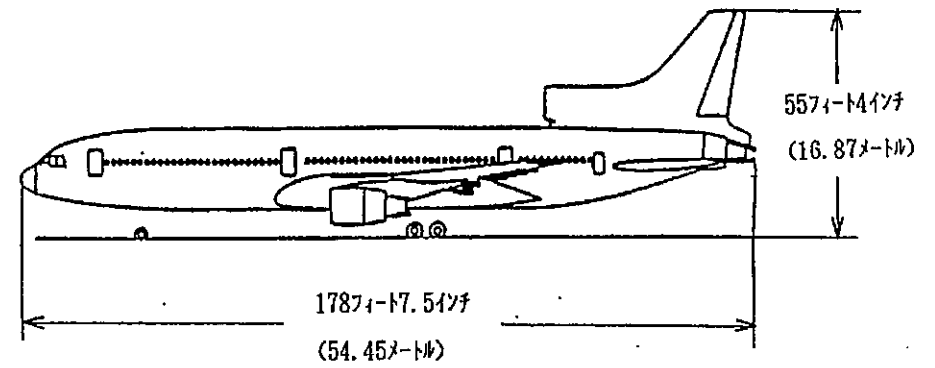
付図 4 機体損傷状況

左主翼翼根部リヤ・スパー及びその周辺部が破損し、第1燃料タンクから燃料が流失した(付図4及び5、写真1及び2参照)。

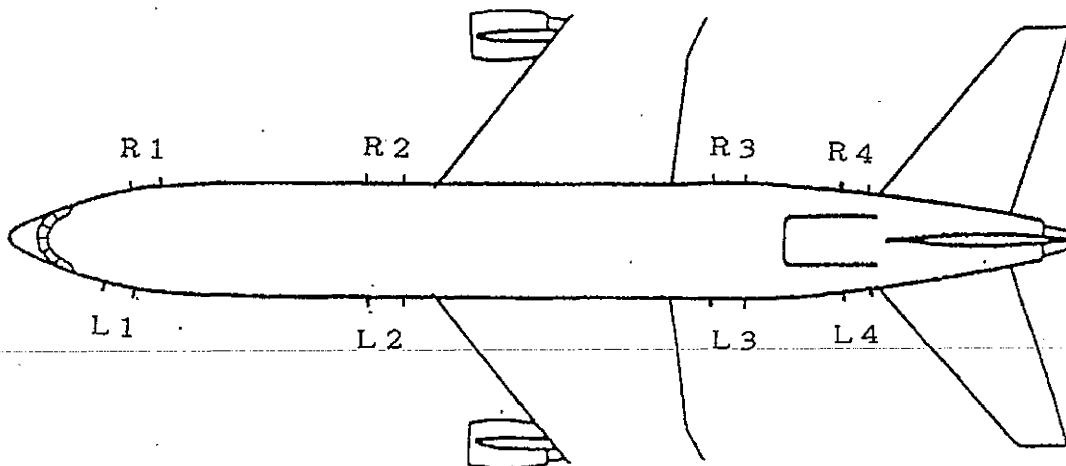
Location of Emergency Doors

The chief purser, who heard the captain's instruction "Emergency evacuation from the right side" only as "Emergency evacuation", opened immediately L1 door. The escape slide, however, was unusable being flapped by wind. Then she hooked the door with the safety strap, and guided passengers to R1 door.

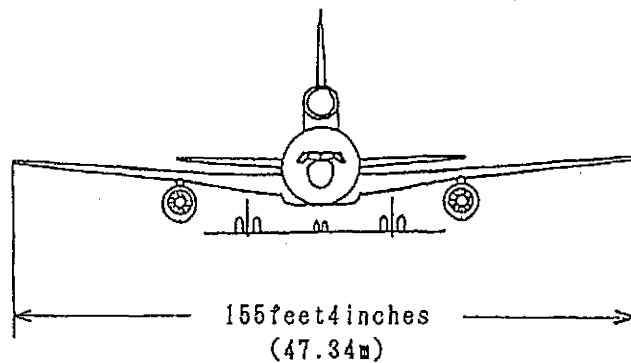
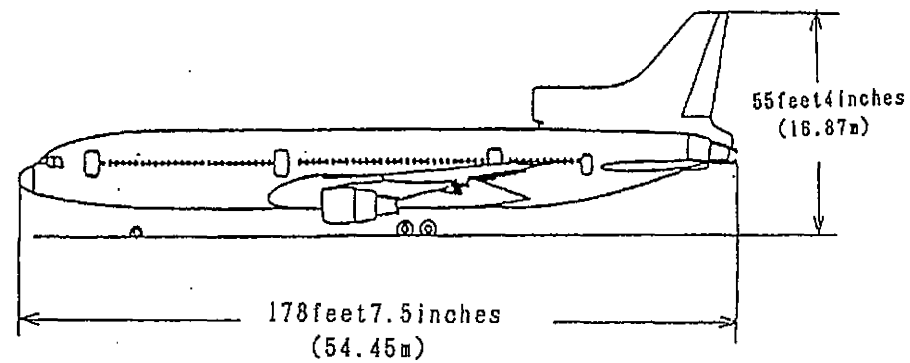
Attached Fig. 4 Damage to Airframe

The rear spar of the left wing root and its vicinity were fractured and fuel leaked out from No.1 fuel tank. (see Attached Figs. 4 and 5, Photos. 1 and 2)

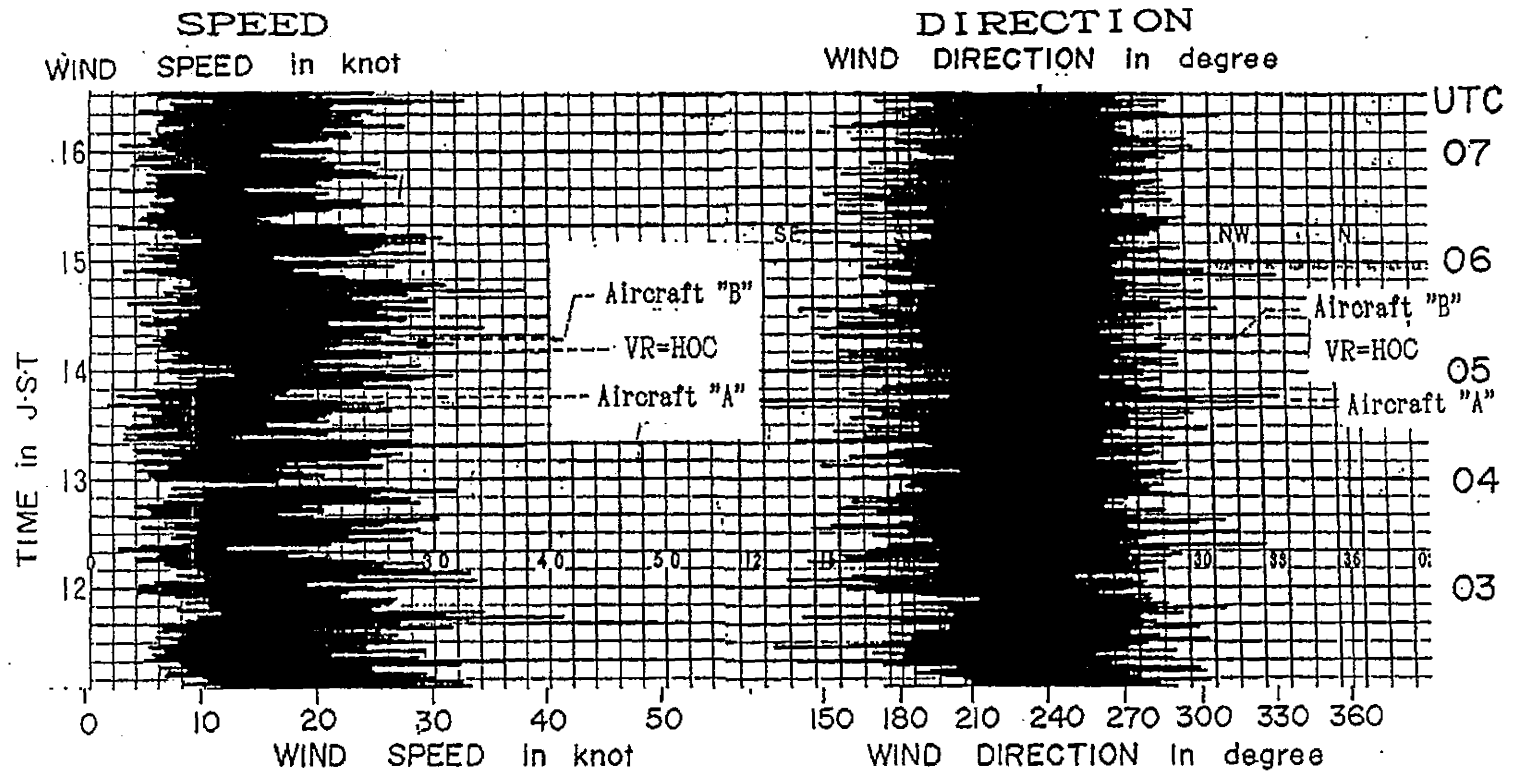
Attached Fig. 11
 Records of Wind Direction/Speed at Runway 16
 0200 - 0700 hours, March 24, 1990

3.2.4.2 According to records of the 2-minute wind sensor, it was about from 0430 to 0600 UTC that the variation in wind direction on the Runway 16 side was remarkable, and about from 0500 to 0540 UTC that the maximum in wind speed was large; and the accident occurred in this time zone in which the gustiness was significant. (see Attached Fig. 11)

The recording paper (see Attached Fig. 11 of the Text) of the runway 16 wind sensor is unable to read the average wind because the recording paper is saturated with recording ink. Therefore, the maximum value deviated to the north (not gust but an average for several minutes) was compared with the average wind recorded in the aircraft on the assumption that when the wind direction was deviated to the north, the average wind would also make a similar change. (see Attached Table 1) According to this,

In the runway 16 wind sensor (see Attached Fig. 11 of the Text) is recorded a maximum of 310 deg/35 kt about 0511 UTC. From this record the duration of the peak can not be estimated, but in the 2-minute average wind sensor (see Note below) is recorded a maximum of 287 deg/27 kt (some error involved in reading of the wind speed) as an average vector for 3 seconds at almost the same time of period.

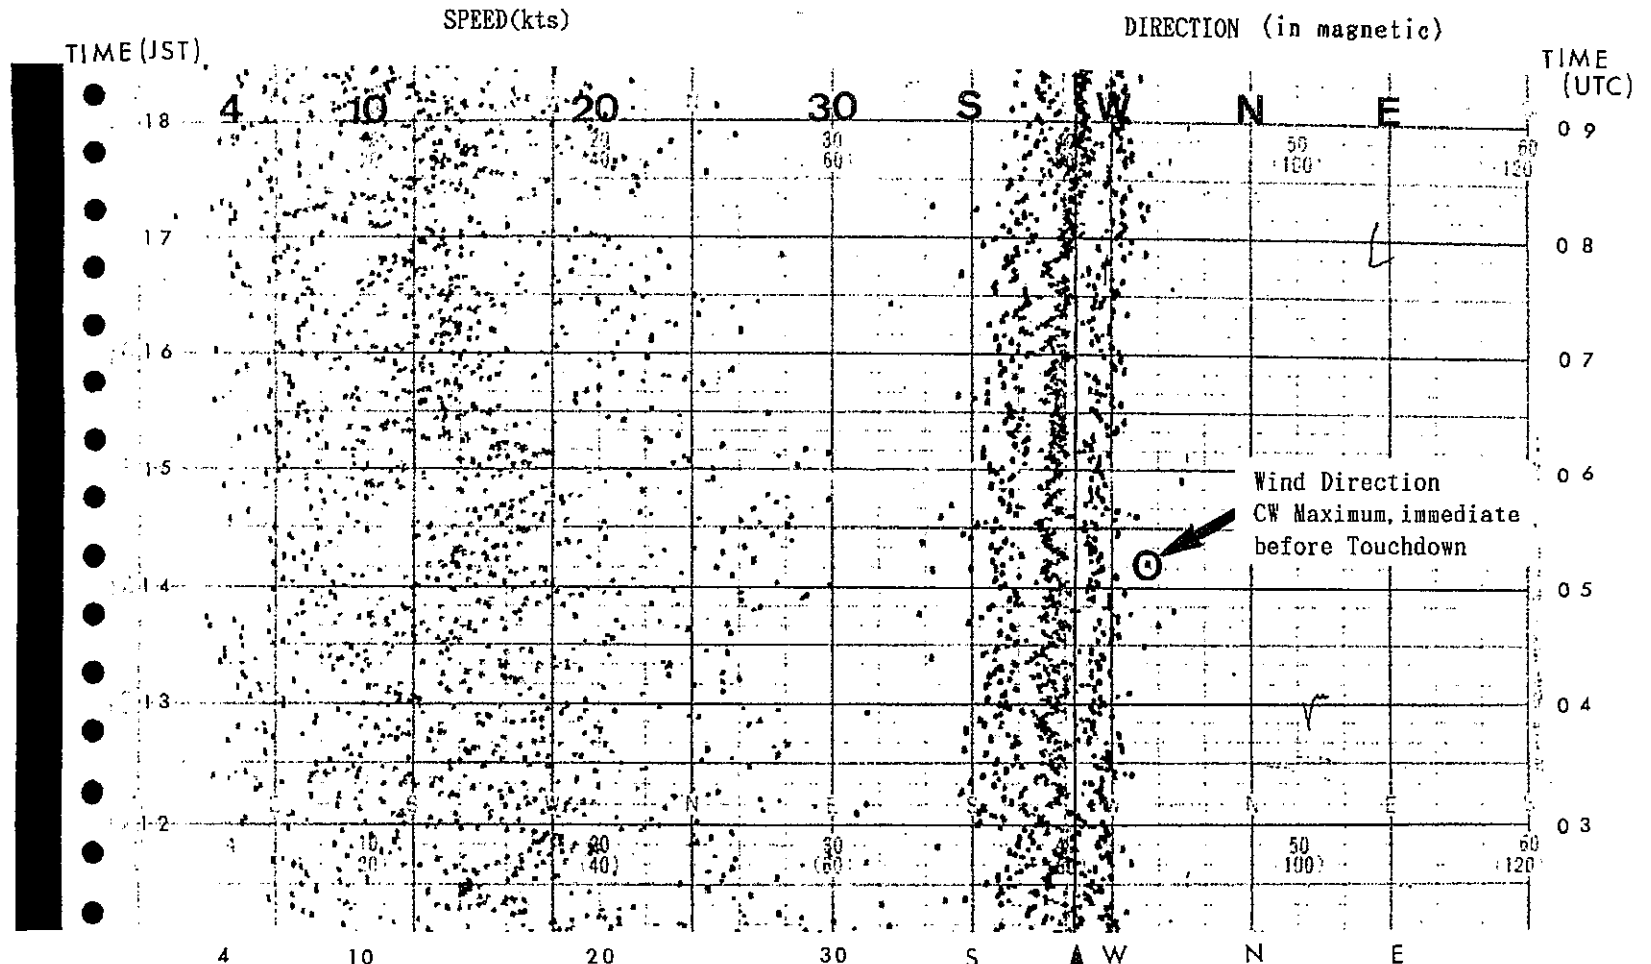
Attached Fig. 12
 Records of TW0(2) Minutes Average of Wind Direction/Speed at Runway 16
 March 24, 1990

(40) values for 2 minutes, the average and the maximum in the 2 minutes are dotted. However, the maximum must be within the 2 minutes, and the time it appears is not recorded. The wind is calculated as a vector. As to the wind speed on the left side of Attached Fig. 12, the light brown indicates a maximum, and the blue an average, while as to the wind direction the green indicates a maximum, and the purple an average.

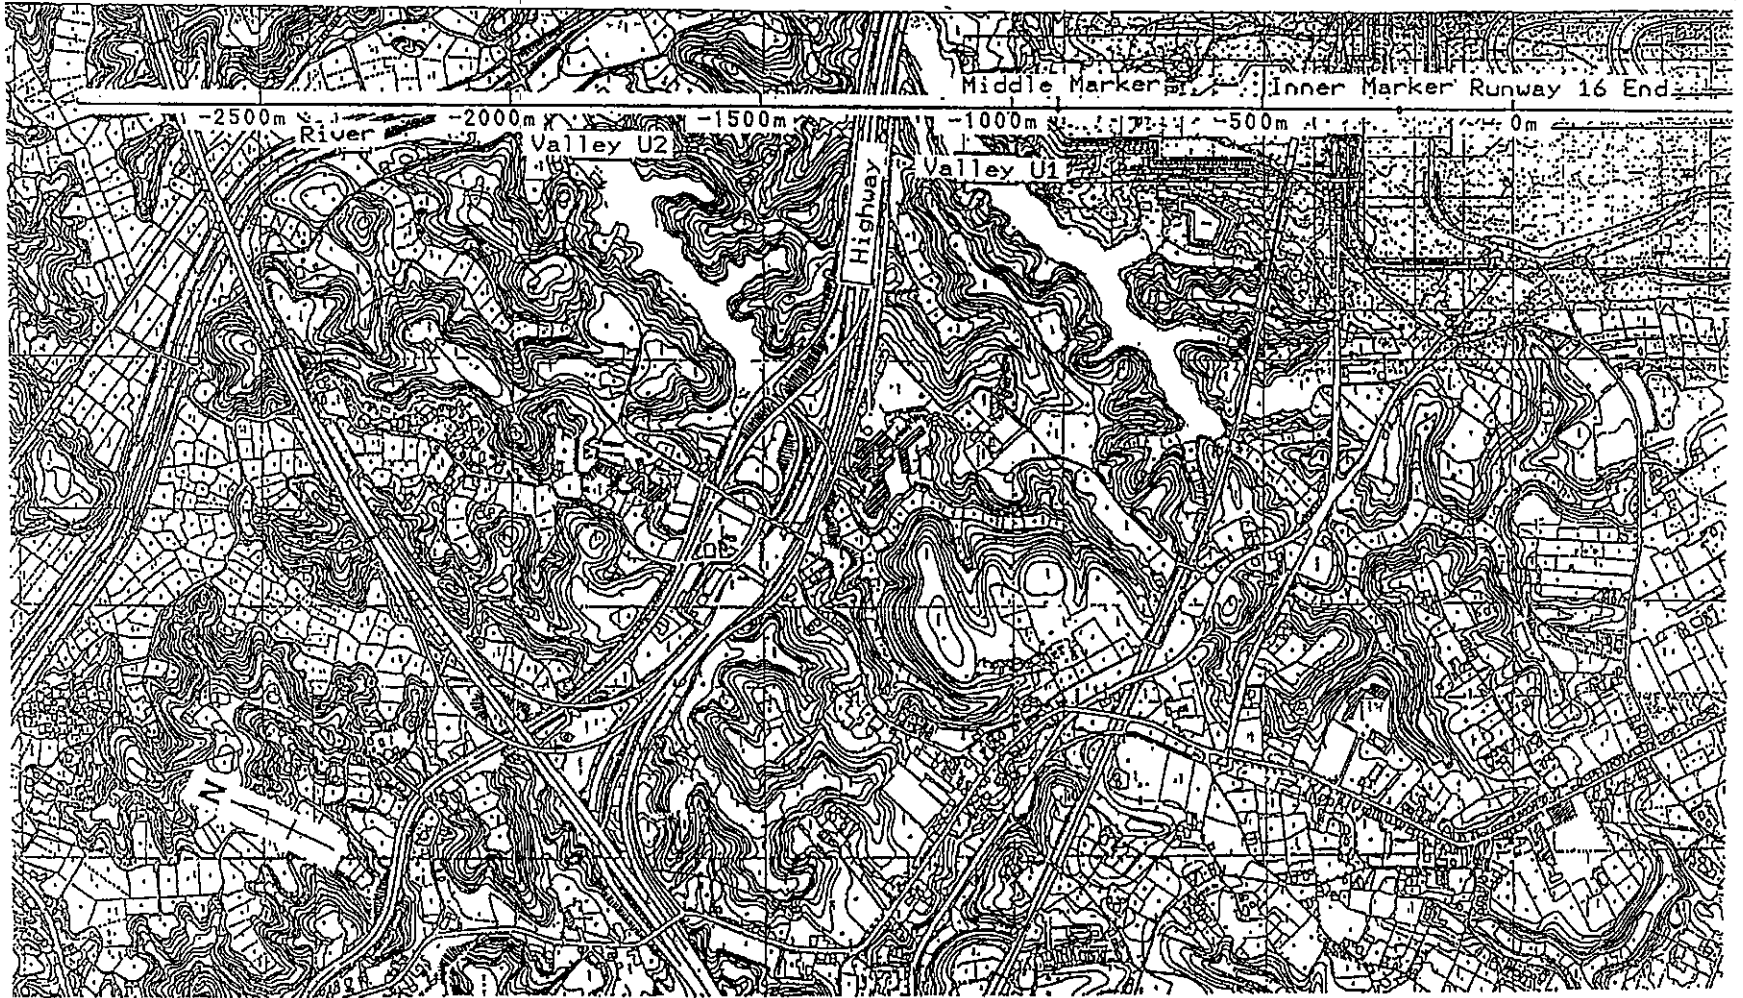
This point is located on the edge of the airport near the middle marker, where the flight height is about 200 ft. The location (Point G or Point H), where change in CAS is significant, is having outsidess of the airport boundary lying beyond about 200 meters on the windward side (i.e., to the right facing the approaching direction) thereof, of such a complicated topography that there are sunken places and hills and, besides, a valley running at a heading of 200 degrees is crossing nearby. (see Attached Fig. 13 "Topographical Chart" of the Text)

In case of Aircraft 'A' and Aircraft 'B', the wind suddenly decreases from near the inner marker. Since such a decrease would be inconceivable as a vertical shear, the abrupt decrease in the wind would be related to the topography. According to Attached Fig. 13 (Topographical Chart) of the Text, the portion where the wind is strong corresponds to an area of such topography that there is a steep cliff on its windward side and the wind blows up, while the portion where the wind weakens corresponds to a

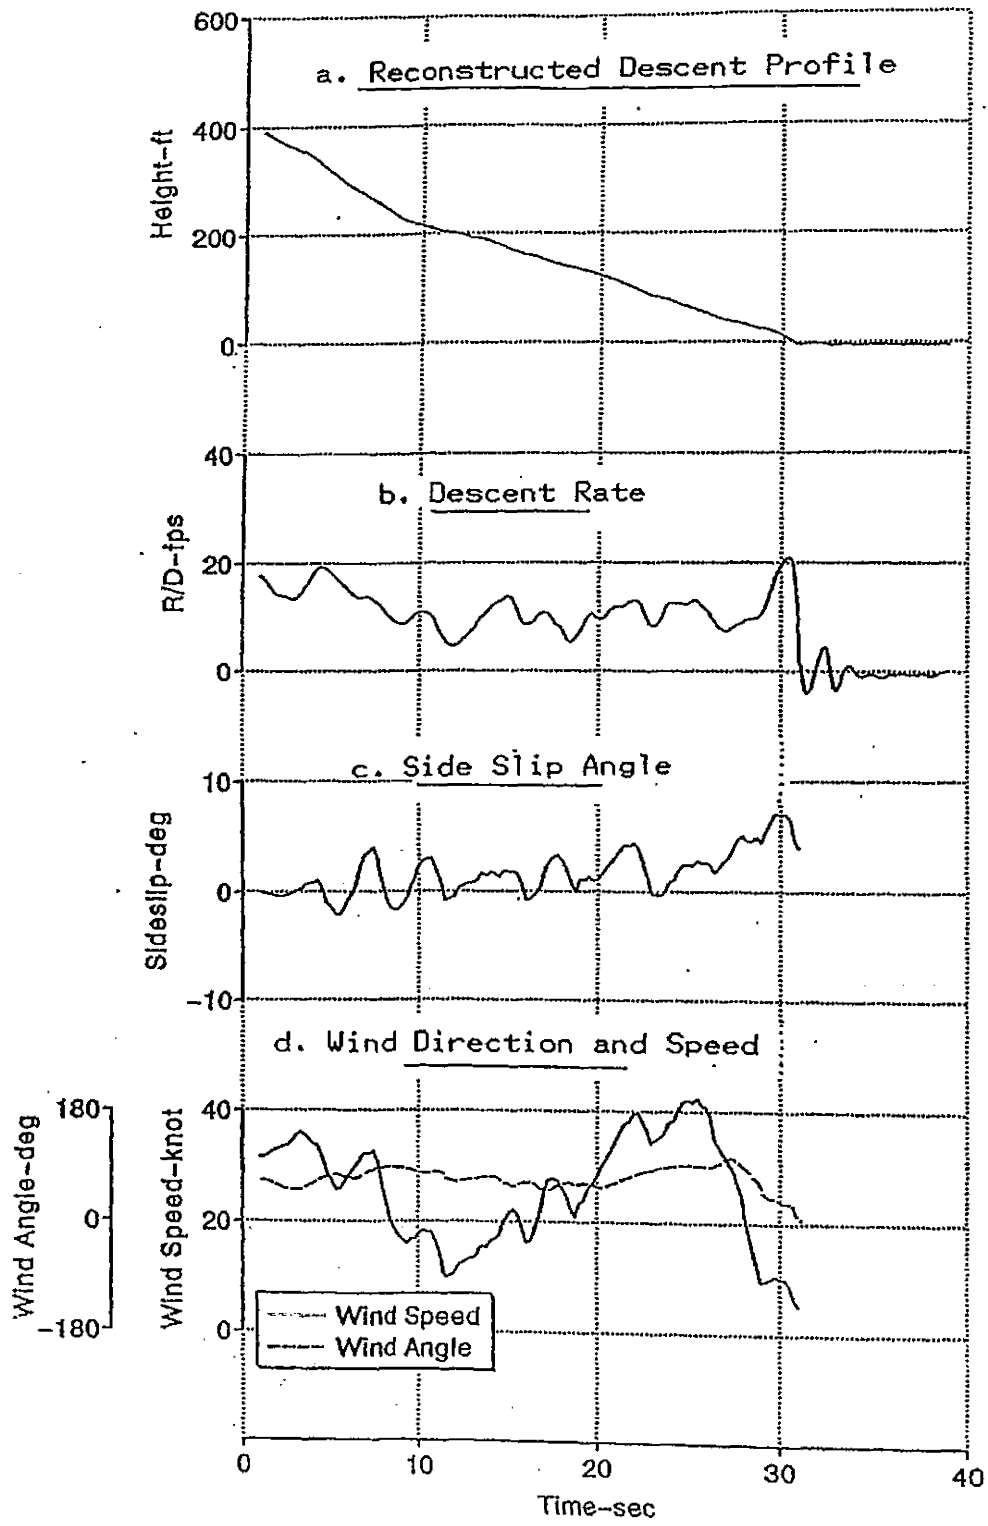
Attached Fig. 14:
Estimation of Descent Rate and Side Slip Angle

Based on readouts of DFDR on the radio altimeter altitude and the vertical acceleration, and using the Karman Filter, the descent rate was estimated for a period from a height above the touch-down zone's elevation mark (hereinafter referred to as "height") of 400 meters down to the touch-down. The Karman Filter is a method to estimate a status amount at a certain time in a manner the most probably accurate, when the status equation (motion equation) representing the system's characteristics as well as the error distribution involved in each estimation are known. Results of the estimation on descent rates are shown in Attached Fig. 14b. It is estimated that the descent rate of the aircraft abruptly increased immediately before touch-down, reaching as much as 21 ft/second.

It is impossible to estimate the crosswise wind by the same method as used in the calculation of the longitudinal wind in (1) above, since no sideslip angle of the aircraft is recorded in DFDR and the recorded data on the lateral position is also less accurate. Therefore, using the Karman Filter in the same manner as in the estimation of the descent rate in para. 3.1.3.1, an estimation was made of the crosswind to the aircraft axis by reconstituting measurements concerning the motion of the aircraft to the lateral direction (each operated amount of aileron, spoiler and rudder, roll and yaw attitude angles, and lateral acceleration). The aircraft characteristics used in the calculation are based on data provided by the Lockheed Company. Results of the estimation are shown in Attached Fig. 14c.

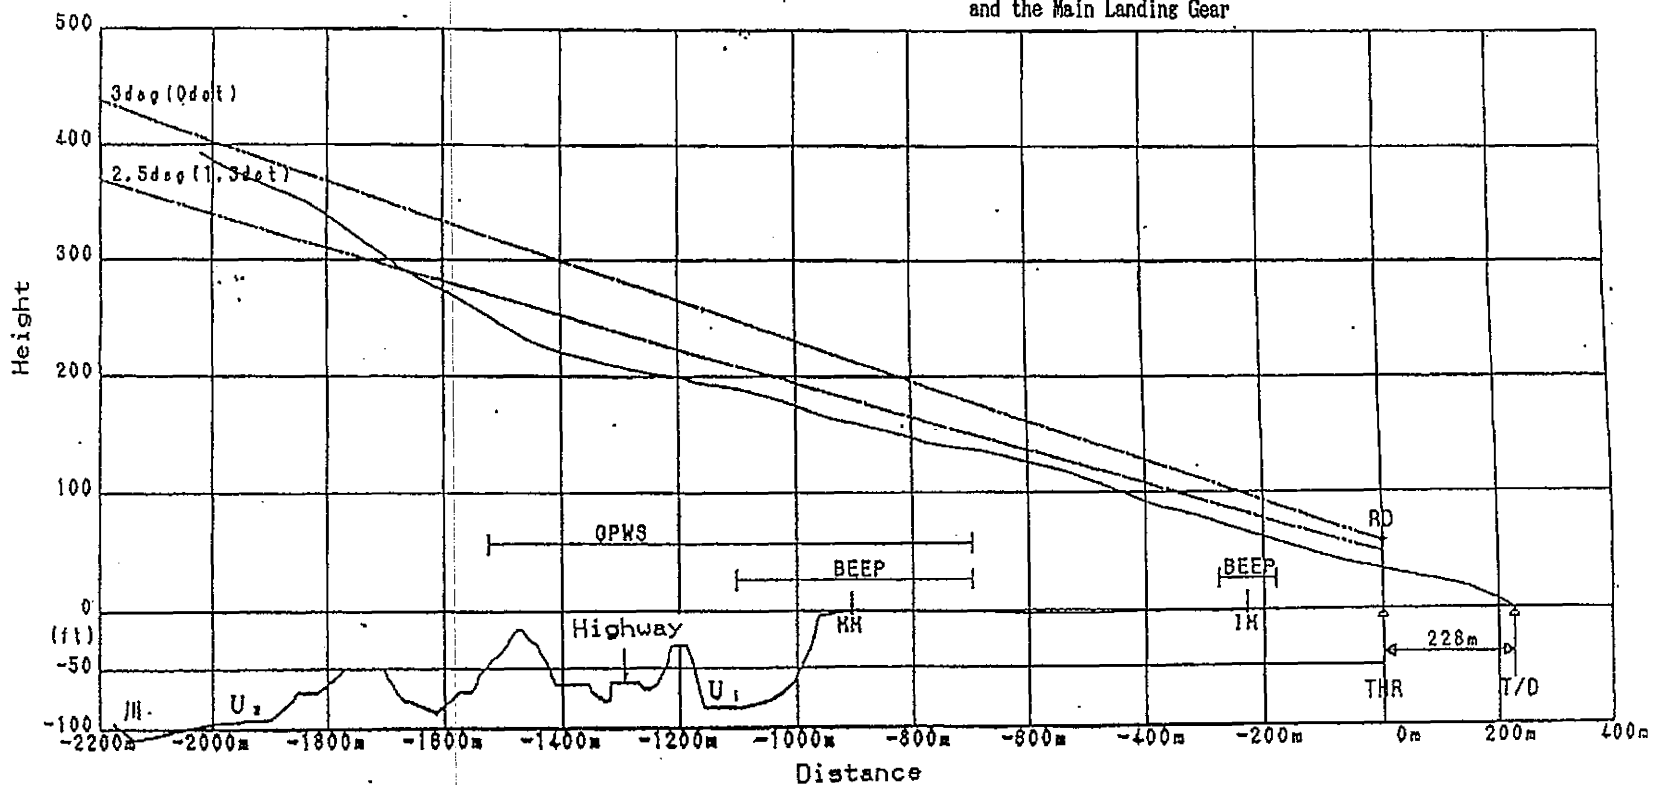
Attached Fig. 18 Estimated Descent Profile

Results of the estimation are shown in Attached Fig. 18. The initial touch-down point of the aircraft is also estimated to have been about 230 meters inside of the approach end of runway.

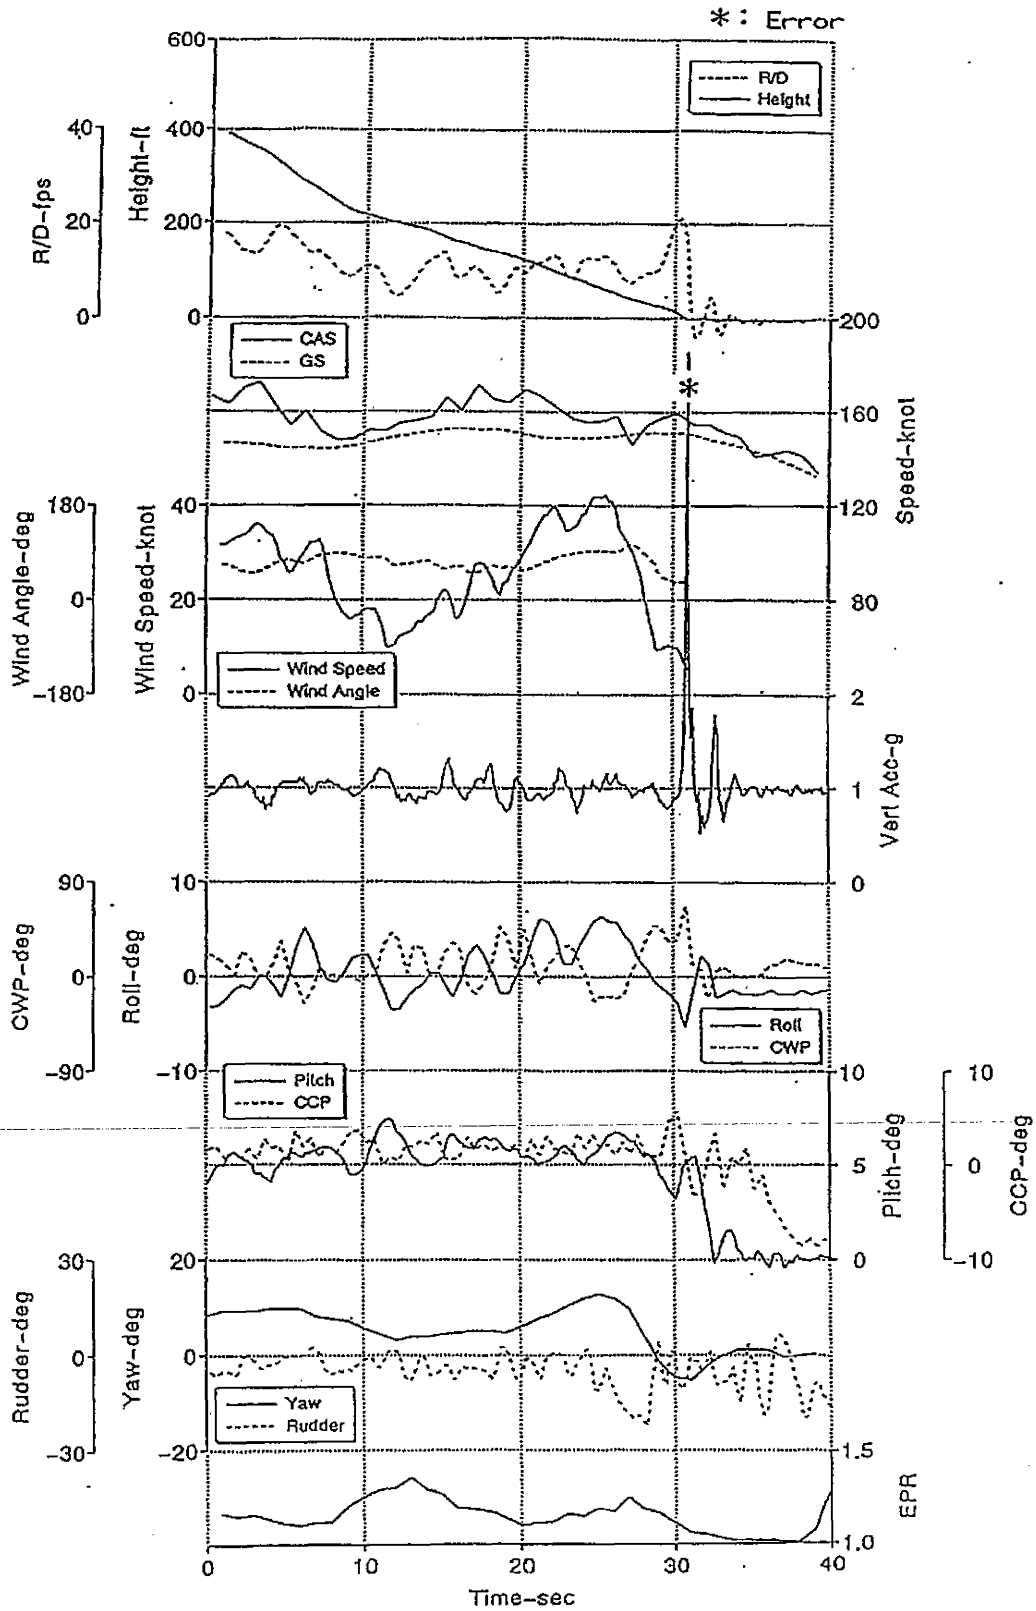
Attached Fig. 19 Chronological Records

In Attached Fig. 19 is shown the chronological sequence up to touch-down of the aircraft from the height of 400 ft, while in Attached Figs. 20 and 21 are shown details of the longitudinal and the lateral motion from 6 seconds prior to touch-down. In these figures, the height, rate of descent, ground speed, and wind direction and speed are values which were estimated in para. 3.1.4, and others are readouts of DSDR.
