Chapter 2 Railway accident and serious incident investigation

1. Summary of major investigation report

Railway 1 During emergency braking of a freight train, one of the container wagons derailed by the coupling force from the following wagons.
(Derailment, in the Suita signal station, the Tokaido Line, Japan Freight Railway Company)

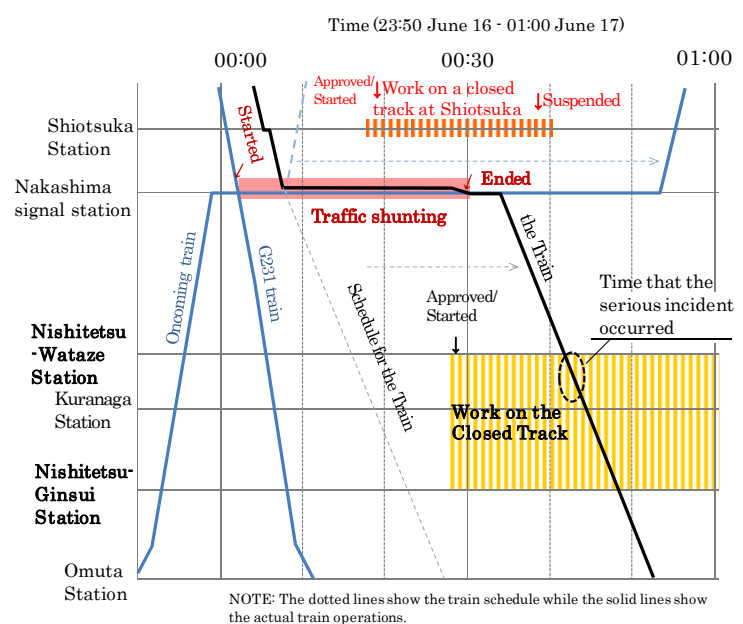
Train schedules for the time around the serious incident

While the Company's track closing regulations specify the procedures for not allowing trains, onto the track closed for work, it is probable that in actual application of the regulations, the train dispatchers had been no doubt that a manual operation to indicate stop signal for the signal devices relevant to work on the closed track, because a stop signal is automatically indicated when train operations on the day have ended, by the train operation control

However, it is probable that the train operation control apparatus will indicate green signal if train operations of the day have not yet ended, and it is therefore incomplete and inappropriate in the context of track closing.

It is probable that this on-the-job site interpretation has been taken for granted; with the result that no one had recognized the intrinsic problems with the interpretation.

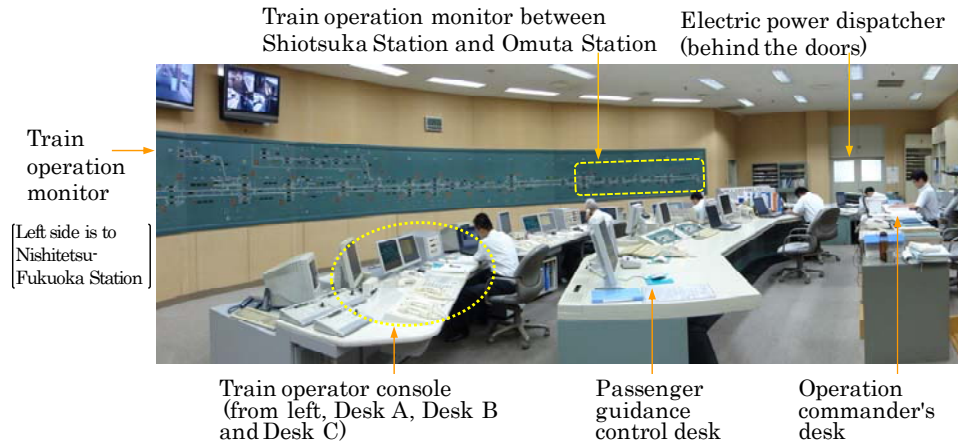
Operation center

In this serious incident, it is highly probable that approval to start the Work on the Closed Track was issued by the train dispatcher without thorough confirmation of the traffic conditions at that time and without double-checking with other relevant train dispatchers, allowing the work to start even though the day's train operations had not yet ended.

- c. Any discrepancy found between the regulations on procedures for approval to start work on the closed track and the actual application of the regulations must be corrected without delay. More fundamentally, the regulations and related systems currently in place must be thoroughly reviewed against the principles of track closing for possible revision.

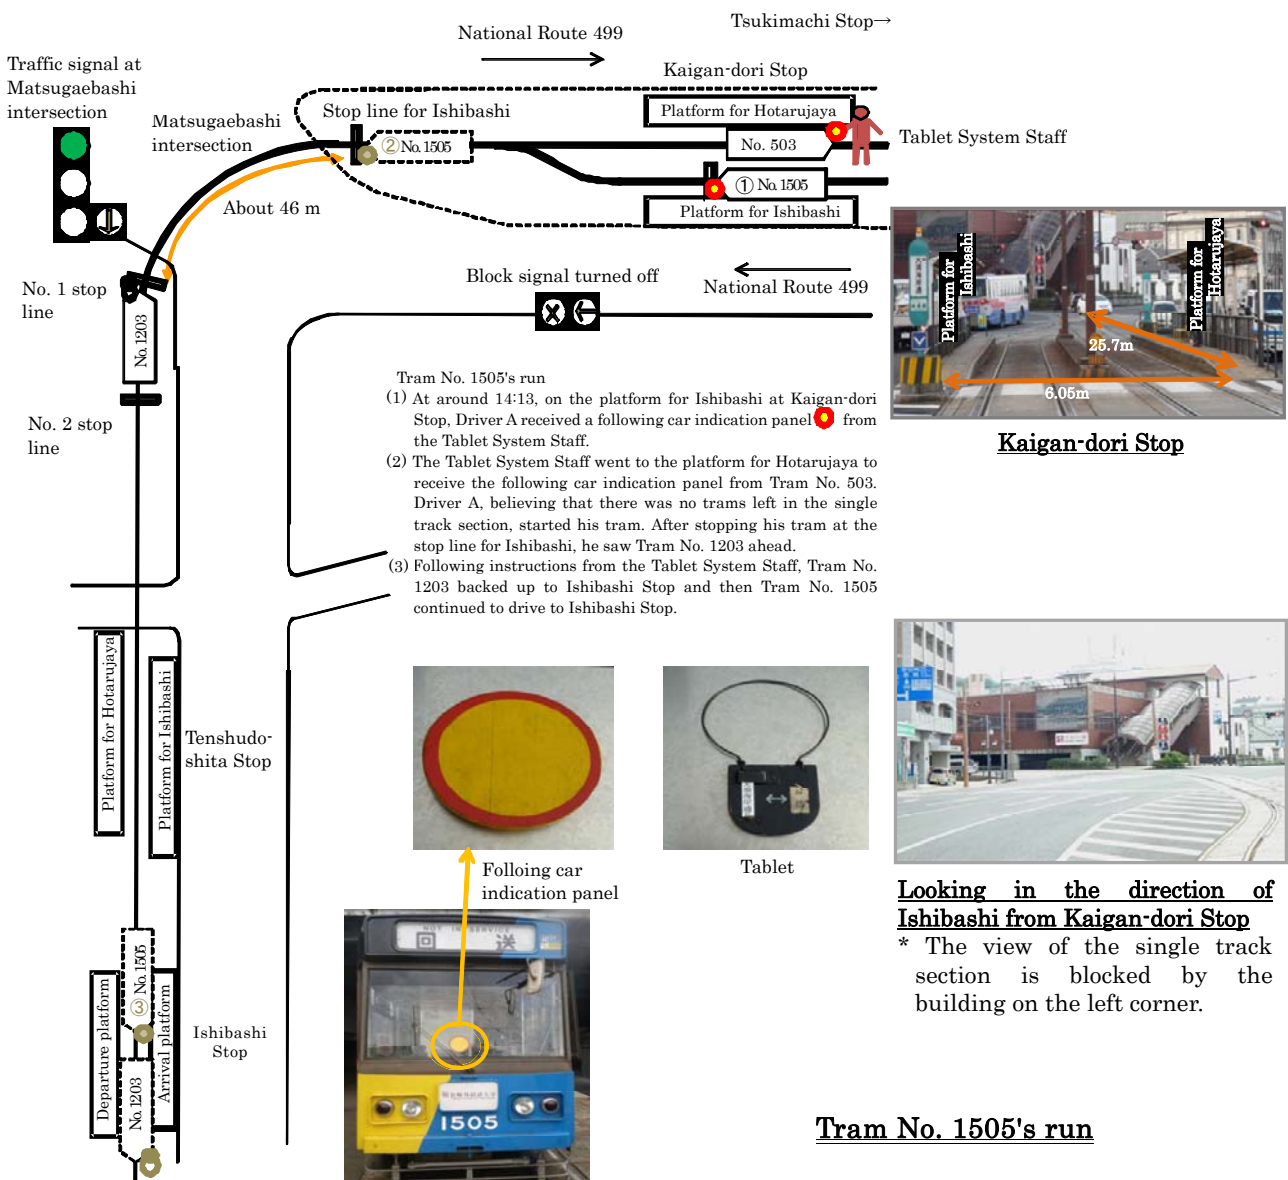
It is probable that, at the Company, tablet system staffs have customarily posted a ticket, i.e., the following car indication panel, to the tram without checking if its driver possesses a tablet, and that drivers have started their trams without questioning this practice. It is somewhat likely that some of the drivers and tablet system staffs at the Company do not fully understand the procedures stipulated in the operating standards or understand them but have carried out operations differently.

It is somewhat likely that, tablet system staff and drivers worried about keeping passengers waiting for long time by following the tablet system procedure, they have customarily turned to different procedures.

The JTSC recommended to the Company on staff education on the company's regulations and standards, improvement in the safety management system and effective promotion and implementation of measures.

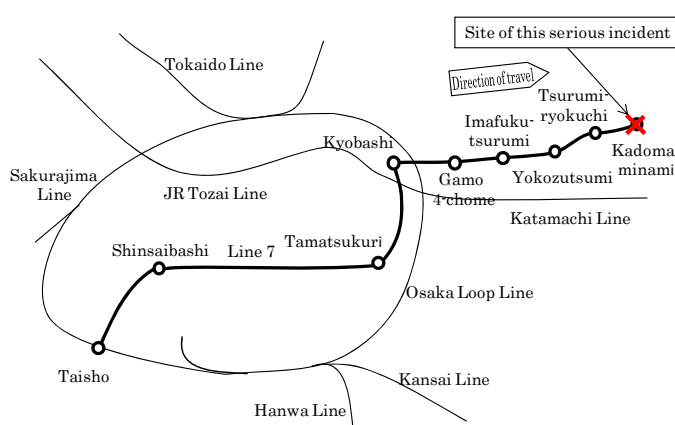
Site of this serious incident

The train “B0504” (Line 7), a 4-car train set, from Taisho Station to Kadoma-minami Station (the Train), operated by the Osaka Municipal Transportation Bureau (the Bureau), departed Kyobashi Station at 05:27. Soon after departure, the ATC*¹ service brake operated, causing the train to stop at about 17 m from where it had started. The driver of the Train disengaged the ATC system as instructed by a train

dispatcher and resumed operation without changing the block system. At Kadoma-minami Station, the Train entered the route to Track No. 2 on which a substitute train, A0504 (the Substitute Train), had been stopped. The driver applied the emergency brake and the Train stopped about 60 m before the Substitute Train.
