## Chapter 3 Marine accident and incident investigation

### 1. Summary of major investigation report

**Marine 1** While a ship was proceeding in the North East Offing of Iriomote Shima, she pitched, and two passengers each suffered a compression fracture in the lumbar spine  
(Passenger ship AN-EI GO No. 98, Casualties of passengers)  
[investigated by Tokyo Office]

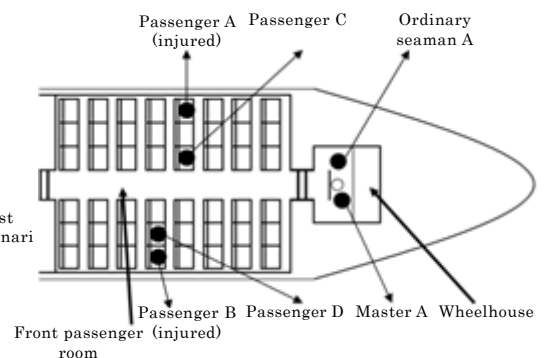
Seat positions in the front passenger room of the injured passengers, and other persons

(6) It is somewhat likely that the following two facts contributed to the occurrence of the accident: the master and the ordinary seaman failed to provide directions or guidance by public address system to the passengers to sit in the rear passenger room because the hull motions would be smaller there; and the master failed to provide the passengers with guidance to wear seat belts.

It is probable that the accident occurred when the two passengers, sitting in the front passenger room, were lifted up and then dropped onto their seats, each suffering a compression fracture in the lumbar spine due to the free fall shock when the Ship's bow rode on the big wave crest and fell down to the wave bottom, because the master, proceeding east-southeast ward along the reefs in the north east offing of Iriomote Shima while hitting consecutive waves of about 1.5 to 2 meter high from east-northeast on the port bow and failing to recognize the big wave approaching until just before its arrival, kept the Ship proceeding at the original speed.

The JTSC recommended Company A to provide safety education in accordance with their safety management regulations and so forth, prepare a safety operation manual in heavy weather applicable to the actual situation of their cruise services, and ensure compliance with the manual.

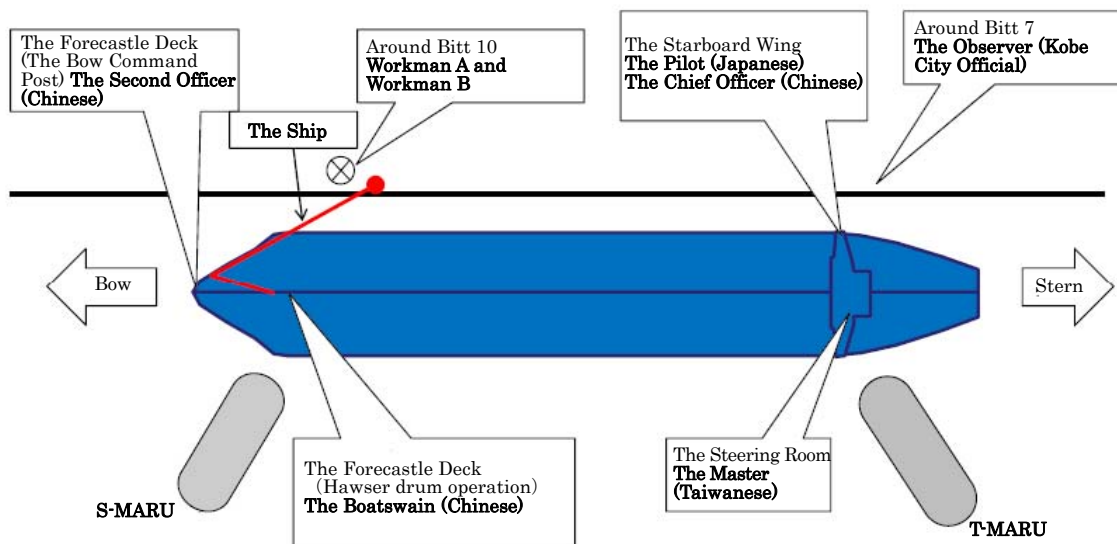
**Positions of the parties concerned at the time of the accident**

At about 07:36 hrs, while the container ship KUO CHANG (the Ship) was docking at Port Island Container Berth 18 (the Berth), a mooring rope moored onto a bitt on the Berth broke, snapped back and hit two workmen (Workman A and Workman B) who were engaged in mooring work. Both of the workmen died.

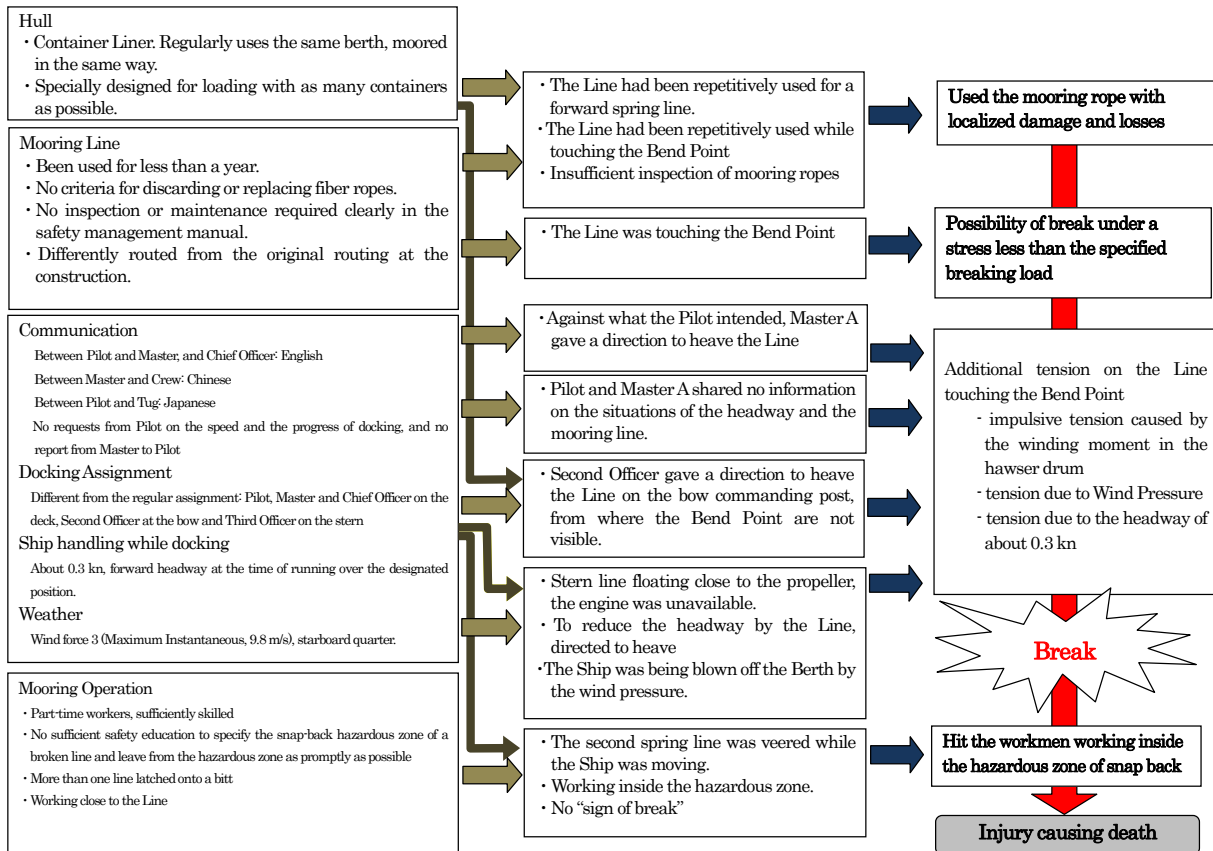
Cause and effect relationship of causal factors

(7) It is probable that the line handling service company had not provided the workman with safety instructions to complete the work swiftly and leave from the snap-back hazardous zone as promptly as possible in case of operations close to a mooring rope under tension, showing the extent of the snap-back hazardous zone of a broken rope under tension.
