Chapter 3 Aircraft accident and serious incident investigations

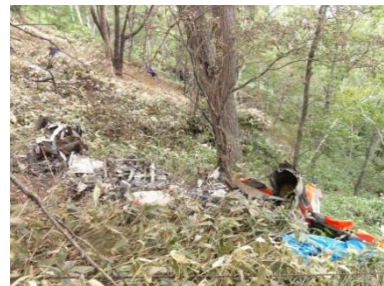
On Thursday, July 28, 2011, a Beechcraft A36, registered JA4215, operated by the Obihiro Branch School of the Independent Administrative Institution Civil Aviation College, took off from Obihiro Airport for flight training at 09:11 Japan Standard Time. At around 09:22, when practicing basic instrument flight in the training and testing area, the airplane crashed into the slope of Mt. Tsurugi in Memuro-cho, Kasai District, Hokkaido.

The airplane was destroyed and a post-crash fire broke out.

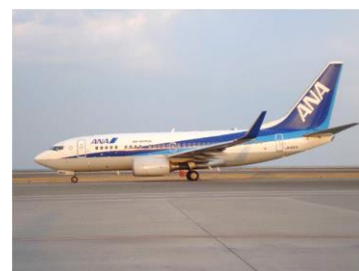
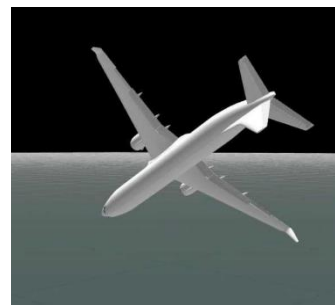
Nippon Co., Ltd., nosedived after having an unusual attitude (upset) at around 22:49 Japan Standard Time (JST: UTC+9hr, unless otherwise stated all times are indicated in JST) at an altitude of 41,000 ft about 69 nm east of Kushimoto while flying from Naha Airport to Tokyo International Airport as the scheduled flight 140 of the All Nippon Airways Co., Ltd.

It is highly probable that this serious incident occurred in the following circumstances: During the flight, the first officer erroneously operated the rudder trim control while having an intention of operating the switch for the door lock control in order to let the captain reenter the cockpit. The aircraft attitude became unusual beyond a threshold for maintaining the aircraft attitude under the autopilot control. The first officer's recognition of the unusual situation was delayed and his subsequent recovery operations were partially inappropriate or insufficient; therefore, the aircraft attitude became even more unusual, causing the aircraft to lose its lifting force and went into nosedive. This led to a situation which is equivalent to "a case where aircraft operation is impeded."

It is probable that the followings contributed to the first officer's erroneous operation of the rudder trim control while having an intention of operating the door lock control; he had not been fully corrected his memories of operation about the door lock control of the Boeing 737-500 on which he was previously on duty; the door lock control of the Boeing 737-500 series aircraft was similar to the rudder trim control of the Boeing 737-700 series aircraft in their placement, shape, size and operability. It is somewhat likely that his memories of operation about the switch for the door lock control of the Boeing 737-500 aircraft had not been fully corrected because he failed to be fully accustomed with the change in the location of the switch for the door lock control. It is somewhat likely that this resulted from lack of effectiveness in the current system for determining the differences training contents and its check method, under which the Air Nippon Co., Ltd. and other airlines considered and adopted specific training programs to train pilots about how to operate the flight deck switches when their locations changed and the Civil Aviation Bureau of the Ministry of Land, Infrastructure, Transport and Tourism reviewed and approved them. It is probable that the first officer's failure to properly manage tasks contributed to his erroneous operation of the rudder trim control.

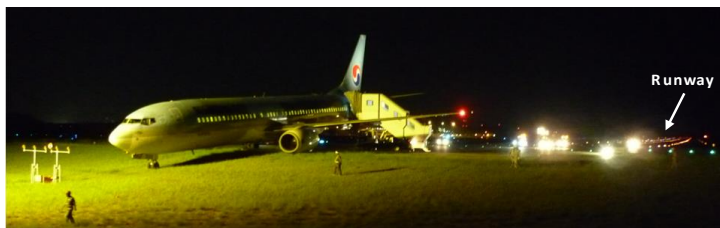
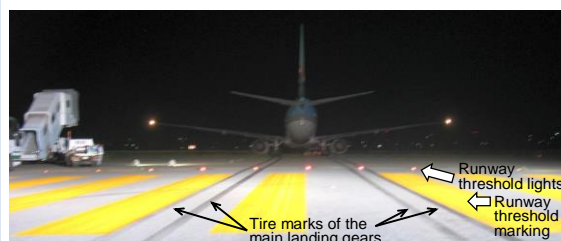
Captain had not flown to Niigata Airport for more than a year and a half, and the F/O had never experienced to land at night on RWY 10 in Niigata Airport.

It is highly probable that the Captain and the F/O had a heavy workload, such as the verifying of the exit taxiway as well as the control for reducing speed and callout after landing, since the Captain and the F/O were not familiar with Niigata Airport which had an intersecting runway, while ground objects and others which pilots could observe during a night landing were limited. It is also somewhat likely that it was difficult for the Captain and the F/O to feel how fast they are in the low speed ground roll area in which they did not count on the airspeed indicator.

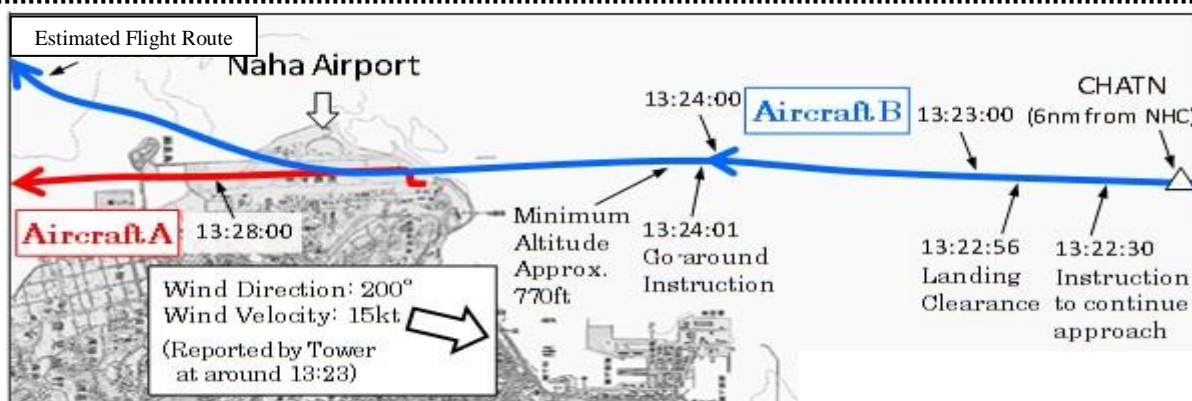
Summary: On July 5 (Thursday), 2012, an Airbus A319-112, registered B2332 (hereinafter referred to as “Aircraft A”), operated by China Eastern Airlines Co., Ltd., was taxiing toward Runway 18 at Naha Airport in order to depart for Shanghai (Pudong) Airport as the scheduled Flight 2046 of the company. Meanwhile, an Airbus A320-214, registered JA01AJ (hereinafter referred to as “Aircraft B”), operated by AirAsia Japan Co., Ltd., was on the final approach after receiving a landing clearance for Runway 18 at Naha Airport during the flight test required before commencing commercial transport services. Although an air traffic controller instructed Aircraft A to hold short of the runway, the aircraft entered the runway; as a result, Aircraft B made a go-around following the instructions from the air traffic controller.
