Annual Report 2018

JTSB Mission

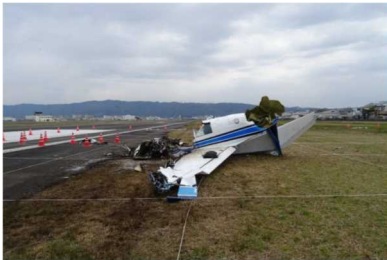
<p>Summary</p>	<p>The aircraft bounced while landing on Runway 27 of Yao Airport and attempted go-around, but stalled during climbing and went into spin, and then crashed into the south side shoulder of the runway. A captain and three passengers were on board and all of them were fatally injured. The aircraft was destroyed and a fire broke out.</p>

<p>Probable Causes</p>	<p>In this accident, the aircraft bounced while landing and attempted a go-around, and it made an abnormal nose-up continued and decelerated, and then the stall could not be avoid in a situation where it imminent; consequently, it is highly probable that it stalled and went into spin, and finally it had crashed.</p> <p>Regarding the reason why the stall could not be avoid in the imminent situation, it is somewhat likely that the captain or passenger A who maneuvered the aircraft could not suppress the excessive nose-up movement because it was exceeding the maneuverable range and others. All members of the aircraft on board were died; accordingly, the investigation was unable to determine the causes.</p> <p>Besides, the aircraft had overweight and aft CG location for the aft limit corresponding to the maximum weight. It is somewhat likely that these condition affected the controllability and the stability, and contributed to the bounce on touchdown, the abnormal nose-up posture during a go-around, the decreased stability at low speed flight and the occurrence of stall and spin.</p>

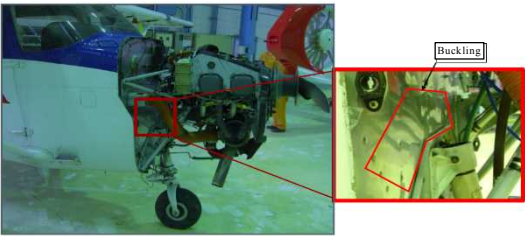
<p>Probable Causes</p>	<p>In this accident, when the aircraft landed, it is probable that it made a dropped landing and bounced; subsequently, it strongly grounded again from the nose landing gear, the empennage struck the runway due to its reaction and the go-around operation, and then the airframe was damaged.</p> <p>Regarding the reason why the aircraft made a dropped landing at its landing, it is probable that the Trainee continued a flare operation without executing a go-around to prevent a dropped landing, even though he felt that the altitude to commence a flare operation was slightly higher more than usual.</p> <p>Regarding the reason why the Trainee continued the flare operation without executing a go-around to prevent the drop-landing, it is somewhat likely that his maneuvering skill was not the level to operate a safe and stable landing including a flare operation. Moreover, the Company did not have a proper skill management system for flight trainees and it allowed the solo flight training even though the Trainee's skill did not fulfill the Safety Criteria for Solo Flight established by it; besides, the methods for a supervision to monitor and an instruction for a solo flight training were inadequate; accordingly, it is somewhat likely that they contributed to the occurrence of the accident.</p>

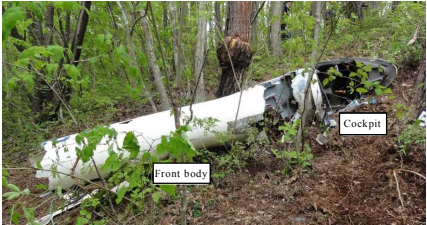
Probable Causes	<p>It is highly probable that this accident occurred when JA21BB crashed in a mountain forest because it broke up in mid-air while flying.</p> <p>It is somewhat likely that the glider broke up in mid-air because, after it had entered a steep turn and stalled while the pilot had succumbed to a state of hypoxia and was semi-conscious, excessive bending occurred owing to aerodynamic force on the glider and the Glider was subjected to load exceeding the ultimate maneuvering load, influenced by the fact that the glider assumed a significant nose-down attitude including spin and nosedived, and that it passed through an area of turbulence.</p> <p>It is somewhat likely that the pilot succumbed to a state of hypoxia because he had forgotten to open the oxygen valve before setting off and thus started the flight with no supply of oxygen, and had not noticed that oxygen was not being supplied because he did not check the oxygen supply during flight, and so continued to climb without noticing signs of hypoxia in himself.</p>

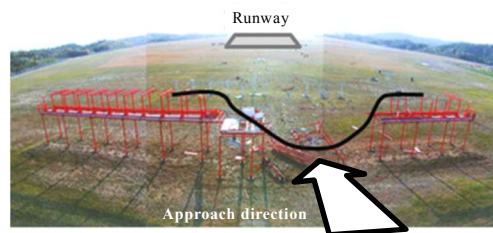
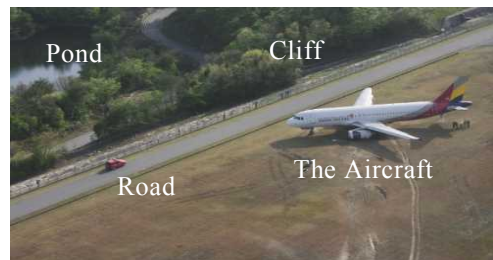
On Tuesday, April 14, 2015, an Airbus A320-200, registered HL7762, operated by Asiana Airlines, Inc., as the scheduled Flight 162 of the company, approached lower than the prescribed approach path during approach to Hiroshima airport. The aircraft collided with the Aeronautical Radio Navigation Aids located in front of the runway 28 at 20:05 JST and KST, and it touched down in front of the threshold of the runway. Subsequently, it moved forward on the runway, and then deviated to the south side of the runway and came to a stop inside the runway strip of the airport.

There were 81 people on board, consisting of the Pilot-in-Command (PIC), six other crew members, a boarding mechanic and 73 passengers. Among them, 26 passengers and two crew members, 28 people in total, were slightly injured.

The aircraft was substantially damaged, but there was no fire breakout.

Regarding the fact that the aircraft undershot, it is probable that there might be following aspects in causes: The PIC continued approaching without executing a go-around while the position of the aircraft could not be identified by visual references which should have been in view and identified continuously at or below the approach height threshold (Decision Altitude: DA); and as well, the first officer, as pilot-monitoring who should have monitored meteorological conditions and flight operations, did not make a call-out of go-around immediately when he could not see the runway at DA.

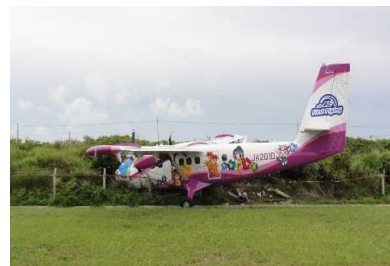
On Friday, August 28, 2015, at around 08:55 Japan Standard Time a Viking DHC-6-400 registered JA201D and operated by First Flying Co., Ltd. departed from the side of the runway during landing at Aguni Airport for the purpose of passenger transport, collided with the airport perimeter fence and lateral groove and damaged aircraft.

There were 14 people on board the Aircraft, consisting of a PIC, a crewmember and 12 passengers (including one company employee). Of these, a crewmember and ten passengers suffered minor injuries.

The aircraft suffered substantial damage, but there was no outbreak of fire.

It is somewhat likely that the PF could not properly control the aircraft as it started to deflect after touchdown, because his knowledge concerning the aircraft system of the aircraft was inadequate, as a result of which he did not fully understand situations that cause deflection to start.

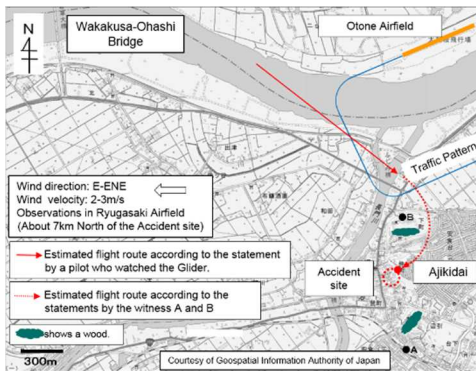
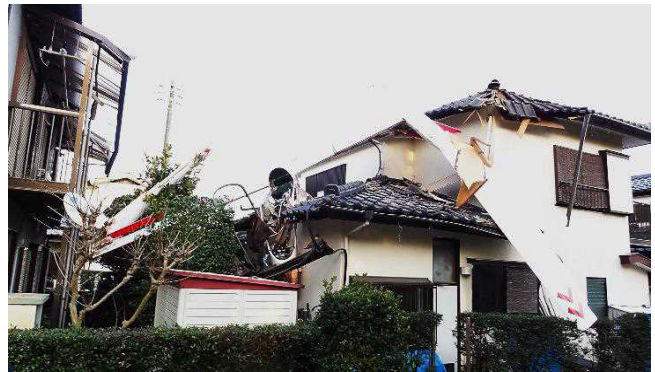
- Thermal: The temperature is apt to rise due to solar radiation since the area around the accident site is a densely populated residential area.
- It is somewhat likely that a thermal was existing locally at the time of the accident.
- It is probable that the glider was banked to left and crashed with the posture that the nose was so low.

The glider had entered a spin since it was flying while rotating with the posture that the nose was so low.

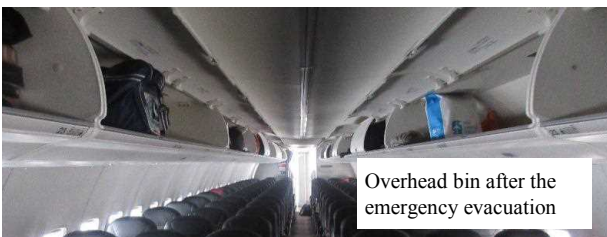
Overhead bin after the emergency evacuation

Many of passengers attempted to go down the slide with baggage not following instructions from the cabin attendants. The cabin attendants removed their baggage near the emergency exit and some of the baggage were piled up at the space in front of the cockpit door. The flight crews hesitated to move to the cabin fearing the risk of clogging the evacuation route for passengers

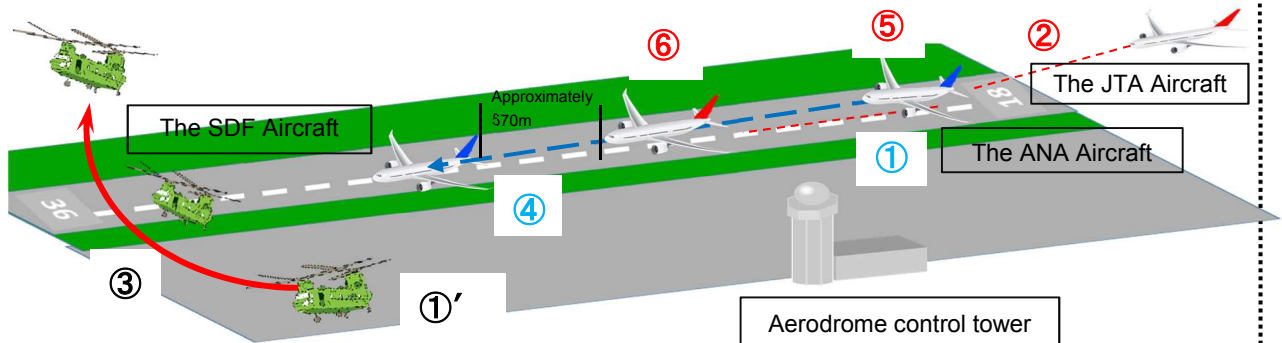
After that, although aerodrome control tower of the aerodrome control facility instructed the JTA Aircraft which approaching the runway to execute a go-around [⑤], it landed on the runway [⑥] before the vacating of the ANA Aircraft at 13:24 JST.

**Probable Causes:****○The take-off of the SDF Aircraft**

→Its pilots misunderstood the take-off clearance for the ANA Aircraft as the clearance for their aircraft.

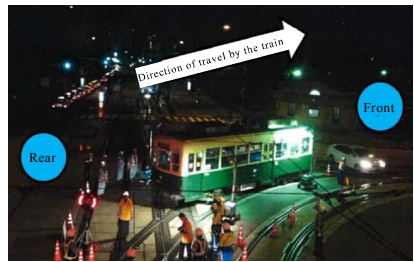
<p>Report</p>	<p>http://www.mlit.go.jp/jtsb/railway/rep-acci/RA2017-1-4.pdf</p>			
<p>5</p>	<p>Date of Publication</p>	<p>Date and accident type</p>	<p>Railway operator</p>	<p>Line section (location)</p>
	<p>March 30, 2017</p>	<p>June 2, 2016 Vehicle derailment</p>	<p>Nagasaki Electric Tramway Co. Ltd.</p>	<p>Between Suwajinja-Mae tram stop and Kokaido-Mae tram stop, Sakuramachi Branch Line (Nagasaki Prefecture)</p>
<p>Summary</p>	<p>While the vehicle was passing the right curved branch line for Nagasaki Eki-Mae tram stop, in the turnout at Kokaido-Mae intersection, the driver of the vehicle felt abnormal situation as if the vehicle was heaved up accompanied with abnormal sound, then the driver applied an emergency brake and stopped the vehicle. The driver got off the vehicle to check the situation, and found that all two axles in the rear bogie were derailed to left of rail.</p> <p>There were a passenger and the driver onboard the vehicle, but there was no casualty. The accident site was in the intersection of the road together with tramway, but the derailed vehicle did not contact nor collide with automobiles, etc., before and after the derailment.</p>

Probable Causes	<p>It is probable that the accident had occurred as the vehicle running right curve in the turnout in the intersection, as the backside of right wheel of the first axle of the rear bogie had been contacting with the side surface of the portion which had the function of guard rail in the diamond crossing, the back side of right wheel climbed up around the tip of the nose rail and started derailment, and after the wheel flange ran on the upper part of the side surface of the portion, the left wheel of the axle ran onto the left rail and the axle derailed to left, then followed the derailments of the second axle in the rear bogie to left.</p> <p>It is probable that the right wheel of the first axle in the rear bogie ran onto the rail and derailed caused by the effects of increased lateral force acting on backside of the wheel due to the abrupt contact of the wheel and the deformed tip of the nose rail, and decreased contact angle between backside of the wheel and the deformed tip of the nose rail.</p> <p>It is probable that the tip of nose rail was deformed by the repeating shocks by backside of right wheels of the front axle of bogies of plural vehicles, acting on the tip of the nose rail in the state of being easily deformed, caused by the effects of the lowered height of the tip of the nose rail by the design modification, in the diamond crossing existed in very small radius curve where wheels always contact with tip of the nose rail structurally.</p>

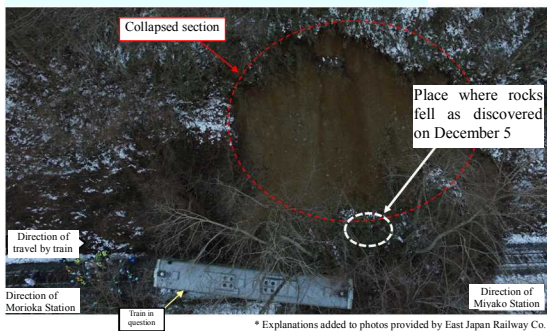
On December 5, 2015, before the accident, rocks used to reinforce the slope fell under the guard net placed over the collapsed section of the slope.

It is somewhat likely that rocks fell in a situation almost identical with the collapse of the slope. It is also somewhat likely that the phenomenon was a predictor of the collapse of the slope.

Probable Causes: It is highly probable that the accident had occurred as the train was derailed by hit and ran onto the fallen trees or earth and sand, etc., flowed into railway track due to the collapse of the slope in track side.

It is somewhat likely that the slope collapsed by the increased weight of the surface layer of the slope due to rainfall and melting snow, where the surface layer of the slope had been unstable by the steep slope and weathering.

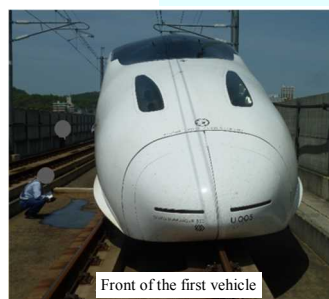
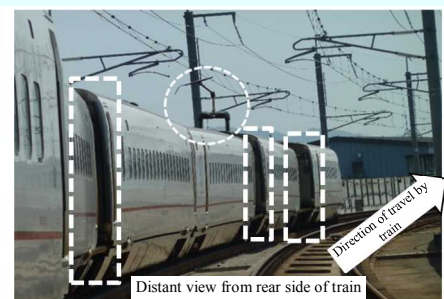
While the train was running some 150m after derailment, 22 of all 24 axles derailed, creating a situation unthinkable under normal operating conditions.

It is probable that vibrations were amplified at the structure's frequency of around 1.3Hz, affected by the natural frequency of the structure.

It is probable that vehicles derailed on both the left and right sides of the direction of travel because structural differences in the positions of individual vehicles running on the viaduct at the same time caused moderate differences in the vibrations each vehicle received from the track so that each vehicle showed different movements.

Probable Causes: It is probable that the accident occurred as the train was derailed due to being acted by the ground motion of the earthquake occurred on about 21:26, April 14, 2016, which was one of the 2016 Kumamoto Earthquakes. As for the process to the derailment, it is probable that many axles were derailed almost the same timing, because each vehicle in the train rolled significantly and wheel flanges of left or right wheels jumped on the rail, due to the amplified rolling motion in the frequency range to promote rolling of vehicles acted in the structures, in addition to the violent shakes in lateral direction to the track acted on just under the structure around the accident site, caused by the amplified ground motion.

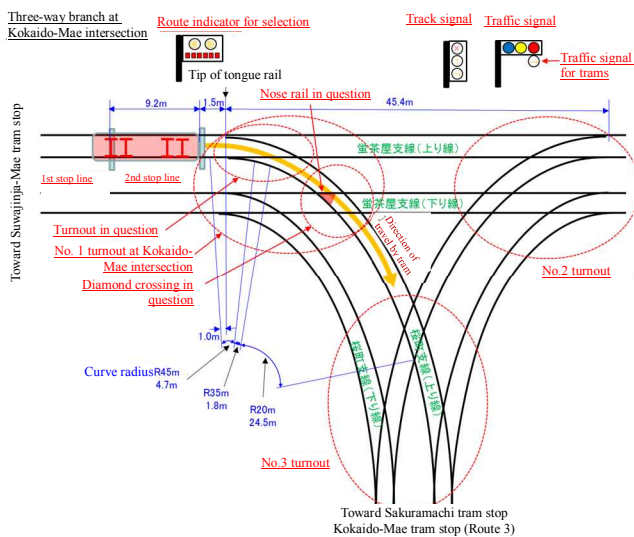
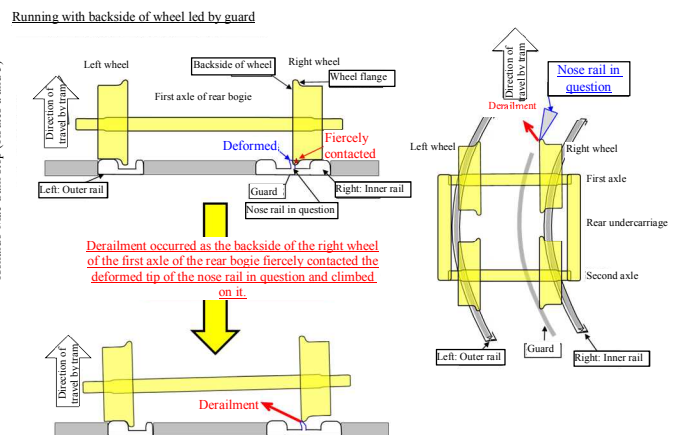
Huge lateral force was created near the tip of the nose rail as the backside of the right wheel of the first axle in the rear bogie of the tram fiercely contacted the tip of the nose rail.

Probable Causes (excerpt): It is probable that the accident had occurred as the vehicle running right curve in the turnout in the intersection, as the backside of right wheel of the first axle of the rear bogie had been contacting with the side surface of the portion which had the function of guard rail in the diamond crossing, the back side of right wheel climbed up around the tip of the nose rail and started derailment, and after the wheel flange ran on the upper part of the side surface of the portion, the left wheel of the axle ran onto the left rail and the axle derailed to left, then followed the derailments of the second axle in the rear bogie to left.

It is probable that the right wheel of the first axle in the rear bogie ran onto the rail and derailed caused by the effects of increased lateral force acting on backside of the wheel due to the abrupt contact of the wheel and the deformed tip of the nose rail, and decreased contact angle between backside of the wheel and the deformed tip of the nose rail.

Following the accident, meanwhile, Nagasaki Electric Tramway Co., Ltd. newly designed a turnout and enlarged the curve radius at the accident site.

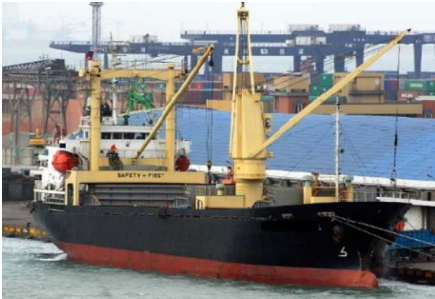
<p>Probable Causes</p>	<p>It is probable that the accident occurred because the master of the ship, with no knowledge about the location of the shallow place in question prior to the vessel's entry into Omaezaki Port, had the vessel sail on the side of the breakwater light beacon C and run on the shallow place.</p> <p>It is probable that the master of the vessel had no knowledge about the location of the shallow place as information about it was unavailable during advance studies on waterways using a nautical chart and other means.</p> <p>It is probable that information about the location of the shallow place was unavailable on the nautical chart and other means because the administration office concerned had not conducted water depth investigations in Omaezaki Port for a long time and so did not have information about the depth of water that should be given to the 3rd Regional Coast Guard Headquarters.</p> <p>It is probable that the administration office in question had not conducted water depth investigation in Omaezaki Port because no major changes in the depth of water had been recognized until 2000 and due to, among other reasons, the absence of a large river flowing into the port.</p> <p>It is probable that the vessel took a course on the side of the breakwater light beacon C as the master steered the ship to starboard in a water area before the central wharf.</p>

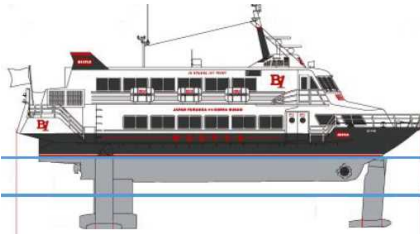
<p>Probable Causes</p>	<p>Concerning the accident, it is probable that the vessel collided with a marine life in spite of a rudder turn since the marine life was discovered in the proximity during the maneuver at a cruising speed (40 km)</p> <p>It is somewhat likely that discovering the marine life in the proximity is associated with the master not directing enhancement of lookout by four persons of a master, a chief engineer, a chief officer, and a first engineer, suspension of inboard sales by cart, seating of cabin crews, and implementation of airing of seat belt wearing to passengers, in addition to decelerated maneuver at 36 – 38 kn (cetacean-cautious maneuver) as well as navigating without enhancing lookout.</p> <p>It is probable that the reason why the master did not direct cetacean-cautious maneuver was that JR Kyushu Jet Ferry Inc. had not established operating guidelines of cetacean-cautious maneuver in the safety management rules and was not thoroughly disseminating them, had informed the allowable delay time associated with implementation of decelerated maneuver, and did not have a grasp of the implementation status of cetacean-cautious maneuver.</p>

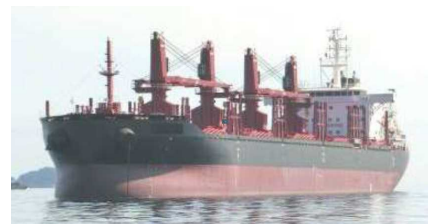
September 28, 2017	January 10, 2016 Near the Port of Sakata, Sakata City, Yamagata Prefecture	Cargo ship CITY (Panama) Grounding

<p>Summary</p> <p>When the ship, with a master and 17 crewmembers on board, was riding a single-anchor near the Port of Sakata in Sakata City, Yamagata Prefecture, a wind velocity increased and though she hove up anchor and attempted to standing out to sea, she was driven by a pressure, and stranded on a tetrapod near the Port of Sakata.</p> <p>Though the ship swamped to the position of the bridge of her hull and became total loss, there was no fatality.</p>		
	<p>Probable Causes</p>	<p>It is probable that the accident occurred because weather and sea information was not appropriately obtained on the ship during anchorage in the waters off the Port of Sakata under the condition of anticipated a wind with a maximum speed of 15 m/s and about 2.8-meter-high waves and the master did not have a grasp of the seaworthiness of the ship, she missed the timing for evacuating to a safe water area, and although she heaved up anchor and tried to head out to sea, the speed necessary to keep the course and the ship became unable to maneuver, and ran on a wave-absorbing blocks.</p> <p>It is probable that the reason why the master did not appropriately obtain weather and sea information because the master thought there was no sign of worsening weather seeing Asian Pacific surface analysis charts and coastal wave analysis charts.</p> <p>It is probable that the reason why the master did not have a grasp of the seaworthiness of the ship was because the safety management manual of Trans Ocean Shipping Co., Ltd. did not describe about seaworthiness such as limiting clutch force and limit wind speed in a ballasted condition and a limit of ship maneuvering for course keeping considering a wind pressure and output power of the main engine in the said condition.</p>

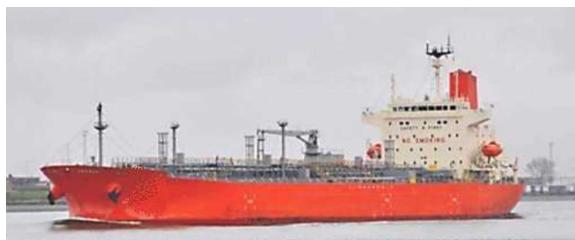
Report	http://www.mlit.go.jp/jtsb/eng-mar_report/2017/2016tk0009e.pdf	
11	Date of Publication	Date and location	Vessel type and name, accident type
	October 26, 2017	September 9, 2016 Off to the south of Gobo City, Wakayama Prefecture	Oil/Chemical tanker EIWA MARU 3 Explosion
	Summary	While the tanker was sailing southeast off to the south of Gobo City, Wakayama Prefecture for Yokkaichi Port, Yokkaichi City, Mie Prefecture, with a master and other nine crew members onboard, after unloading base oil, which is a base material of lubricants and other products, at Wakayama Shimotsu Port, Wakayama Prefecture, and with her crew cleaning her cargo tanks, an explosion occurred in her cargo tanks. One crew member of the tanker was killed and two crew members suffered serious injuries. The tops and bulkheads of the vessel's No. 2 and No. 3 cargo tanks were bent.

<p>Probable Causes</p>	<p>It is probable that the accident occurred when, as the Vessel was proceeding southeast off to the south of Gobo City while conducting cleaning of the cargo tanks at night after unloading base oil in her No. 1 and No. 3 cargo tanks at Wakayama Shimotsu Port and leaving port, explosions occurred when, under conditions in which the tanker began cleaning the cargo tanks using seawater with Butterworth cleaning machines and the cargo pumps and, in the course of the cleaning, base oil that remained in No. 2 cargo pump, bottoms of the No. 1 and No. 3 cargo tanks, and cargo-handling piping for the tanks was sprayed in the No. 3 cargo tank and became airborne up to the starboard No. 3 cargo tank ventilation duct, base oil in the duct and starboard No. 3 cargo tank vaporized and ignited because the chief engineer conducted welding on the starboard No. 3 cargo tank ventilation duct.</p> <p>It is somewhat likely that the chief engineer conducted the welding of the starboard No. 3 cargo tank ventilation duct as cleaning work was being done in tanks that had carried base oil with a high flash point because he thought there was no danger because the welded area was small and welding ted quickly. It is probable that not flushing the cargo tanks, etc., prior to cleaning of the cargo tanks contributed to the circumstances in which base oil was sprayed in the No. 3 cargo tank and became airborne up to the starboard No. 3 cargo tank ventilation duct.</p> <div data-bbox="742 465 1428 817" style="text-align: center;"> <p>(Looking forward from the back of starboard No. 3 tank) (Looking forward from the front of starboard No. 3 tank)</p> <p>Note: The (1) to (5) appearing in the photos correspond to items 2.3 (1) to (5).</p> </div>

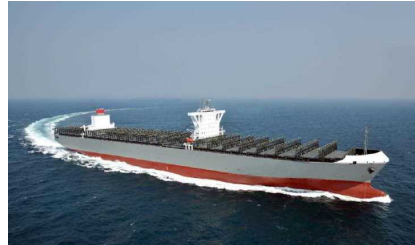
Probable Causes	<p>It is probable that the accident occurred, in the night time, while the ship was docking at the port of Felixstowe, United Kingdom of Great Britain and Northern Ireland, an explosion occurred within the furnace of the auxiliary boiler.</p> <p>It is considered somewhat likely that explosion occurred in the furnace is because under existence of carbon monoxide gases heated by incomplete combustion and flames in the furnace, the second engineer operated the forced draft fan and the secondary air was supplied. The explosion occurred by a rapid chemical reaction changing heated carbon monoxide gas. Or in the situation where marine gas oil existed as a highly concentrated flammable gas in the high temperature furnace, the forced draft fan was operated and secondary air was supplied, then the flammable gas was mixed with air, the concentration was between the upper limit and lower limit concerning the explosion. As a result, the explosion occurred.</p> <p>It is probable that the second engineer operated the forced draft fan for the purge in the furnace.</p> <p>It is probable that the existence of the marine gas oil a highly concentrated flammable gas was as follows. Under slimy wax-like material stuck to strainer etc., which was clogged causing the marine gas oil pressure drop but the marine gas oil pressure did not drop to fuel oil low pressure alarm set point, the marine gas oil to the rotary cup burner flow reduced. The primary air and the secondary air was supplied as same volume as before marine gas oil clogging, the marine gas oil was blown away and the atomizing marine gas oil became unevenly stable. The flame was cooled by the excess air and flame pattern was broken causing the combustion status very bad and remaining unburnt marine gas oil in the furnace and unburnt marine gas oil vaporized.</p> <p>It is probable that the carbon monoxide gases heated by incomplete combustion and flame existed in the furnace because the forced draft fan stopped by the Furnace (Flame-Eye) Abnormal alarm, the secondary air damper was closed, secondary air was not supplied, and combustion continued under insufficient air quantity.</p> <p>It is probable that the strainer was clogged as follows. When the ship used the marine gas oil containing a large amount of paraffin wax and the Cold Filter Plugging Point of it was high, the temperature around the auxiliary boiler oil burning apparatus was below the cold filter plugging point of the marine gas oil and the paraffin wax precipitated in the strainer.</p>

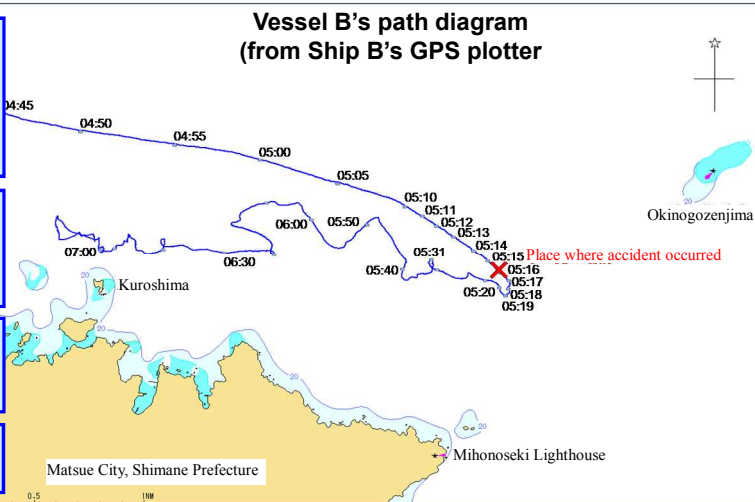
Capsizing (at around 5:15)

The marine area near the place where the accident occurred is off the marine area sheltered by the Oki Islands. It is probable that waves there were higher than those near Okinogozenjima and in waters around the island, in addition to reflected waves from Mihonoseki.

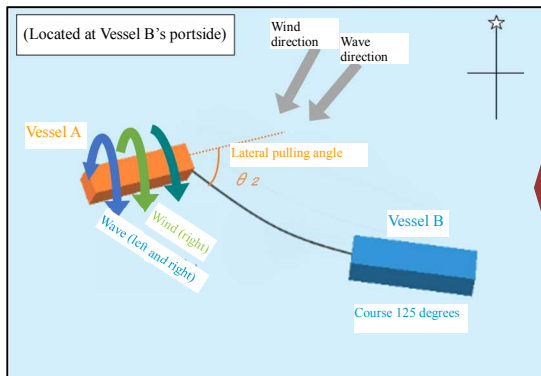
(Situation of capsizing)

- It is probable that the stability of Vessel A was reduced due to addition of structural objects, etc. to it and water tanks on its deck and the freeboard of the ship also decreased.
- Vessel A was exposed to the risk of a sudden increase in heeling moment because the towing rope was not long enough. It is somewhat likely that the heeling moment increased due to the.
- It is probable that the angle of the heel of Vessel A became larger than the bulwark submerge angle due to a combination of Vessel A's steady heel caused by wind, rolling motions caused by waves and Vessel A's heeling energy caused by the tension on the towing rope.
- While Vessel A's angle of heel exceeded the bulwark submerge angle and the righting lever became smaller, it is somewhat likely that continuous waves capsized Vessel A with the bulwark acting as resistance to stability.

Probable Causes (excerpt): It is somewhat likely that the accident occurred as follows: The main engine of Vessel A stopped at night when the ship's stability was reduced and its freeboard decreased. While being towed southeast by Vessel B north of the Mihonoseki lighthouse, Vessel A became almost unable to regain stability as the angle of the heel exceeded the bulwark submerge angle and capsized by continuous waves.

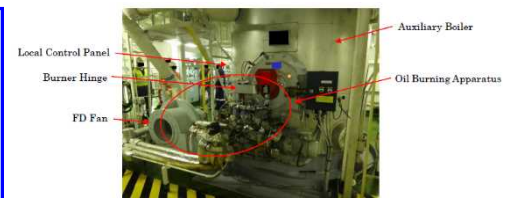
*An explosion occurred in the furnace of the auxiliary boiler (at around 23:04)
The duty oiler died, the Engineer A suffered injuries*

- It is somewhat likely that under the condition where the primary air and the secondary air was supplied as same volume as before MGO clogging, the MGO pressure dropped and the MGO flow to the rotary cup burner was reduced and then the atomizing of MGO became unstable. The flame was cooled by excessive air and the burning process was disturbed causing the combustion status very bad and unburnt MGO remained in the furnace.

- After automatic combustion of the rotary cup burner was stopped, unburnt MGO remaining in the furnace during automatic combustion was vaporized, became a flammable gas and continued to burn. Then Furnace (Flame-Eye) Abnormal alarm was activated, FD fan stopped, the secondary air damper was closed and combustion air was not supplied. As a result, flame of incomplete combustion and flammable carbon monoxide gas or flammable gas of the MGO became present in the furnace.

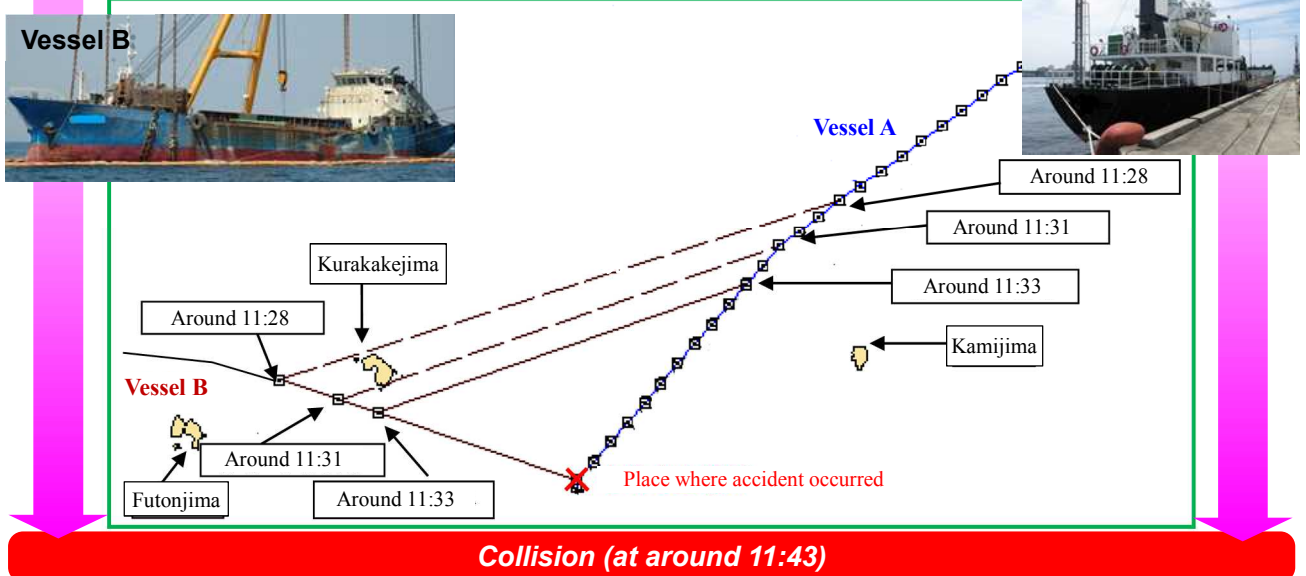
(Vessel A's presumed sailing route based on GPS records and Vessel B's presumed route)

Collision (at around 11:43)

Probable Causes (excerpt): It is probable that the accident occurred as follows: Vessel A was sailing southwest off the east coast of Kurakake Island while Vessel B was traveling southeast. The master on Vessel A did not notice Vessel B early enough as he engaged in such work as filling in a document and did not maintain a lookout, considering that there was no ship ahead as an obstacle. At the same time, the navigation officer on Vessel B noticed Vessel A on Vessel B's portside bow but thought Vessel A would eventually give way. Although the officer sounded a whistle signal, he did not take actions to avoid the collision in time.
