Chapter 3 Aircraft accident and serious incident investigations

3 Statistics of investigations of aircraft accidents and serious incidents

Aircraft accident investigation reports published in 2018

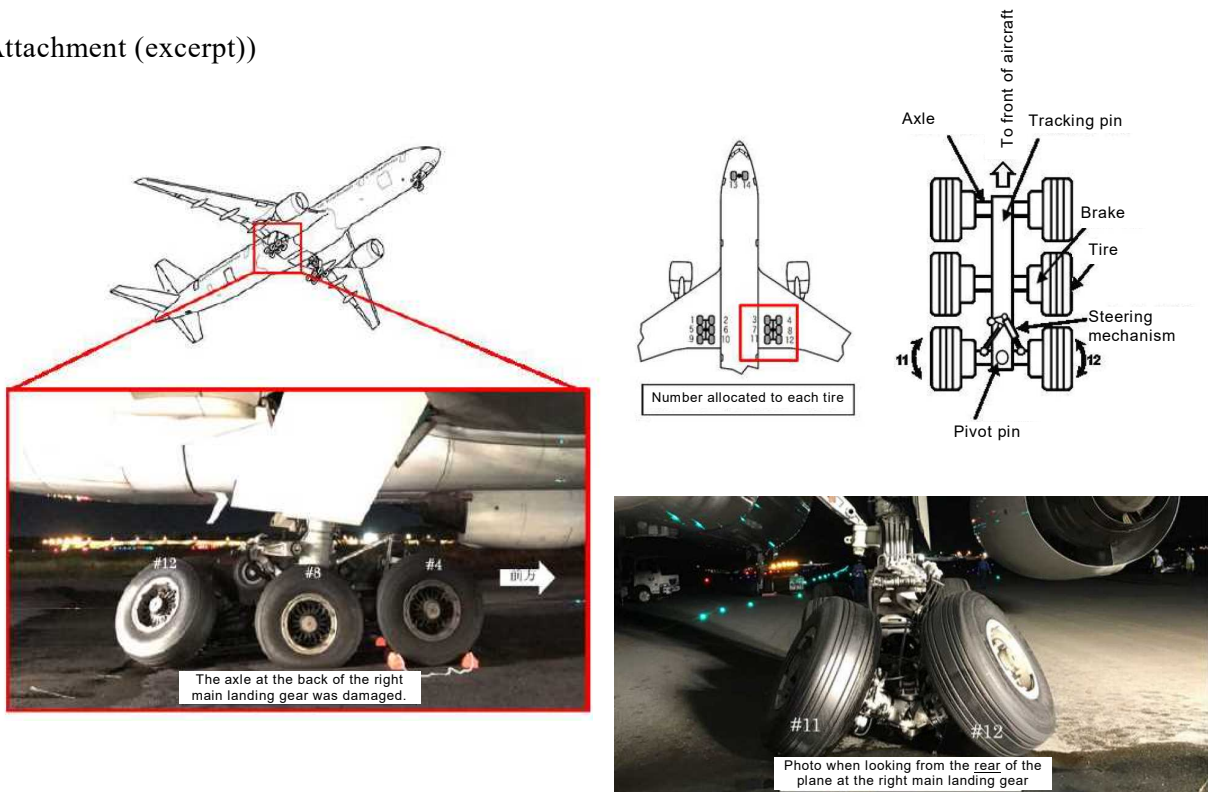
(Attachment (excerpt))

A detailed investigation is scheduled in the near future concerning the reason the axle broke, etc.
