Chapter 4 Railway accident and serious incident investigations

2 Procedure of railway accident/serious incident investigation

3 Statistics of investigations of railway accidents and serious incidents

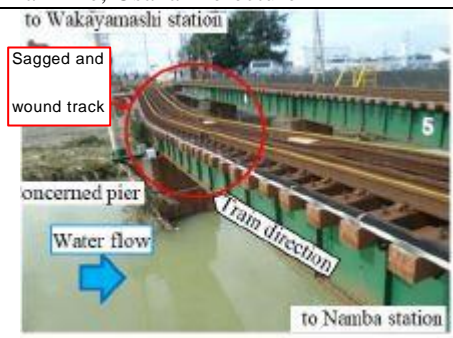
Probable Causes	<p>It is highly probable that the accident occurred as the 2nd axle in the rear bogie of the 3rd vehicle had derailed to right because the train was running on the track on the bridge significantly deformed by the subsided and tilted pier, after that, the derailed axle restored in the level crossing while passed as being derailed.</p> <p>It is probable that the pier had subsided and tilted because the ground in around the pier was scoured in wide area by the swollen river water at the time of the occurrence of the accident, while the function to protect the piers from scouring had already been deteriorated before the occurrence of the accident, such as the subsided riverbed in around the pier caused by the concentration of the river water due to the change of the water route, damages of the foot protection as the scour protection work, etc.</p> <p>It is probable that the deterioration of the function to protect scouring was related with that the measures such as the repair, reinforcement, etc., of the foot protection were not implemented, because the evaluation for the unusual status were not implemented sufficiently, even though the unusual status of the foot protection of the pier was recognized in the inspection of the piers.</p>

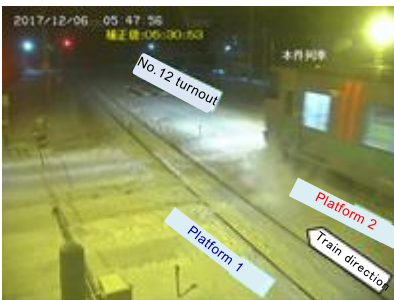
Probable Causes	<p>It is probable that the accident occurred as the left wheel of the 1st axle in the front bogie of the 1st vehicle climbed up the left rail, i.e., the outer rail, and derailed to left, while the train Japan Transport Safety Board was passing the level crossing in the premises of the station, located in the right curved track in the refuge track for inbound and outbound trains where the frequency of train operation was low.</p> <p>It is somewhat likely that the derailment was caused as the wheel flange climbed up the compacted snow which had existed on the rail and the flangeway in the level crossing.</p> <p>It is somewhat likely that the compacted snow had been formed as it snowed hard in the previous day of the accident in the situation that the temperature around 0 °C had been continued, and the snow had been trodden hard by the automobiles passing the level crossing road in the long interval between the concerned train and the train operated just before the concerned train. In addition, it is somewhat likely that the compacted snow formed on the rail and the flangeway had been remaining without removed, because the snow removal works had not been implemented before the concerned train passed.</p> <p>It is somewhat likely that the snow removal works had not been implemented related with that the accident occurred before the period to prepare the snow removal formation in winter, that the status check of the level crossing had been implemented by the simple inspection such as the visual inspection, etc., and that the interval of the train operation was not considered well in the onsite confirmation and in the judgement to implement the snow removal work.</p>

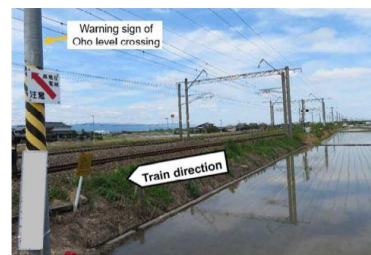
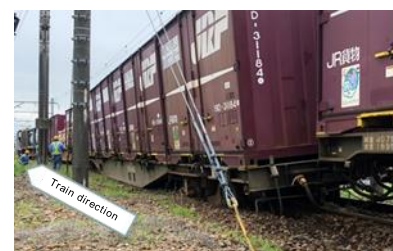
Probable Causes	<p>It is probable that the accident occurred as all four axles of the wagon, the 4th vehicle from the front, derailed because the gauge widened while the freight train composed of 19 vehicles</p>

<p>was running in around the 106-B turnout in the premises of Soga station.</p> <p>It is probable that the gauge in around the 106-B turnout widened due to the decreased rail fastening force caused as the Japan Freight Railway Company, who was in charge of the management of track maintenance, had not implemented the measures such as the replacement of sleepers or the repairing work, etc., although the sleepers, which had been judged as inferior in the periodic inspection, existed continuously.</p> <p>It is somewhat likely that Japan Freight Railway Company had not implement the measures such as the replacement of the sleepers or the repairing work, etc., because it had not recognized the dangerous situation against the gauge widening well, as the irregularity of gauge measured under unloaded condition in the periodic inspection was within the maintenance standard value.</p>		
	Report	<p>http://www.mlit.go.jp/jtsb/eng-rail_report/English/RA2019-4-1e.pdf http://www.mlit.go.jp/jtsb/railway/p-pdf/RA2019-4-1-p.pdf (Explanatory materials)</p>

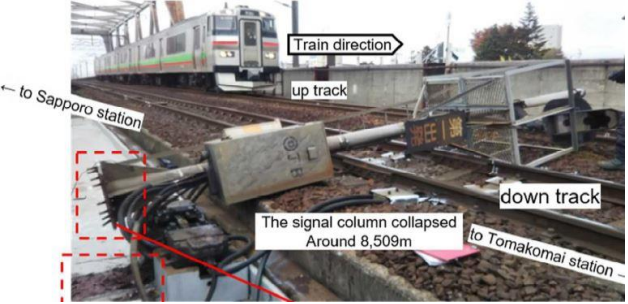
<p>Probable Causes</p>	<p>It is probable that the concerned serious incident had occurred because there was the inferior construction work as the insufficient cleaning in the hole after drilled into concrete body in the construction work of the metal extension anchor based on the "after constructing anchor method", in the planting work of the down line No.1 starting signal column.</p> <p>It is probable that the metal extension anchor was in the status as insufficient tolerance against tensile force because the cone of the metal extension anchor had not expanded the swelling part of the anchor due to the inferior construction work when the signal column had been planted.</p> <p>Therefore, it is somewhat likely that the signal column had collapsed because the external force exceeded the tolerance of the metal extension anchor fixing the signal column of the home signal, as the anchor of the metal extension anchor was loosening gradually, caused by vibration due to running trains on the viaduct in addition to the effects of the external force such as windstorm, earthquake, etc., in the period of about 38 years from planting, in the status that the metal extension anchor supporting the signal column had been insufficient endurance against tensile force, in cooperation with the wind pressure of about 20 m/s instantaneous wind speed on the collapsed day.</p>

As all eight of the metal expansion anchors to which the traffic signal pole was fixed were removed from the concrete body, and the cone remained in the perforation of the concrete body, it is probable that all eight anchors had the same construction conditions.

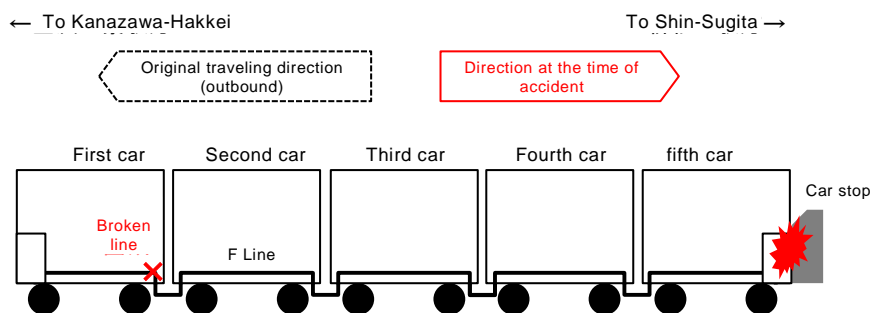
- Disconnection of the F line near the rear end of the first car on the Kanazawa-hakkei Station side [1. (1)]
- Of the F line (forward direction command) and the R line (reverse direction command), the F line is disconnected.
- One of the broken portions of the F line is welded to a member on the vehicle body side [1. (2)].
- The broken F line was detached from the bundle of cables [1. (3)]

- In the records of the operation of the station ATO on-board equipment and the station ATO ground equipment, there is no record showing any abnormality of the equipment related to the occurrence of this accident. [4.]

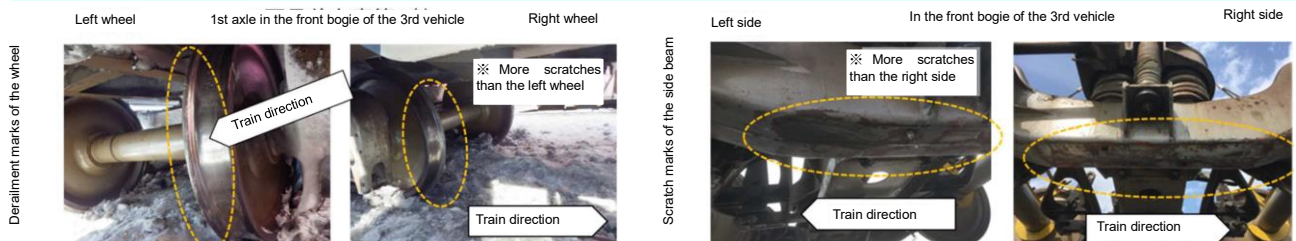
Probable cause: It is probable that the accident occurred as the flange of the right wheel of the 1st axle in the front bogie of the 3rd vehicle climbed over the right rail and derailed at the place where large amount of ice and snow were stacked on the track, while the train was passing the straight track section in the premises of the station, and after that the train restored in the turnout while passing in the status as derailed. It is somewhat likely that the 1st axle in the front bogie of the 3rd vehicle of the train derailed because the side beam of the front bogie of the 3rd vehicle was pushed up over the ice and snow stacked on the railway track, at the same time, the wheel flange was raised up by the hard ice and snow which had existed in around the flangeway. It is somewhat likely that large amount of ice and snow had been stacked on the railway track in around the place where the derailment accident occurred, related with a large amount of snow fall and stacked snow in the previous day of the concerned accident, and that the snow removal works had not been implemented for 6 days before the occurrence of the accident.
