Chapter 5 Marine accident and incident investigations

1 Marine accidents and incidents to be investigated

2 Procedure of marine accident/incident investigation

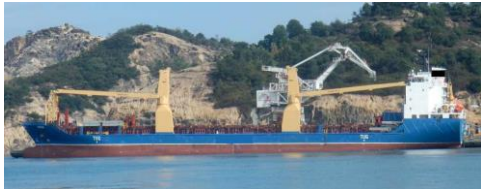
Summary	<p>While the vessel was moored at the Mitsubishi Naoshima wharf, with the master and 14 crew members on board, 4 crew members were performing the cleaning work of the upper hatch coaming of the cargo holds after unloading cargo, and an able seaman fell from the upper deck to the bottom floor of the cargo hold and dead.</p>

Probable Causes	<p>It is considered probable that this accident occurred because Crew Member A who was working while being in an unstable posture on the Ladder fell forward and fell from the upper deck to the bottom of the cargo hold bottom when he doing the cleaning work while the vessel was moored at Mitsubishi Naoshima wharf.</p> <p>It is considered probable that the vessel carried out the cleaning work by the methods that differed from the Ladder guidelines of the CSWP, and that because there was nothing to support his upper body on the Ladder, Crew Member A was performing the cleaning work while being in an unstable posture on the Ladder.</p> <p>It is somewhat likely that Company A was insufficient in monitoring that the crew members clearly understood the Ladder guidelines of the CSWP and then applied and performed the Ladder guidelines in the cleaning work, because the vessel carried out the working methods being different from the Ladder guidelines in everyday work.</p>

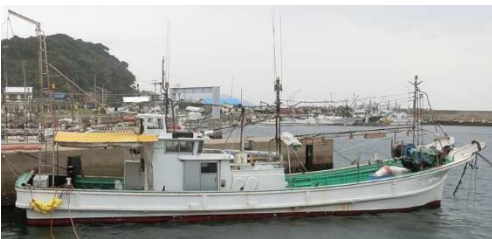
Report	<p>http://www.mlit.go.jp/jtsb/eng-mar_report/2019/2018tk0014e.pdf</p>	
	Reference	<p>Case Studies (page 156)</p>	
3	Date of Publication	Date and location	Vessel type and name, accident type
	February 28, 2019	October 4, 2018 Off the north of Oshima, Munakata City, Fukuoka Prefecture	Recreational fishing boat SEIRYOMARU Fatality of a Fishing passenger
	Summary	<p>While the Vessel was returning to Konominato Fishing Port, Munakata City, with one master and four passengers on board, one of the passenger fell into the water and died.</p>	
	Probable Causes	<p>It is probable that this accident occurred when the Vessel was shaken by the waves from the portside while returning to Konominato Fishing Port at night, Passenger A, who was not wearing a life jacket, fell into the water from the starboard side edge and drown due to the difficulty to keep his face above the water.</p>

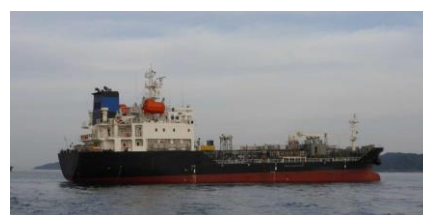
Report	<p>http://www.mlit.go.jp/jtsb/ship/rep-acci/2019/MA2019-3-2_2018tk0019.pdf</p>	
7	Date of Publication	Date and location	Vessel type and name, accident type
	March 31, 2019	April 8, 2018 Off the southeast of Kunisaki Port, Kunisaki City, Oita Prefecture	Chemical tanker GOLDEN SUNNY HANA (Republic of Korea) Explosion (cargo oil tank)
	Summary	<p>While the Vessel with a master and 14 crew members on board, was proceeding southeast off the southeast of Kunisaki Port, Oita Prefecture, conducting cleaning work in a cargo oil tank, an explosion occurred in the cargo oil tank.</p> <p>Two of the Vessel's ordinary seamen were injured and her cargo oil tanks had holes and other damage.</p>	
	Probable Causes	<p>It is probable that the accident occurred when, as the Vessel was conducting the Circulation Work in the No. 2 port cargo oil tank and the No. 2 starboard cargo oil tank during cargo oil tank cleaning work while off the southeast of Kunisaki Port, Oita Prefecture, an explosion occurred in the No. 2 port cargo oil tank because steam was injected into the No. 2 port cargo oil tank under conditions in which a combustible gas mixture of vaporized pyrolysis gasoline and air in the explosive range was present.</p> <p>It is probable that the presence of the combustible gas mixture of vaporized pyrolysis gasoline and air in the No. 2 port cargo oil tank was not noticed because the gas concentration in the No. 2 port cargo oil tank was not measured prior to cleaning of the cargo oil tanks.</p> <p>It is somewhat likely that the combustible gas mixture was within the explosive range because flushing of the cargo lines and cargo oil tank bottoms was conducted under conditions in which ventilation and other measures were not implemented even though the gas concentration measurement taken after unloading was within the explosive range and approximately 30 liters of pyrolysis gasoline subsequently remained in both the No. 2 port cargo oil tank and the No. 2 starboard cargo oil tank, and the vaporized pyrolysis gasoline was not expelled outside, its gas concentration increased further with the passage of time, and it became mixed with air.</p> <p>It is probable that steam was injected into the No. 2 port cargo oil tank with the intention of raising the temperature of the seawater used in the work of repeatedly pumping up liquid collected on the cargo oil tank's bottom with a pump installed in the cargo oil tank and then spraying the liquid with the Cleaning Machine.</p>

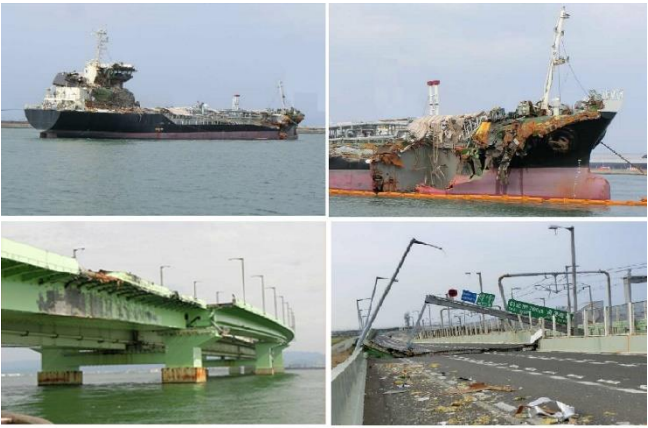
<p>Report</p>	<p>http://www.mlit.go.jp/jtsb/ship/rep-acci/2019/MA2019-4-1_2018tk0021.pdf</p>	
<p>11</p>	<p>Date of Publication</p>	<p>Date and location</p>	<p>Vessel type and name, accident type</p>
	<p>April 25, 2019</p>	<p>September 4, 2018 Kansai International Airport Access Bridge, Senshu Port, Osaka Prefecture</p>	<p>Oil tanker HOUNMARU Collision (Bridge)</p>
	<p>Summary</p>	<p>When Typhoon No. 21 was approaching the Seto Inland Sea, including Osaka Bay, and a maritime typhoon warning was issued, the Vessel, with the master and 10 crew members on board, was anchored off the southeast of the Senshu Port. The Vessel was struck by strong wind which increased with the approach of the typhoon and being drifted to the north dragging the anchor pushed by the strong winds and waves. As a result, the vessel collided with Kansai International Airport Access Bridge.</p> <p>The deck on the starboard bow of the Vessel was crushed, and the road girder of Kansai International Airport Access Bridge was bent, broken, and scratched. The railway girder was collapsed, the rail was warped, and the gas pipe was broken. However, no crew members were injured.</p>

<p>Probable Causes</p>	<p>In this accident, the Vessel continued single anchoring at the east side of the Oil Tanker Berth (hereinafter referred to as "the Anchorage") located on the southwest side of the Senshu Port in Osaka Prefecture, where Kansai International Airport Access Bridge is located about one nautical miles north of the southeast of the 'Kansai International Airport First Stage Airport Island' (hereinafter referred to as "the Kanku Island") for the purpose of typhoon evacuation, under the condition that the Typhoon No. 21 was approaching and the maritime typhoon warning was issued in the Seto Inland Sea including Osaka Bay. In addition, the Vessel continued to anchor at the Anchorage due to the strong wind and waves caused by the approaching typhoon. Besides, once the drifting stopped by using the main engine so the master continued to hold the joystick in</p>

<p>the HOVER position as a result the Vessel was forced to drift down again and collided with Kansai International Airport Access Bridge under the condition that there was no sufficient distance to control the Vessel.</p> <p>It is probable that the reason why the Vessel anchored at the Anchorage, which is located about one nautical miles north of the southeast of the Kanku Island, was that the master thought that Typhoon No. 21 would pass the east side of the Anchorage and the left semicircle of the typhoon would enter the Anchorage, that the typhoon was traveling at a high speed and that strong wind would not blow for a long time, that the area was surrounded by the shore, that the seabed material was mud and the anchor would be highly effective, that other vessels were anchoring at the time of typhoon evacuation, that the next loading was planned to be carried out in the Sakai-Senboku Area of the Hanshin Port, and that he did not know the 2011 leaflet "Let's Prevent Anchor Dragging Maritime Accident ." and did not recognize to anchor avoiding the sea area within three nautical miles from the Kanku Island.</p> <p>It is probable that the reason why the Vessel kept single anchoring at the Anchorage was that the master thought that the double anchoring would be entangled when the wind direction changed and the mooring force would decrease, and that the master had the experience of using the main engine to cope with the typhoon wind.</p> <p>It is probable that the master set the joystick in the HOVER position because he thought that the anchor was stopped when the GPS speed over the ground indicated on the radar became zero, and that the Vessel would move forward if the joystick was in the forward position.</p> <p>It is probable that the reason why the Vessel was drifted down again that, under the situation where the forward thrust was lost due to the dispersion of the propeller thrust while the joystick was kept in the HOVER position, the anchor chain left the seabed with the increase of the water depth due to the high tide, the mooring force decreased, and the wind pressure on the hull and the wave drifting force increased.</p> <p>It is somewhat likely that Hinode Shipping Co., Ltd. and Tsurumi Sunmarine Co., Ltd. were involved in the occurrence of this accident because they did not provide the master with confirmation of the rough anchoring, information on the typhoon and information on the anchorage, and did not discuss the safe operation.</p>

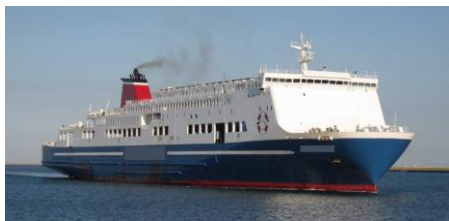
Probable Causes	<p>In this accident, it is probable that the Vessel, in the sea area west of the west exit of the Akashi Strait Passage, drifted to carry out the work of passing over the one passenger (hereinafter referred to as "the Patient"), who were lying in a state of stupor due to convulsions, to the Japan Coast Guard Patrol Craft NUNOBIKI (hereinafter referred to as "the Passing Work") at night, and while the Japan Coast Guard Patrol Craft NUNOBIKI was trying to go to the portside, the Vessel was drifted to the vicinity of the Kantama South Light Buoy due to the current, and collided with the Light Buoy because the Vessel could not secure a safe distance to pass the</p>

<p>Light Buoy.</p> <p>It is probable that the reason why the Vessel could not secure the distance to safely pass the Kantama South Light Buoy when the Vessel was pushed down toward the vicinity of the buoy by the tidal current was as follows :</p> <p>(1) The master of the Vessel was not able to continuously confirm the relative position between the Vessel and the Kantama South Light Buoy, and he did not notice the change in the direction in which the Vessel was being drifted, because he paid attention to the Passing Work. Therefore, he thought that the Vessel might pass through the south side of the Light Buoy, although he was concerned about the proximity to the Light Buoy.</p> <p>(2) The master of the Vessel had been anxious to disembark the Patient as soon as possible because the time had passed since the occurrence of the sudden illness patient, and he was thinking of continuing the Passing Work as much as possible.</p> <p>(3) When the master of the Vessel decided to operate the wing angle in order to obtain forward thrust in order to secure the distance from the Kantama South Light Buoy, he operated the wing angle step by step, because he had concerned about the influence of the rapid operation of the wing angle on the Japan Coast Guard Patrol Craft NUNOBIKI.</p>

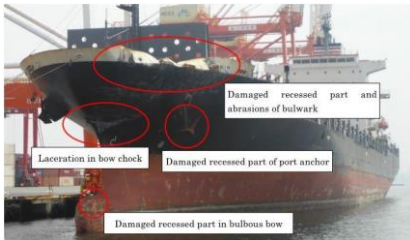
Report	http://www.mlit.go.jp/jtsb/ship/rep-acci/2019/MA2019-7-2_2018tk0005.pdf	
17	Date of Publication	Date and location	Vessel type and name, accident type
	August 29, 2019	June 17, 2017 Off the southeast of Irouzaki, Minamiizu Town, Shizuoka Prefecture	Container ship ACX CRYSTAL (Vessel A, Philippines) Missile destroyer warship USS FITZGERALD (Vessel B, USA) Collision
	Summary	The Vessel A, with a master, a second officer, an able seaman and 17 crewmen on board, proceeding to northeast in the southeast off Irouzaki, Minamiizu town, Shizuoka Prefecture for Tokyo zone of Keihin port, and the Vessel B, with a commanding officer, three watch officers, an able seaman, and 288 crewmen on board, proceeding to south in the southeast off Irouzaki, collided. Seven crews died and three crews were injured on board the Vessel B, which was flooded as a result of having holes and other damage in the starboard midship front shell, and the Vessel A had curve and other damage in the port bow bulwark.

Probable Causes	It is probable that in this accident, at night, in the southeast off Irouzaki, while the Ship A was navigating for the northeast and the Vessel B was navigating for the south, the Vessel B navigated while keeping the course and speed without proper lookout for the Vessel A because the attention was paid to an ocean-going container ship, which navigated parallel in the north of the Vessel A, and the Vessel A navigated while keeping the course and speed, and therefore this accident was caused by the collision of the both vessels. It is somewhat likely that Vessel B, because the fact that the ocean-going container ship approached the starboard bow side of the Vessel B and Radar information of the Vessel A were not surely obtained, paid attention to the ocean-going container ship, which navigated parallel in the north of the Vessel A, and was not properly on the lookout for the Vessel A. It is probable that the Vessel A, because daylight signalling lamp were emitted to the Vessel B and it was expected that the Vessel B would recognize them and avoid the Vessel A, navigated

while keeping the course and speed.	
	Report	http://www.mlit.go.jp/jtsb/eng-mar_report/2019/2017tk0009e.pdf http://www.mlit.go.jp/jtsb/ship/p-pdf/MA2019-8-1-p.pdf , (Explanatory Materials)	
18	Date of Publication	Date and location	Vessel type and name, accident type
	August 29, 2019	July 28, 2018 Sakurajima Port, Kagoshima City, Kagoshima Prefecture	Passenger Ferry SAKURAJIMAMARU No. 18 Collision (quay)
	Summary	<p>The Vessel, with the master and 8 crew members, carrying 171 passengers and 55 vehicles on board, collided with the northeast end of Berth No.4 at the Sakurajima Port Ferry Terminal in Kagoshima City, Kagoshima Prefecture, while approaching the Berth No.4.</p> <p>Two passengers were seriously injured, 15 passengers and two onboard salespersons were slightly injured, and the fender structure on the starboard bow of the Vessel was dented.</p> <p>The Berth No.4 had a defect at the northeast end.</p>

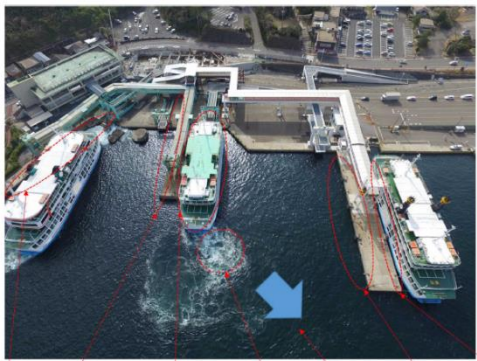
Probable Causes	<p>In this accident, it is probable that, while the Vessel was approaching Berth No.4 of the Sakurajima Port Ferry Terminal under the circumstance where discharging flow caused by propellers of the Consort Vessel at the Berth No.3, flowed from left to right on the course of the Vessel, the bow of the Vessel was pushed to the right by the water flow therefore the master set the propellers on both sides fully astern, but the starboard bow collided with the northeast end of Berth No.4 because he could not stop the coasting of Vessel.</p>

<p>It is probable that the reason why the bow of the Vessel was pushed to the right was that the Consort Vessel was pushing herself against the Berth No.3 by running the propellers on both sides, and the strength of the discharging flow generated from the propellers on the Consort Vessel was stronger than the discharging flow generated only from the propeller on one side, which is the usual way.</p> <p>It is probable that the reason why the Vessel could not stop the force to move her forward was that the master kept the Vessel close to Berth No.4 at a speed faster than the standard speed.</p> <p>It is somewhat likely that the reason why the master kept the Vessel close to Berth No.4 at a speed faster than the standard speed was that the master was accustomed to maneuvering the Vessel to approach Berth No.4 at a speed faster than the standard speed.</p>

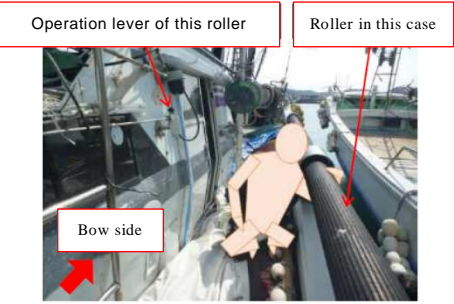
Report	http://www.mlit.go.jp/jtsb/ship/rep-acci/2019/MA2019-8-2_2018tk0010.pdf	
19	Date of Publication	Date and location	Vessel type and name, accident type
	August 29, 2019	September 14, 2018 Off the west of Oshima Island, Amakusa City, Kumamoto Prefecture	Fishing vessel SEIRYOMARU No.3 Injury of a crew member
	Summary	<p>While the vessel with the chief fisherman, the master and 3 other crew members on board, was anchoring off the west of Oshima Island, Amakusa City, Kumamoto Prefecture and was hauling the net, the chief fisherman was caught in a side roller and was seriously injured.</p>

<p>Probable Causes</p>	<p>It is probable that this accident occurred while the Vessel was anchoring off the west of Oshima Island, Amakusa City at night, hauling the net by adjusting the winding of the net with the bow side and the stern side roller for gathering a school of the fish to the bow side and making the bottom of the net flat, the chief fisherman who wore rubber gloves tried to fix the net to the stern side roller while the stern side roller was rotating, and so that the fingertips of the rubber gloves on the left hand were caught between the hauling net and the stern side roller, and then the left arm was got caught in the stern side roller.</p> <p>It is probable that the reason why the chief fisherman tried to fix the net to the stern side roller by himself was because the lifting of the net was proceeding by the stern side roller rather than the bow side roller, and because the bow side of the net became heavy due to the uneven distribution of the fish in the net therefore the crew members except the chief fisherman, who were working to lift the net into the ship by pushing the net to the top of the side roller rotating toward the stern side at the most aft work position, had moved toward the net with the bow side roller.</p> <p>It is probable that the reason why the chief fisherman wore rubber gloves and tried to fix the net to the stern side roller while the stern side roller was rotating was that he was impatient because he wanted to return to the port as soon as possible and secure a pier with good conditions for landing because of good fishing and prolonged operation time, and that he was used to the work.</p>

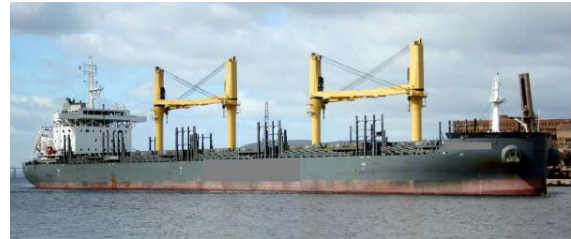
Summary	<p>Under the situation where Typhoon No. 24 was approaching, while being anchored at an anchorage in Yokohama section, Keihin Port, a cargo ship, MARINA, with 12 crew members, including the master, dragged the anchor and drifted toward to the northeast, and collided with the seawall at Ogishima, Kawasaki section.</p> <p>MARINA suffered dents, etc. to her starboard stern. The seawall suffered collision damage, etc.</p>

Probable Causes	<p>It is probable that in the accident, while being anchored in ballast at Anchorage Y1 at the Keihin Port for the purpose of evacuating from the typhoon under the situation where, during nighttime, Typhoon No. 24 was approaching and a typhoon warning had been announced for the northern part of the waters of the Kanto Section, including Tokyo Bay, the vessel dragged anchor when wind waves caused by the typhoon increased because she continued riding at single anchor and that the master set the main engine to full ahead but the vessel could not achieve sufficient forward thrust and drifted toward and collided with the seawall.</p>

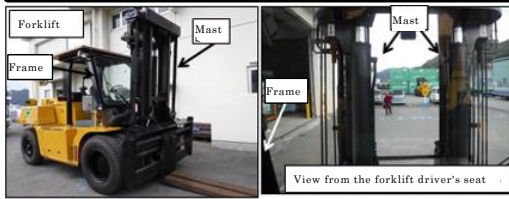
Ship Particulars : Gross Tonnage 2,502 tons, Length Over All × Width 121.00m × 16.50m
 Summary of the accident : While the cargo ferry was unloading at the quay, Officer B jumped out of the sidewalk area near the air blower and contacted the moving forklift.
 Damage : Officer B died of severe chest trauma.

Officer B did not understand that the movement of the forklift and existence of the blind spot from the driver's seat because he was about one month after he got on board.
 The vessel borrower did not provide appropriate education as stipulated in the regulations.
 Officer B did not notice that the forklift was approaching due to the noise from the air blower and other equipment.

Although Worker B noticed that Officer B was near the air blower, Officer B entered the blind spot of the forklift and was traveling at a speed of about 17km/h. He did not notice that Officer B had jumped out of the sidewalk area, and the brake operation was delayed.

- The crew members shall, in principle, walk on the sidewalk area of the vehicle deck during the loading and unloading work using the forklift. They shall also accurately grasp the surrounding conditions and shall not protrude from the shadows of the cargo. [Safety check]
- The forklift operator shall operate the forklift at a speed at which it can be stopped immediately when the forklift operator is travelling on the vehicle deck where a person is present. [Safety check]

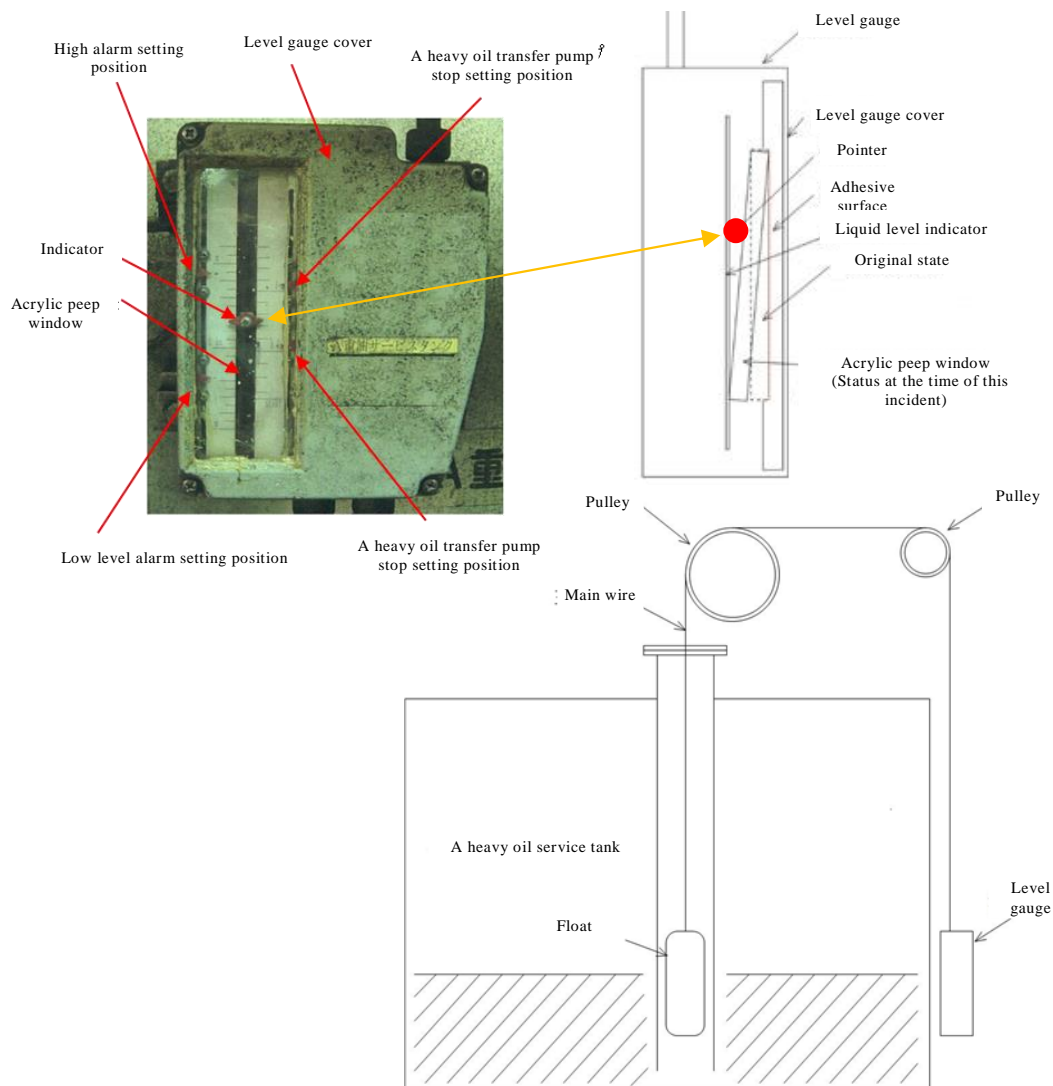
③ Cause of shutdown of the generator

- Acrylic cover installed outside
- level indicator installed independently of pump and alarm

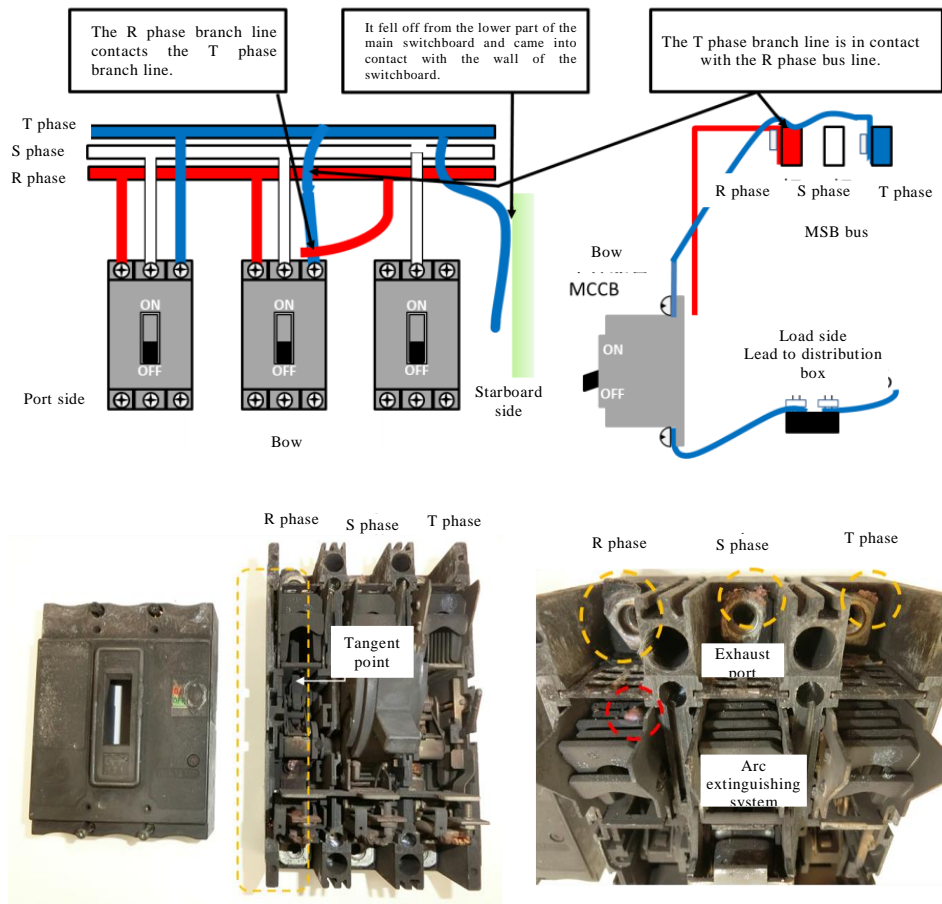
Arc gas was discharged from the molded case circuit breaker for wiring of the main switchboard which had a history that short - circuit current flowed several times due to failure on the load side and short - circuit of the electric circuit, and the bus copper band branch line was blown and jumped off, and the branch line was short - circuited to a branch line of different phase and grounded to the hull.

- MCCB Update
- Review of insulation resistance measurement methods for electric circuit

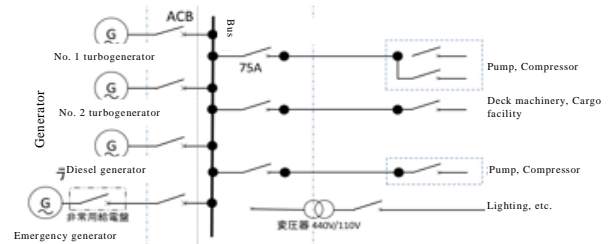
The turbine generator was unable to continue operation due to an misfire in the main boiler, the performance of the diesel generator was degraded due to contamination of the air cooler, and the emergency generator was unable to supply ACB due to an electrical system failure.

The flame of the gas - fired burner of the main boiler is extinguished.

- ✓ Turbo generator cannot be used due to reduced steam pressure
- ✓ Performance degradation of the auxiliary diesel generator
- ✓ Inability to back up emergency generators

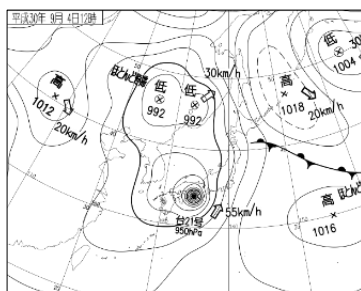
Surface weather chart at around 12:00 on September 4

The Vessel started single anchoring at the anchorage for the purpose of typhoon evacuation.

Around 12:30

(northeast to east-northeast wind, maximum instantaneous wind velocity over 20m/s)

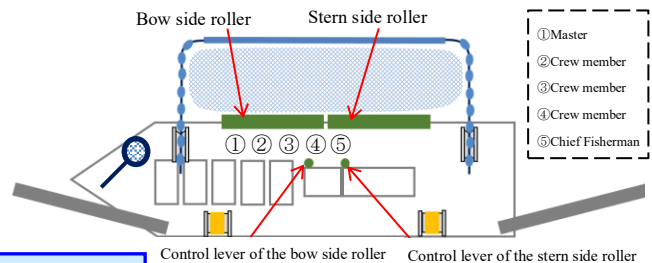
(Image of staffing situation during work)

The fingertip part of the rubber glove of the chief fisherman was caught between the net during hauling and the rotating stern side roller, and then the left hand and the left arm was caught and injured (around 04:30.)

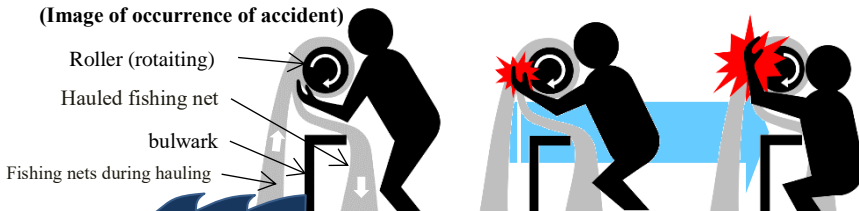
(Image of occurrence of accident)

A school of fish was unevenly distributed on the bow side, requiring manpower for hauling with the bow side roller, and the chief fisherman independently fixed the net to the stern side roller.

Probable Cause (excerpt): It is probable that this accident occurred while the Ship was anchoring off the west of Oshima Island, Amakusa City at night, hauling the net by adjusting the winding of the net with the bow side and the stern side roller for gathering a school of the fish to the bow side and making the bottom of the net flat, the chief fisherman who wore rubber gloves tried to fix the net to the stern side roller while the stern side roller was rotating. As a result, the fingertips of the rubber gloves on the left hand were caught between the hauling net and the stern side roller, and then the left arm was got caught in the stern side roller.

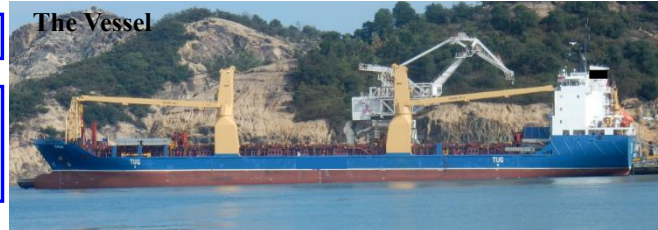
Crew Member D looked at Crew Member A, who came to be in an unstable posture and fell forward, then twisted his body and tried to clutch at the upper hatch coaming of the No. 2 cargo hold with his left hand. However, he fell head-first with his back facing downward to the bottom of the No. 2 cargo hold at around 17:26.

Fell to the bottom of the cargo hold (at around 17: 26)

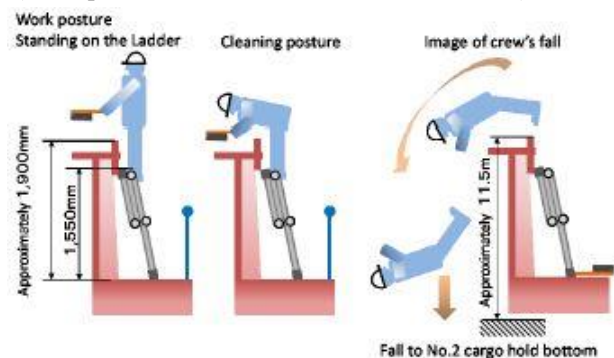
(Work posture on the Ladder and situation of fall)

Probable Causes (excerpt): It is considered probable that this accident at around 17:26 on September 18 when Crew Member A fell forward and fell from the upper deck to the bottom of the cargo hold bottom occurred because Crew Member A was working while being in an unstable posture on the Ladder when the vessel was doing the cleaning work while the vessel was moored at Mitsubishi Naoshima wharf.

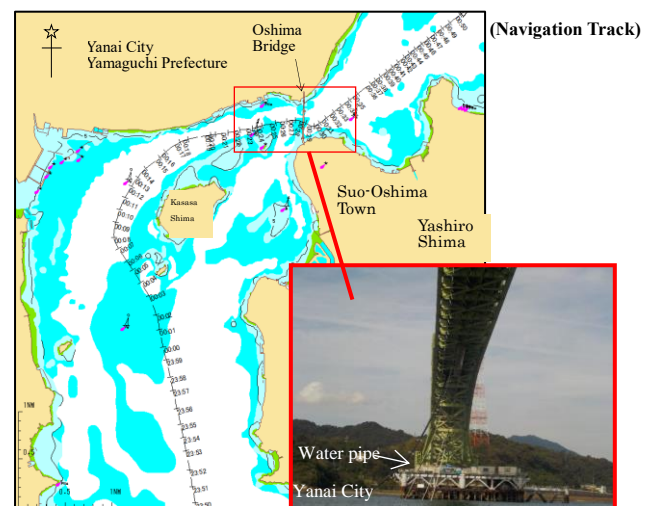
The Vessel received dents and other damage to three of her four cranes as well as a bent damage to her aft mast; however, there were no fatalities or injuries on the Vessel.

Oshima Bridge suffered cracks, dents, and other damage to its girders; an inspection passage that was installed under its girders was broken and fell, and a water pipe was severed, causing a water outage that lasted for forty days affecting almost all of Suo-Oshima Town, Yamaguchi Prefecture; power cables, communication cables and others were severed as well.

Probable Causes (excerpt): It is probable that the accident occurred when, while the Vessel was proceeding east in Obatake Seto at night, the Vessel collided with Oshima Bridge because the Vessel proceeded under a bridge that the Vessel was unable to pass through at the height of crane and mast.
