## Chapter 5 Marine accident and incident investigations

## 2 Procedure of marine accident/incident investigation

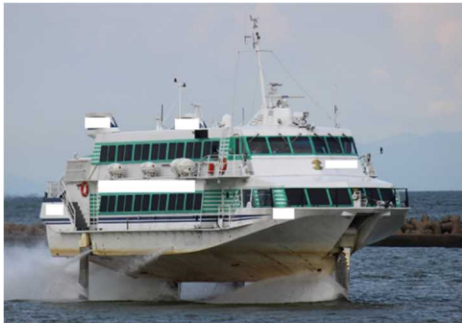
Probable Causes	<p>It is probable that this accident occurred as follows: After GINGA passed the slowdown zone located east off the coast of Himesaki, it accelerated, heading westward in a foilborne state, when the captain observed floating objects in the direction of the port bow (front left side) of the ship. He attempted to avoid a collision with the objects but failed. As a result, the objects hit the rear hydrofoil wing, resulting in lumbar fractures in several passengers.</p>

<p>It is probable that the captain could not avoid the collision despite his maneuvering because when he noticed them for the first time in the front left direction, they had already approached passed an avoidable distance.</p> <p>It is probable that the reason he could not visually identify the objects until they were so close was that they were submerged.</p> <p>Regarding the cause of many passengers' lumbar fractures, it is probable as follows: After the rear hydrofoil collided with the floating objects, the fuse pins fractured, causing the rear hydrofoil to pivot backward from the points where it was attached to the ship's hull. This lowered the stern and at the same time, the rear hydrofoil pulled the ship's body into the sea due to the water resistance against the rear hydrofoil. As a result, the bottom of the ship at the stern impacted the sea surface, generating significant upward and backward acceleration causing a severely impact to the passengers.</p>

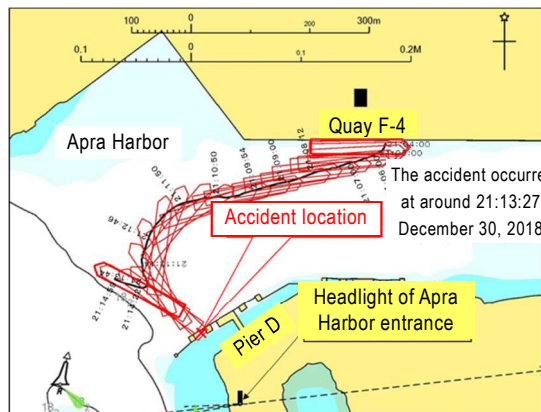
Probable Causes	<p>It is probable that this accident occurred as follows: When the captain steered the NIPPONMARU leftward in the sea area from quay F-4 of Apra Harbor, Guam, he tilted the joystick fully sternward in his attempt to facilitate the left turn although he should have tilted it fully in the starboard direction. Since he continued his full tilt of the sternward and was unaware of his mistake, the ship went astern while its bow was turning leftward causing the stern to collide with the pile dolphin of pier D located opposite to quay F-4.</p> <p>In fact, the captain intended to tilt the joystick fully in the starboard direction but tilted it fully sternward. It is probable that although he was aware that tilting the joystick fully in the starboard direction requires tilting it fully toward the left side of his body while orienting his body toward the stern, he was in a standing position with his body positioned in a different direction from what he was used to. This resulted in him tilting the joystick fully toward the left side of his body while facing astern, and not sternward.</p> <p>It is probable that the captain was unaware of his misdirection because he performed the operation without watching the way his hands controlled the joystick or the outboard display. He did not think that what was reported to him by the navigation officer in charge of the stern indicated an approach toward pier D, and he understood neither the proposals nor advice by a navigation officer supporting ship's handling nor those of the pilot.</p> <p>It is probable that the captain was unaware of his misdirection because he performed the operation without watching the way his hands controlled the joystick or the outboard display. He did not think that what was reported to him by the navigation officer in charge of the stern indicated an approach toward pier D because the ship was turning leftward by means of a side thruster and a tugboat and because he interpreted what the navigation officer in charge of the stern reported to him as evidence of the ship continuing a left turn. In this way, he selectively collected information corroborating what he was thinking was right and therefore was convinced that his handling of the ship was correct.</p> <p>It is probable that the reason the captain could understand neither the proposals nor advice by the support navigation officer or the pilot was that he ignored any information that might disprove what he was thinking to be right.</p> <p>It is likely that the captain believed that he should always be in charge of the handling, undocking and turning around of the ship and recognized that the navigation officer in charge of steering the ship was a newcomer in training. All these factors led to his prioritizing his own judgements rather than heeding the suggestions and advice of the pilot and the support navigation officer, which likely caused his continued tilting the joystick fully sternward.</p>

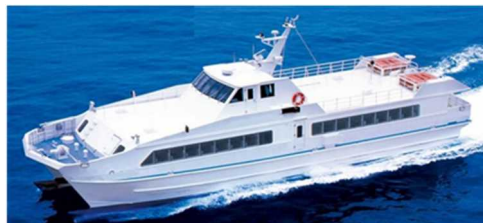
The passenger ship SORA, with the master, the chief engineer, and 29 passengers on board, departed from the Kaijo Access Terminal of Senshu Port, heading north for a pier at the Kobe Airport Kaijo Access Terminal in Hanshin Port Kobe District 5 on July 26, 2017 around 21:29. Then the vessel collided with the Kobe Airport east approach light beacon in Hanshin Port Kobe District 6.

On SORA, four passengers were severely injured, and 21 passengers and two crew members suffered minor injuries. The hull suffered collapses and other damage to the portside bow area. The Kobe Airport east approach light beacon suffered abrasions to the support legs.

There were many injuries, including those who suffered severe injuries. It is probable that many passengers did not wear seat belts.

The collision caused the passengers to be thrown in the bow direction, hitting themselves against the front chairs. It is likely that the chairs that came off the floor contributed to this magnitude of human damage.

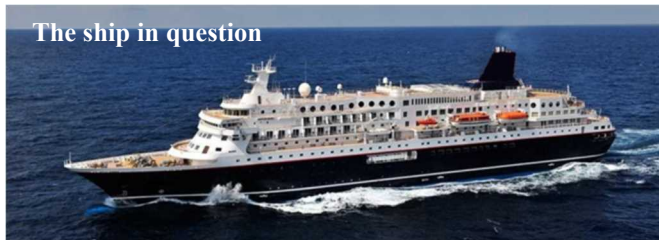
The ship in question

**Collision (at around 21:13:27)**

(Difference between the captain’s recognition of how he was handling the ship and how he was actually handling the ship)

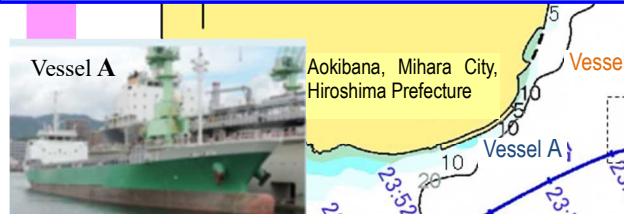
Soon after passing the Koneshima (island) lighthouse, navigation officer A visually confirmed the starboard and mast lights of Vessel B behind Aokibana, Mihara City, Hiroshima Prefecture, in the port bow direction.

Navigation officer A, in an attempt to pass Vessel B by “port-side to port-side” navigation and to secure a safe passing distance from Vessel B near Aokibana, took two right turns at about 2° to 3° each.

Vessel B still did not change course. Navigation officer A felt that was unusual but that the Vessel B would maneuver right sooner or later.

Since Vessel B still did not change course and was now on a collision course with Vessel A, navigation officer A, recognizing the danger, activated the ship’s searchlight (about 15 seconds from collision), switched to manual steering and turned the ship rightward by 30° to 40°.

**Probable cause:** This accident occurred at night at an offshore area west from Sagishima, Mihara City, Hiroshima Prefecture on Vessel A’s northeast route and Vessel B’s the south-southwest route. It is probable that navigation officer A decided to pass Vessel B “port-side to port-side” and continued on near the center of Aoki-seto. Meanwhile, duty officer B felt unsafe about passing Vessel A “port-side to port-side,” so he decided on a “starboard to starboard” maneuver and asked his skipper’s permission for a left turn. He mistakenly thought that permission was granted and continued navigating near the center of the channel. As a result, the two ships collided.

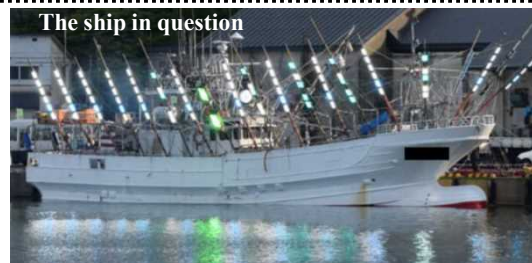
The ship in question

**Probable cause:** Under circumstances in which a high wind maritime alert was issued and a low-pressure system was approaching, the Vessel bound for Hanasaki Port was navigating westward east of Cape Nosappu in the face of winds and ocean waves. It is likely that the lateral waves hitting the port-side oscillated the vessel (causing a maximum expected value of 1/1000), a strong wind blast blew when its port-side (windward side) horizontally oscillated maximally, its tilt moment due to the winds rapidly increased and tilted in the starboard direction in excess of the bulwark submersion angle, causing the starboard bulwark to submerge, thereby capsizing the vessel.

(Conceptual drawing of the impact of wind wave)

In this case, it is highly probable that strong ocean waves caused a horizontal oscillation (269°) equivalent to a maximum expected value of 1/1000, a windblast struck the ship simultaneously with the maximal horizontal oscillation of the portside (windward) and the tilt moment rapidly increased (1.5 times higher than that in the case of a steady wind), which resulted in the rapid capsizing of the ship.

- It is likely that this accident could have been avoided, had the captain decided to return to the port sooner, passing the sea area where the accident occurred before the growing atmospheric depression approached, this accident could have been avoided.
- Therefore, captains should appropriately judge meteorological and hydrographic conditions, and if necessary, decide to return to port early to avoid risk.

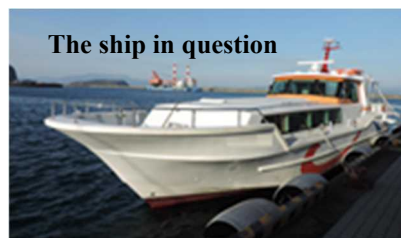
The ship in question

The ship passed the breakwater and lighthouse located at the north of Nejime Port at a speed of about 12 knots. It was navigating north-northwest while being struck tossed upward by tidal waves (1.5 to 2.0 m in height) outside the port. When the ship climbed over an oncoming high wave, the bow lifted, tossing passengers seated in the anterior passenger compartment into the air. When the ship subsequently dropped between the waves, passengers were slammed violently down into their seats.

(Analysis of the accident)

Among 14 injured passengers, 9 suffered spinal fractures and 5 suffered minor injuries.

Those who suffered spinal fractures had been seated in the 1st to 3rd row seats of the passenger compartment. The situation involving the passenger compartment and seats of Vessel A are as follows:

The Japan Transport Safety Board has provided recommendations to the Ministry of Land, Infrastructure, Transport and Tourism. For details, please refer to "Chapter 2: Summary of recommendations and opinions issued in 2020 (page 22).
