Chapter 3 Aircraft accident and serious incident investigations

Aircraft accident investigation reports published in 2021

Aircraft serious incident investigation reports published in 2021

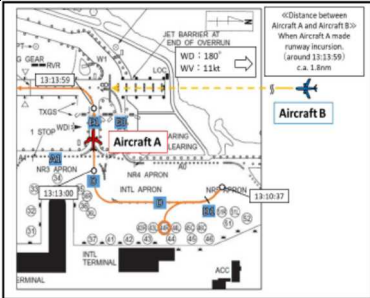
1	Date of publication	Date and location	Operator	Aircraft registration number and aircraft type
	January 21, 2021	July 21, 2019 On runway 18 at Naha Airport	Asiana Airlines, Inc. (Aircraft A)	HL8256 Airbus A321-231 (Large aeroplane)
			Japan Transocean Air Co., Ltd. (Aircraft B)	JA01RK Boeing 737-800 (Large aeroplane)
	Summary	Aircraft A made incursion into runway 18 at Naha Airport without obtaining ATC clearance when aircraft B was on the final approach to the runway after obtaining landing clearance.		
	Probable causes	<p>It is highly probable that this serious incident occurred because aircraft A entered the runway despite of being instructed to hold short of runway 18, when aircraft B, which were cleared to land by the tower, attempted to land at the same runway.</p> <p>Regarding the fact that aircraft A entered the runway, it is probable that when the PIC A received the ATC instruction, he mistook the tower's instruction to hold short of runway as the instruction to line up and wait, and his misunderstanding was not corrected.</p> <p>It is probable that the reason why the PIC A's misunderstanding was not corrected is because the PIC A and the FO A did not cross-check the ATC clearance, as specified in the company A's manual.</p>

Probable causes	<p>In this serious incident, it is probable that aircraft A made an incursion on the runway which aircraft B with landing clearance was approaching on the final course, because the PIC of aircraft A who was waiting on the taxiway in front of the runway misunderstood the departure delay information provided by the air traffic controller as the take-off clearance, failed to listen to the controller's corrective response by reporting the completion of pre-flight procedures immediately after making incorrect read-back, and failed to visually confirm the final approach course.</p>		
	Safety Actions	<p>(1) Major safety actions the 3rd Wing of JASDF took upon occurrence of the serious incident</p> <ol style="list-style-type: none"> 1. Ensured to listen to ATC instructions and clearance, etc. 2. Ensured to perform basic procedures and actions. 3. Revised the reporting procedures in the case of solo flight. 4. Ensured to establish the mutual supplementary system. 5. Reconfirmed the status in which deviations from ATC communications are likely to occur. <p>(2) JASDF notified all the Flight Squadrons of safety information concerning the serious incident, and each Flight Squadron provided safety training according to this information.</p>

Safety Actions	<p>Measures Asiana Airlines, Inc. took to prevent the recurrence of similar accidents</p> <ul style="list-style-type: none"> · Updating the Airport Information and notifying all the flight crew for flight safety. · Changed in Standard Callouts*1 during taxi. · Company campaign for the prevention of runway/taxiway incursion.

<ul style="list-style-type: none"> · Strengthening evaluation standards and line audit procedures for all the flight crew. · Remedial education and training to the flight crew involved in this serious incident. <p>*1 "Standard Callouts" means callouts excluding orders for specific operations like "FLAP UP" from the various callouts for normal operations.</p>		
	Report	https://www.mlit.go.jp/jtsb/eng-air_report/HL8256_JA01RK.pdf		
2	Date of publication	Date and location	Operator	Aircraft registration number and aircraft type
	January 21, 2021	October 3, 2019 On runway 10 of Misawa Airbase	Japan Air Self-Defense Force (Aircraft A)	93-8550 F-2A (Large aeroplane)
			J-AIR Corporation (Aircraft B)	JA216J Embraer ERJ 170-100 STD (Large aeroplane)
	Summary	<p>Aircraft A made incursion into runway 10 at Naha Airport without obtaining ATC clearance when aircraft B was on the final approach to the runway after obtaining landing clearance.</p>

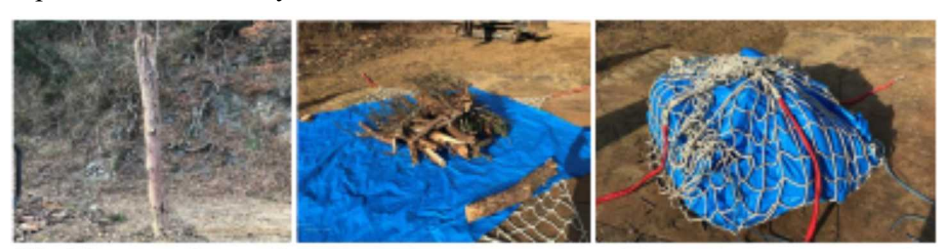
Probable causes	<p>In this serious incident, during the flight at low speed, it is highly probable that some of the dead trees dropped on the fallow field due to the wind pressure including downwash because the measures to prevent the slung dead trees from dropping were not sufficient.</p>		
Safety Actions	<p>On December 9, 2020, the company additionally stipulated in the Toho Standard Operating Procedure the methods for packaging and the procedures to suspend the slinging work to prevent dropping, made it public within the company and implemented the safety education.</p>

<p>Wind the rope at around 1/3 or around 1 m of carried out tree with the root side (thicker side) above basically.</p> <p>Use a blue sheet to prevent branches or trees from coming out of the net.</p> <p>Bind at the four corners of the net in the same way as packaging for general goods.</p>
