Uncontrolled Crash into the Ground with Damaged Tail Rotor by Sling Cable during Cargo Transport Flight

Summary: On Monday October 3, 2011, a Eurocopter AS350B3, operated by Company A, took off from the Karasawa temporary helipad in Kiyokawa Village, Aiko-gun, Kanagawa Prefecture to transport cargos and sustained damage to its airframe during flight. The helicopter crashed into the Choja-yashiki Campground.

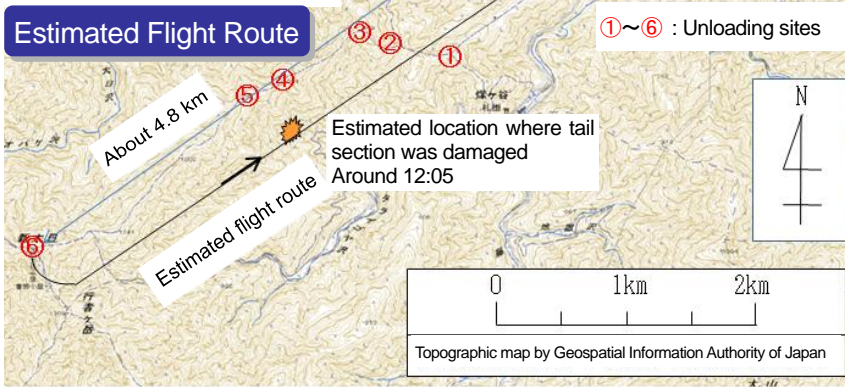
Damage to the Tail Rotor

It is probable that the sling cable contacted the tail rotor, damaging with and damaged the tail rotor and resulting in a loss of the tail rotor thrust.

The mount of the tail gear box was broken by the impact of the contact of sling cable with the tail rotor causing the tail rotor shaft to tilt backward.
