Case 6

Fire occurrence from rear hold during power transmission lines inspection flight led to a forced landing, followed by flames and destruction of the helicopter

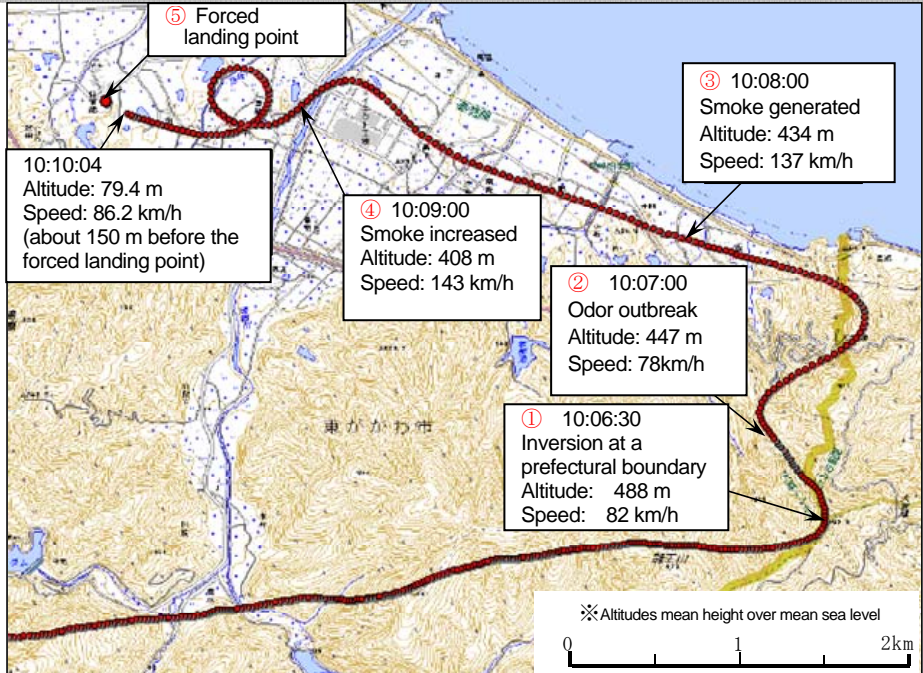
Estimated Flight Route (From Geospatial Information Authority of Japan)

Around 09:23

The helicopter took off from Takamatsu Airport to inspect power transmission lines, and flew eastward while inspecting the power transmission lines located to the south of the Airport, which extended from west to east.

① Around 10:06

The helicopter turned around at the prefectural border with Tokushima Prefecture and headed for another power transmission line extending to the northwest.

② Around 10:07

All members on board sensed a burnt smell in the helicopter. The pilot, who suspected that the smell had come from outside, checked how things were on the ground, but did not see anything unusual, including smoke. At the same time, he suspected a trouble in the electrical system and switched the generator on and off and tried other operations. Since the smell in the cabin continued, he decided to fly back to the airport.

③ Around 10:08

Immediately after the helicopter turned its nose toward Takamatsu Airport, smoke started to rise from near the floor of the rear seats.

④ Around 10:09

The pilot attempted to increase speed and fly to wherever allows the landing, and he decided to land a baseball field.

⑤ Around 10:10

The cabin had been filled with white smoke that made instruments invisible, but it made a forced landing on the field.
