Case 1

A crew member who inhaled chloroform gas while checking the condition inside a cargo tank became unable to breathe and died of hypoxia

Outline: While the chemical tanker which departed from Komatsu Wharf in Sakai-Senboku Quarter Section 7 of Hanshin Port was sailing north toward Osaka Quarter Section 1 of the Port, the second officer was found lying inside No.1 cargo tank on the port side at around 12:29, February 7, 2012. Although rescued, he became unable to breathe due to toxic gas inhalation and died of hypoxia.

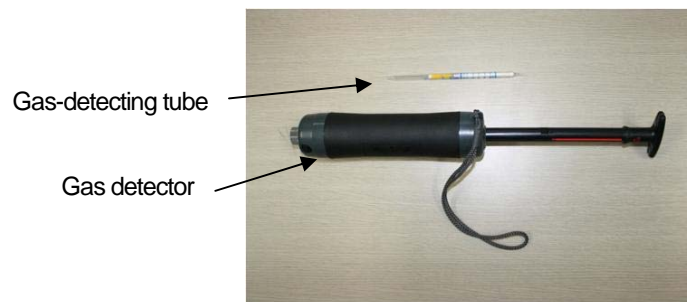
Precautions when entering a cargo tank and instructions on oxygen and gas concentration measurement

1. Concerning the precautions when entering a cargo tank, Company A did not clearly define tank cleaning procedures when washing water was remaining in a cargo tank, although it required making sure of absence of any residual liquid or odor.

Failure to measure oxygen and gas concentration when entering the cargo tank or the ballast pump room.

- (1) The companies should instruct their crew never to fail to implement oxygen and gas concentration measurement when entering enclosed space. They should also visit their vessels on a regular basis to make sure that oxygen and gas concentration measurement has been properly implemented.
