# JTSCB Digests

JTSCB(Japan Transport Safety Board)

## Digest of Marine Accident Analyses

### For prevention of “Fatal and Injury Accidents Caused by Oxygen Deficiency or Gas Poisoning”

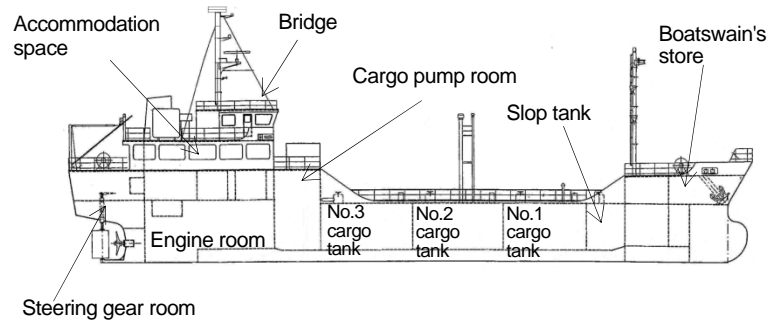
### General arrangement

Sensing a smell of chloroform when 2/O was opening a manhole hatch to check the condition inside portside No.1 cargo tank, C/O told 2/O not to enter the cargo tank, saying that it contained chloroform.

The chief engineer found 2/O lying with his back against the bulkhead inside portside No.1 cargo tank.

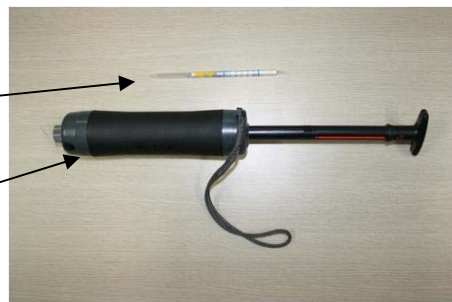
Gas detector

- ◆ It is considered probable that in spite of replying to C/O's instructions not to enter portside No.1 cargo tank, 2/O did not follow the instructions as he found chloroform washing water remaining in the suction well of the cargo tank, and entered the cargo tank on his own judgment to remove the washing water while C/O went to the accommodation space for getting oxygen and gas concentration measuring instruments (portable and pocketable) (hereinafter referred to as "Both Measuring Instruments").
- ◆ According to the findings that Both Measuring Instruments were not available to 2/O when C/O went for them, it is certain that 2/O did not measure oxygen and gas concentration when entering portside No.1 cargo tank.

- (1) The companies should instruct their crew never to fail to implement oxygen and gas concentration measurement when entering enclosed space. They should also visit their vessels on a regular basis to make sure that oxygen and gas concentration measurement has been properly implemented.

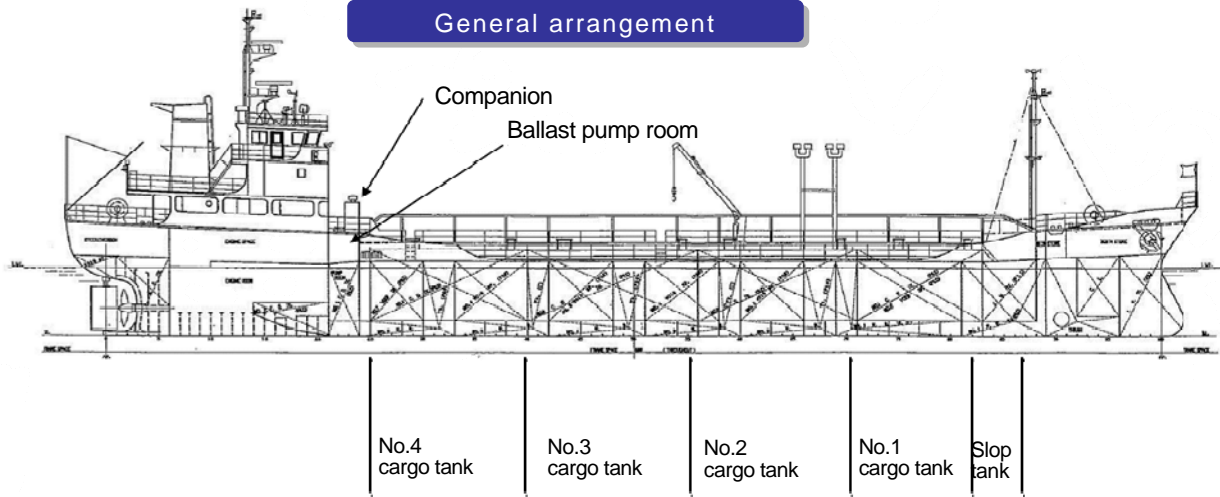
#### General arrangement

Outline: At around 16:40, July 7, 2011, while the Vessel was sailing north toward an anchorage near Umi-Hotaru, an artificial island on the Tokyo Bay Aqua Line, after completing the unloading of about 50 tons of chloroform at a cargo handling pier in Chiba Section of Chiba Port, the first engineer found a wiper lying without consciousness in a ballast pump room. The wiper was rescued, and recovered consciousness.

Entering the ballast pump room to look for the wiper, 1/E found the wiper lying without consciousness near the sea water intake valve.
