JTSB Newsletter

Special edition
Marine Accidents

Japan Transport Safety Board

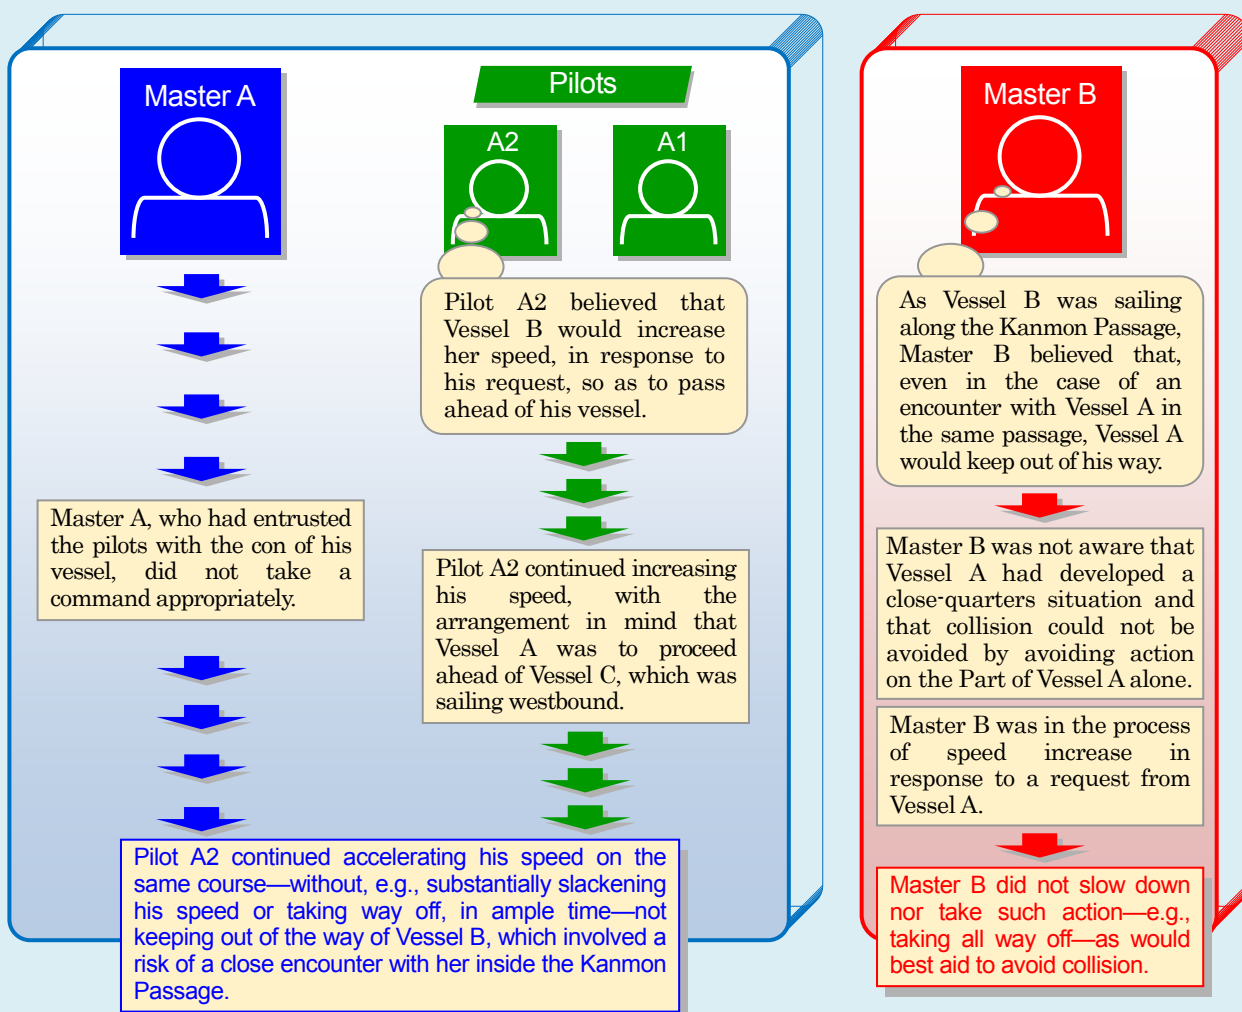
Analysis of coordination on the bridge of Vessel A

As indicated in the analysis of the accident, it is considered probable that Master A did not take the con of his vessel for appropriate shiphandling in this accident. The investigation report says that Master A's not taking the con for appropriate maneuvering is considered attributable to a lack of appropriate advice from the pilots, and the inappropriate use of information on the bridge, together with poor coordination among personnel on the bridge.

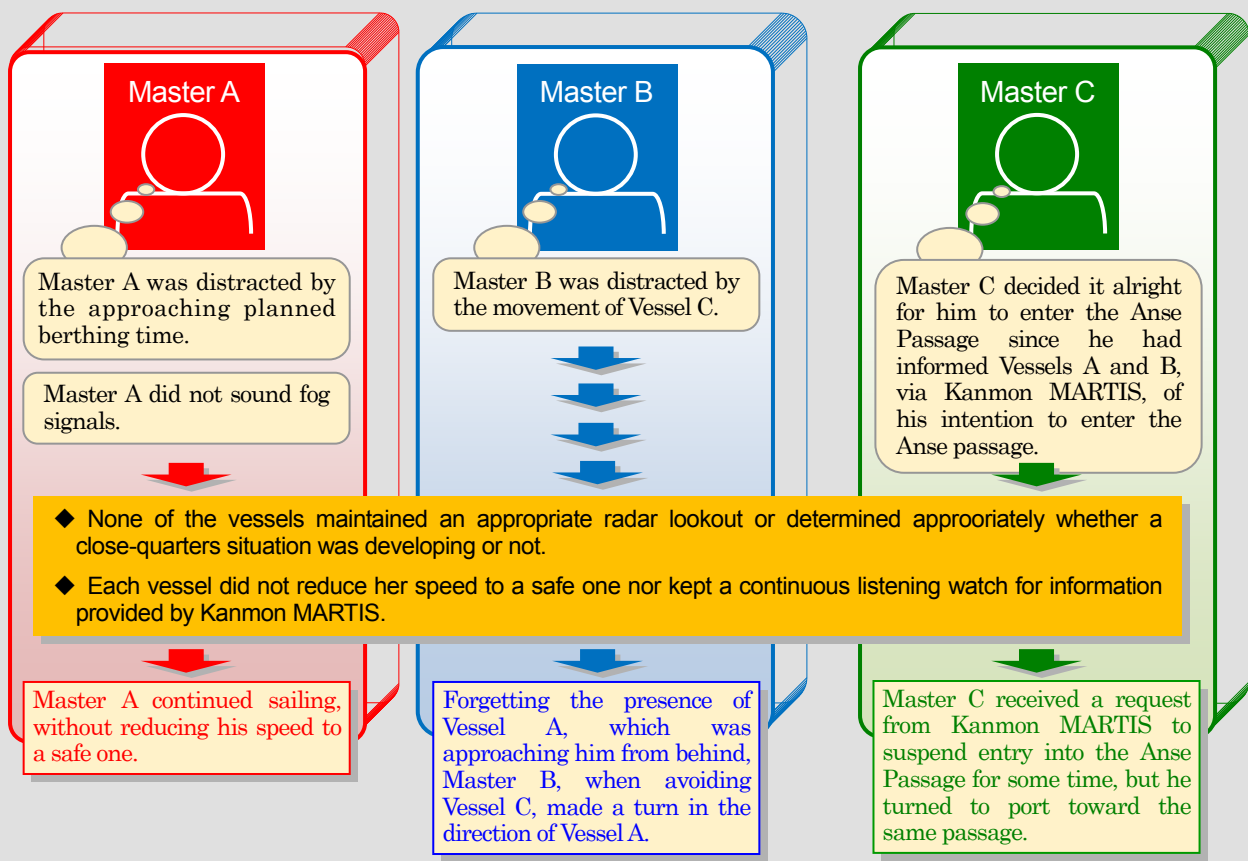
Restricted
visibility
condition

- Each vessel should have determined if a close-quarters situation was developing and/or risk of collision existed. If so, they should have taken avoiding action in ample time.
- Each vessel should have sounded fog signals and proceeded at a safe speed.

- ◆ Kanmon MARTIS provided Vessels A, B and C with information about the movement of each vessel.

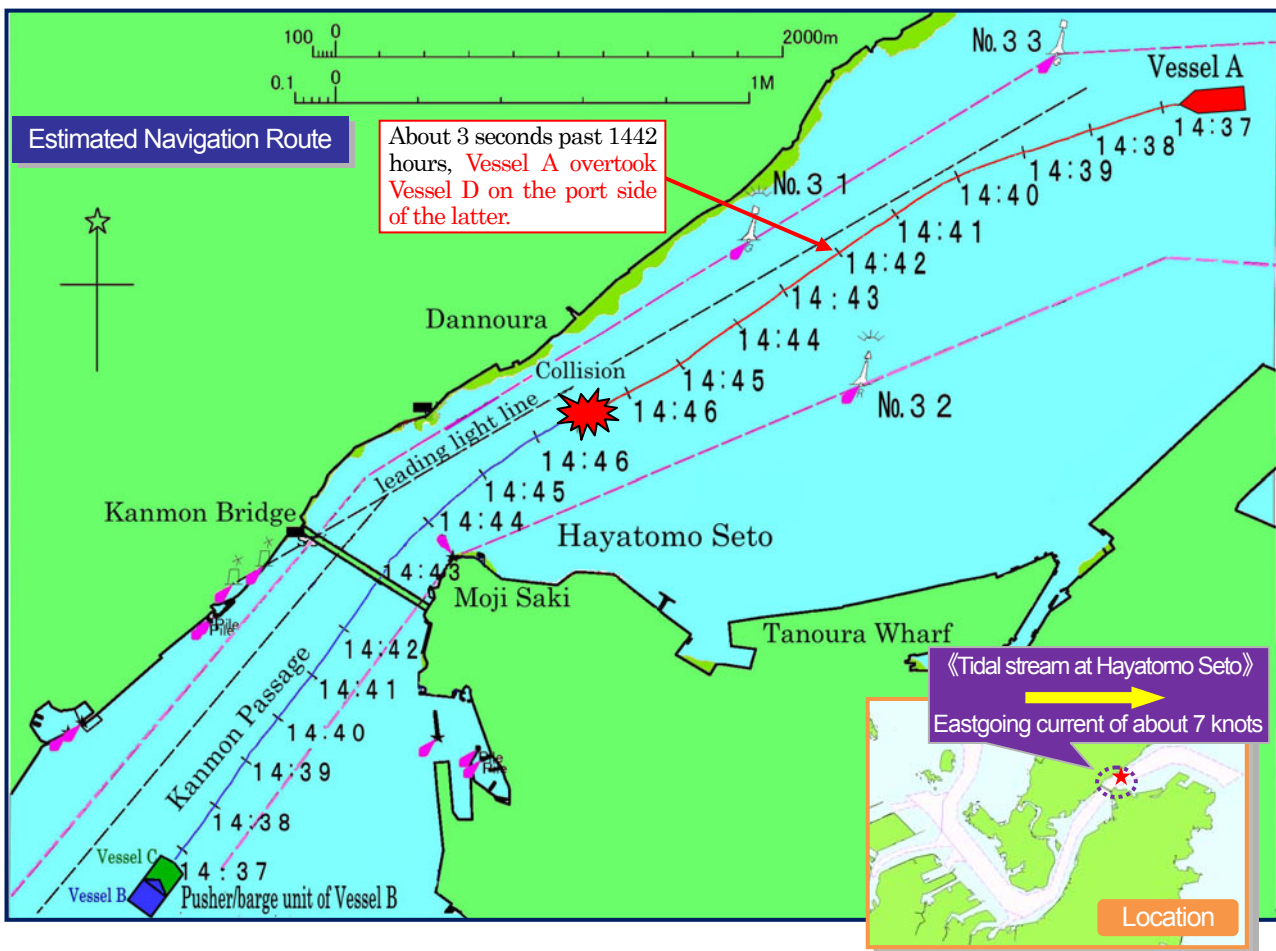
Analysis on navigation rules

In Kanmon Port, vessels are supposed to observe special sailing rules as specified in the Regulations for the Enforcement of the Act on Port Regulations. To Vessel A and the pusher/barge unit of Vessel B, the sailing rules for 'overtaking' and 'keeping to the starboard side' apply. It is considered probable that they did not comply with these rules.

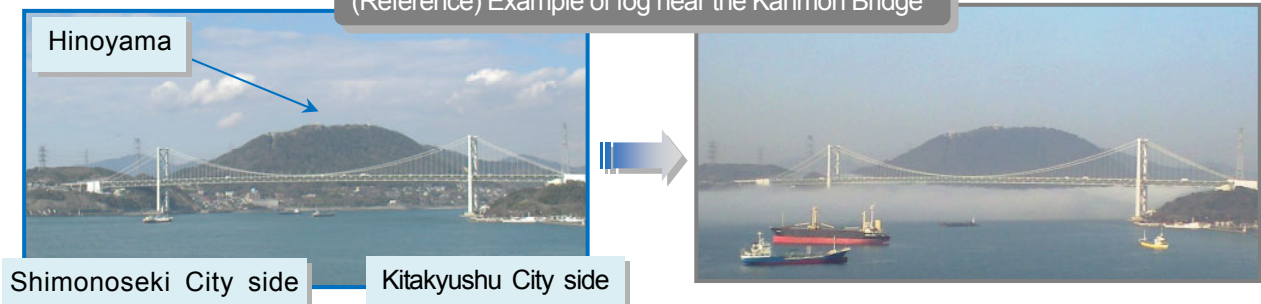
It is considered probable that this accident occurred, in the Kanmon Passage in a restricted visibility condition because of thick fog, as follows: While sailing northeastward and, at the same time, closing to Vessel B from behind, Vessel A lost track of Vessel B on the radar screen when her radar image was covered by that of the Kanmon Bridge; whereupon Vessel A did not slacken her speed; as a result, she drew closer and at the moment when lights of Vessel B were sighted, the latter was at a distance of about 50 m off on the port bow of Vessel A; and, in order to avoid collision, Vessel A turned to starboard.

It is considered probable that: As visibility had dropped to below 1,000 m, Vessel A should have taken shelter at an anchorage in a safe area or other means, by complying with the relevant safety management manual; although, after having observed Vessel B on the radar screen, she continued sailing at such a speed as would bring her closer to the other, she should have slackened her speed to a safe one.
