AI2015-4

**AIRCRAFT SERIOUS INCIDENT
INVESTIGATION REPORT**

**CHINA EASTERN AIRLINES CO., LTD.
B2332
AIRASIA JAPAN CO., LTD.
JA01AJ**

1. CHINA EASTERN AIRLINES CO., LTD.
AIRBUS A319-112, B2332
 2. AIRASIA JAPAN CO., LTD.
AIRBUS A320-214, JA01AJ
- RUNWAY INCURSION
ON RUNWAY 18 AT NAHA AIRPORT
AT ABOUT 13:24 JST, JULY 5, 2012

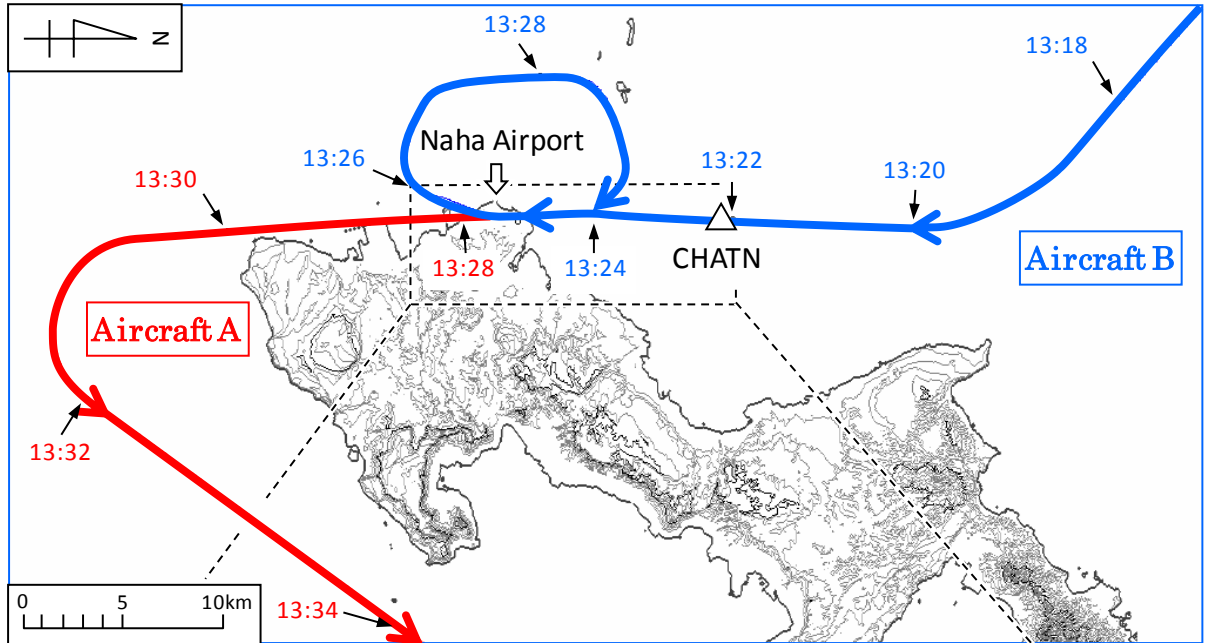
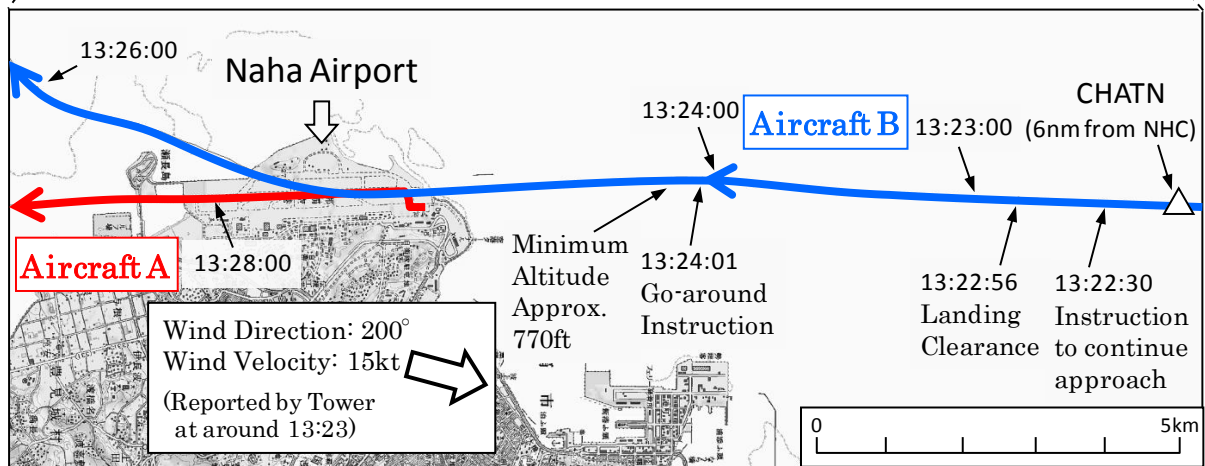
Figure 2: Estimated Flight Route

(See Figure 1: Estimated Taxiing Route, Figure 2: Estimated Flight Route, Figure 3: DFDR Records, and Attachment 1: ATC Communication Transcript)

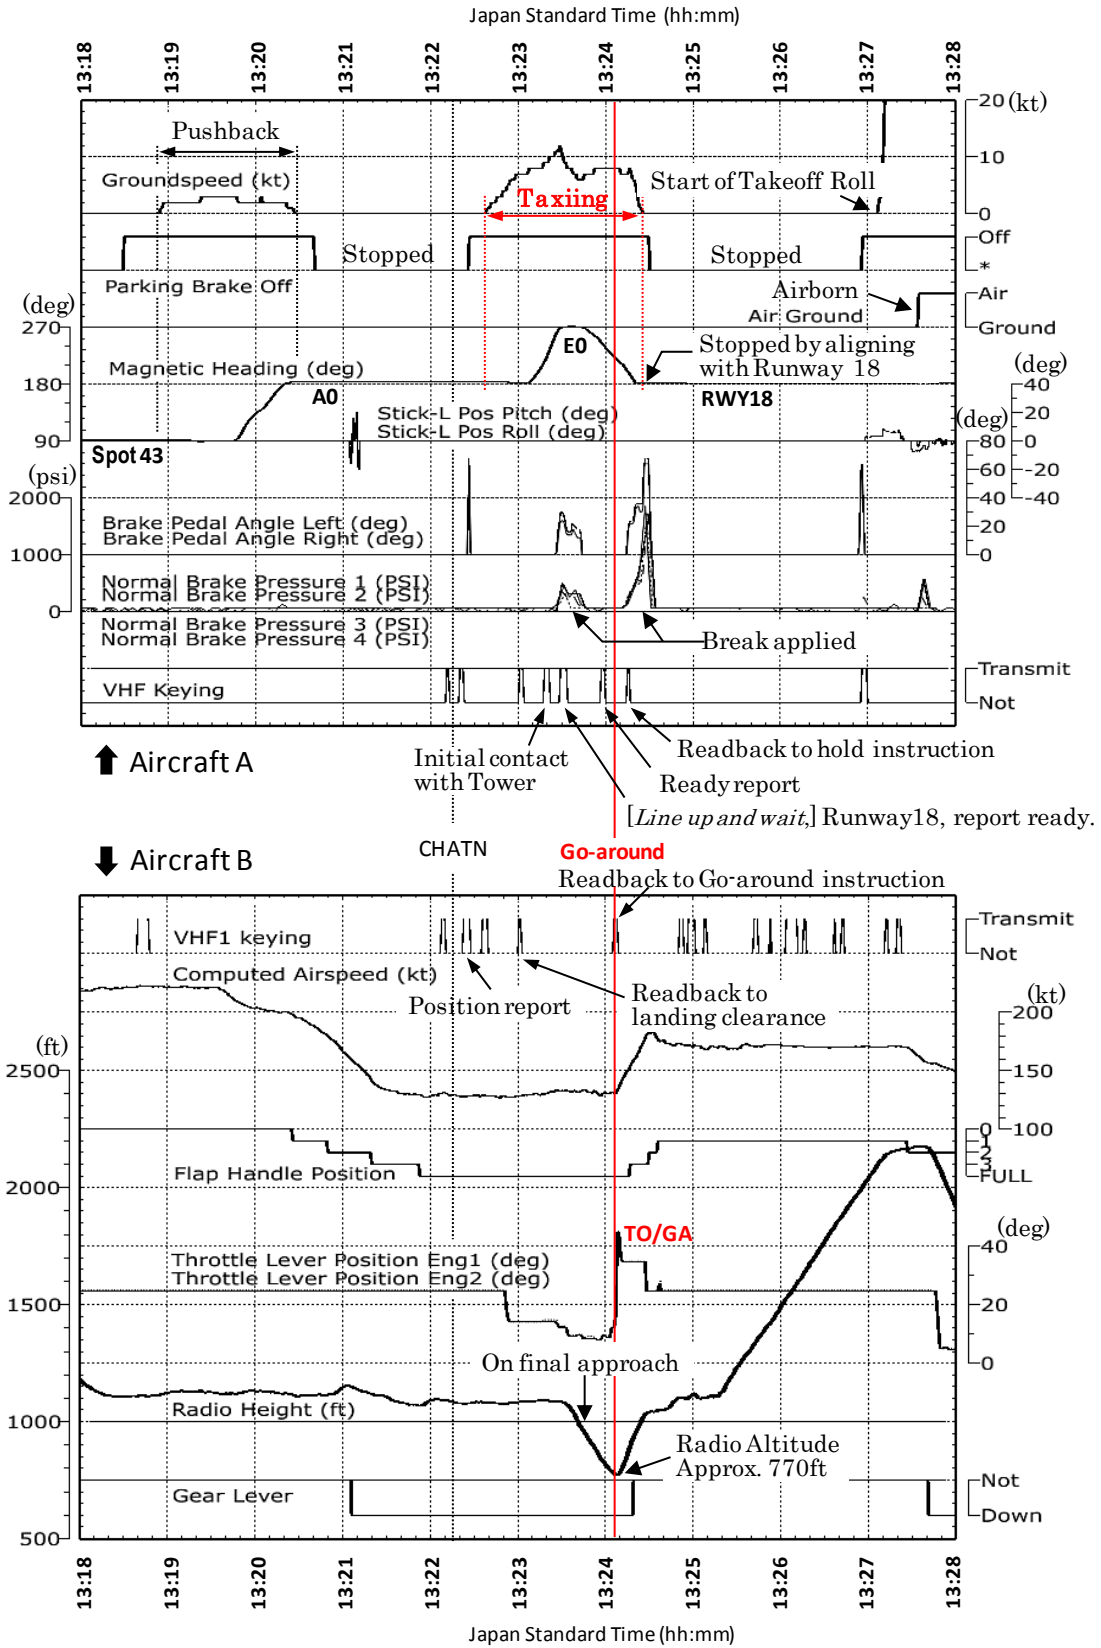
Figure3: DFDR Records

Moreover, according to the DFDR Records in Figure 3, after Aircraft A began taxiing, it gradually increased its taxiing speed and reached 12 kt at 13:23:29, when it had nearly completed turning from Taxiway A0 to Taxiway E0. Starting from immediately before this at 13:23:27, its brakes were applied and at 13:23:41, its speed was reduced to 6 kt. According to the statements of the FO in 2.1.2.1(2), it is probable that this deceleration was to perform the Before Takeoff Checklist before entering the runway. Subsequently, the brakes were not applied, and the speed of Aircraft A was slightly increased to 8 kt as it passed the runway holding position marking; therefore, it is probable that the flight crewmembers of Aircraft A had no doubt about entering the runway.
