**AIRCRAFT SERIOUS INCIDENT  
INVESTIGATION REPORT**

**KOREAN AIR**

**H L 7 2 4 0**

**KOREAN AIR  
AIRBUS INDUSTRY A300B4-600R, HL7240  
AT AN ALTITUDE OF APPROXIMATELY 33,000 FT, OVER THE  
VICINITY OF HIKARI CITY, YAMAGUCHI PREFECTURE,  
JAPAN  
AT ABOUT 19:36 JST, JUNE 23, 2009**

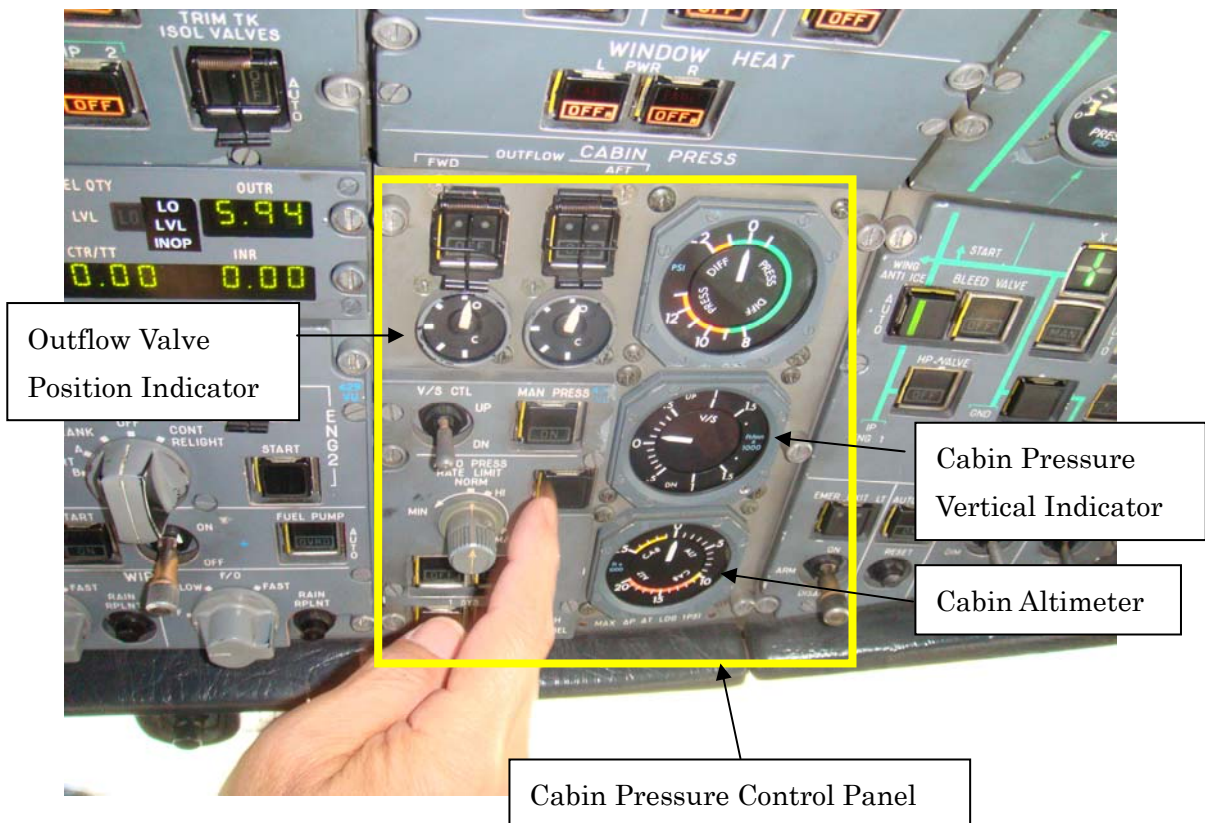
Photo 4 Cabin Pressure Control Panel

descent, the Aircraft's cabin pressurization system returned to normal. Subsequent inspections at Chubu Centrair International Airport and in Korea found no faults in the open/close control system of the outflow valves. The cause of the full-open display of the outflow valves could not be ascertained.

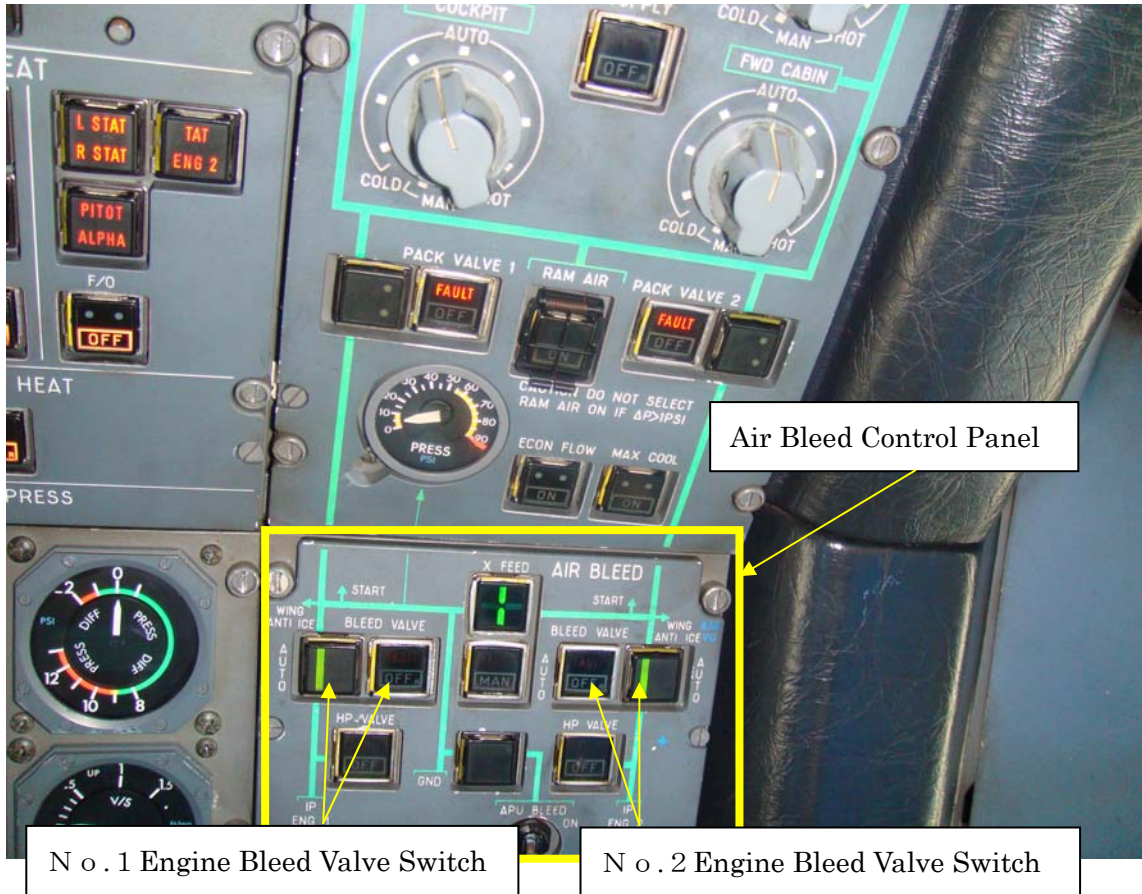
Photo 5 Air Bleed Control Panel

It is considered highly probable that the two AC systems stopped functioning as the failures of the No. 1 fan air valve and the No. 2 pneumatic controller lead to closure of both engine bleed valves.
