**AIRCRAFT SERIOUS INCIDENT
INVESTIGATION REPORT**

**IBEX Airlines Co., Ltd.
J A 0 7 R J**

AIRCRAFT SERIOUS INCIDENT INVESTIGATION REPORT

MULTIPLE MALFUNCTIONS IMPEDING THE SAFE FLIGHT OF AIRCRAFT, BOMBARDIER CL-600-2C10, JA07RJ IBEX AIRLINES CO., LTD. AT AN ALTITUDE OF APPROX. FL 360 OVER ODA CITY, SHIMANE PREFECTURE AT 20:12 JST, APRIL 18, 2022

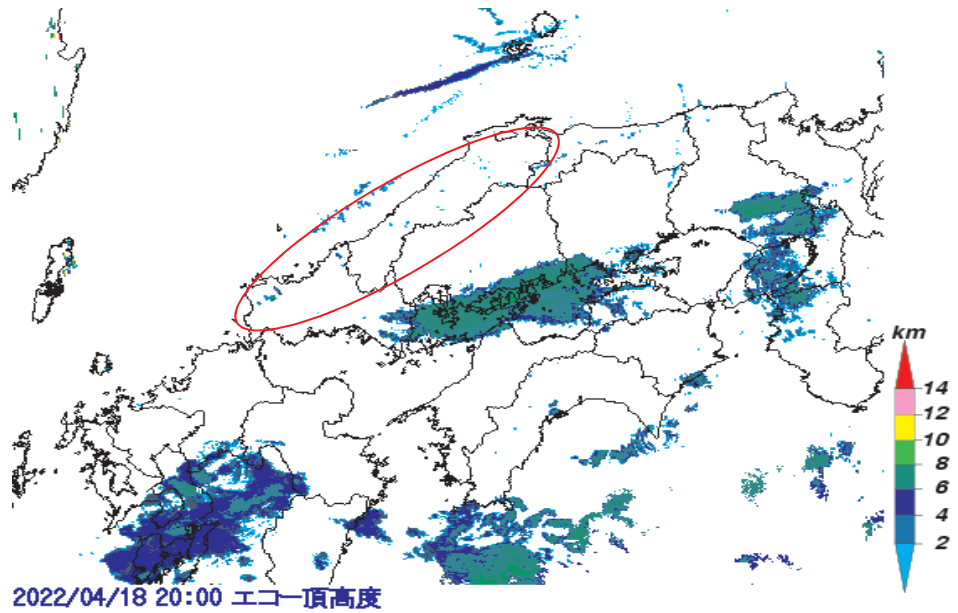
Figure 2: Radar Composite Chart (Echo Top Height)

20:00 Wind direction: 330°, Wind velocity: 2 kt, CAVOK Temperature 14°C; Dew point 11°C; Altimeter setting (QNH): 29.97 inHg	
	(2) Radar Composite Chart (Echo Top Altitude*7) and Domestic Significant Weather Analysis Chart	
	According to the Japan Meteorological Agency's radar composite chart (echo top altitude) at 20:00, the maximum altitude of the echo top altitude in the vicinity of the serious incident site was 8 to 10 km (Figure 2). And according to the domestic significant weather analysis chart at 21:00, jet streams centered at FL 350 and FL 390 were observed respectively on the north and the south in the vicinity of the serious incident site (Figure 3).

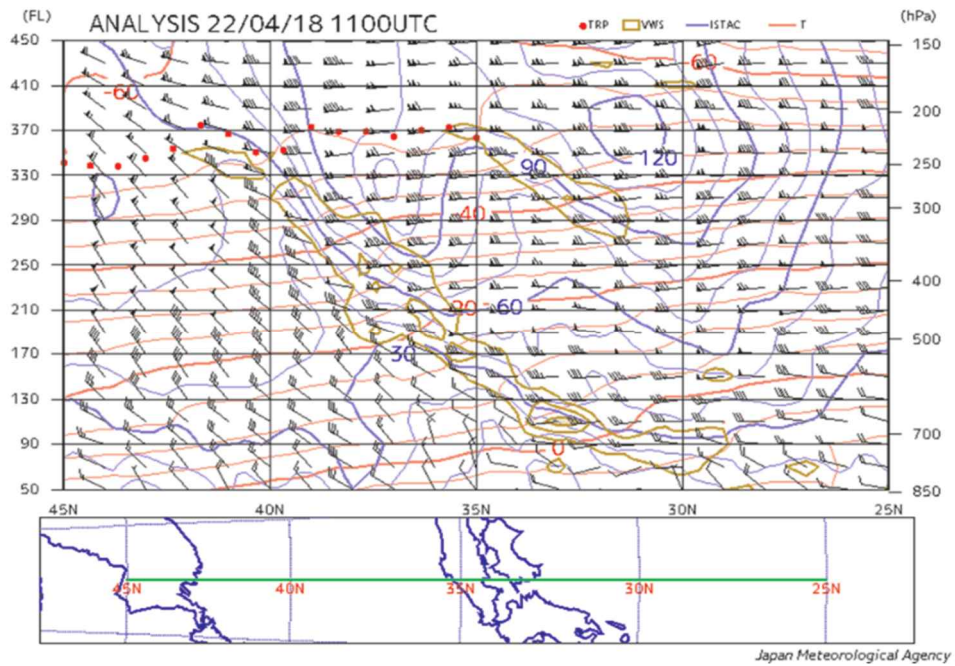
Figure 4: Hourly-Analysis Chart

According to the Japan Meteorological Agency's hourly analysis chart, at 20:00 (JST), the wind direction and velocity at FL 360 in the vicinity of the serious incident site showed a wind at about 100 kt blowing from the west, and FL 360 was the altitude near the tropopause, the boundary between the troposphere and the stratosphere (Figure 4).
