**AIRCRAFT SERIOUS INCIDENT
INVESTIGATION REPORT**

**IBEX AIRLINES CO., LTD.
J A 1 1 R J**

ABNORMAL DECOMPRESSION INSIDE AN AIRCRAFT IBEX AIRLINES CO., LTD. BOMBARDIER CL-600-2C10, JA11RJ OVER OHNAN-CHO, OHCHI-GUN, SHIMANE PREFECTURE FL260 AT ABOUT 18:02 JST, OCTOBER 30, 2019

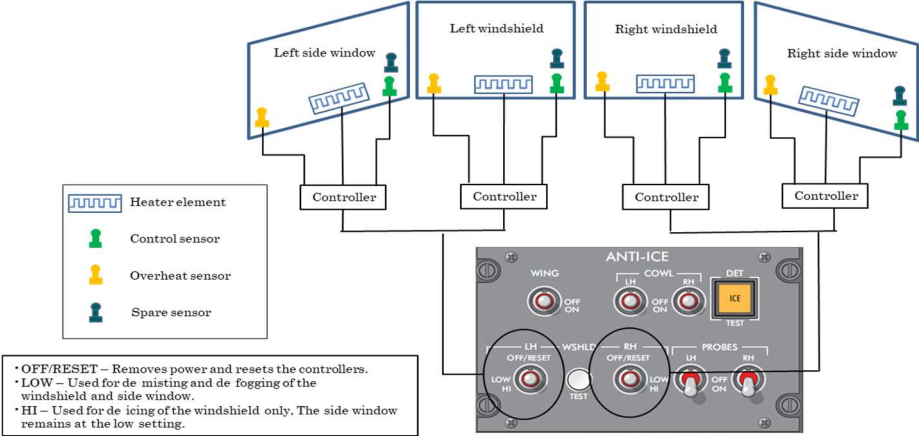
<p style="text-align: center;">Anti Ice Control Panel</p> </div> <p style="text-align: center;">Figure 3: Windshield anti-ice systems</p>

In the upper part of the left windshield, arcing marks were recognized in the heater element layer, but cracks were not recognized in the glass layers.

As for the left windshield and the left side window removed from the aircraft, the investigation on sensors and heater elements was performed according to the AMM, and it was found that only the resistance of the heater element of the left windshield substantially exceeded the reference value, while all functioned normally for the left side window.

The two heater controllers and the anti-ice control panel were sent to a repair shop for investigation, which revealed all functioned normally.

Based on the information obtained through the interview with the PIC, the operator replaced the following parts according to the maintenance actions specified in the AMM established by the Design and Manufacturer of the aircraft.

After the replacement of all the above-mentioned parts, the function test on the windshield/anti-ice systems was performed and all functioned normally.

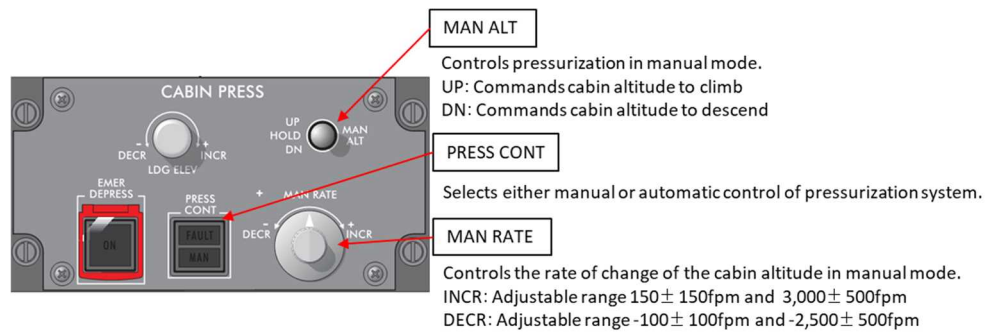
Figure 6: Cabin Pressurization Panel

<p>As the PIC decreased the cabin pressure manually according to the check list, the cabin altitude started to increase.</p> <p>At around 17:58, when the PIC was going to commence descending, EICAS displayed “CABIN ALT” (Caution), which soon turned into “CABIN ALT” (Warning *4).</p> <p>At around 17:59, the PIC commenced an emergency descent according to the check list. Considering the expansion of the crack in the windshield, the PIC had the aircraft descent to 10,000 ft at a descent rate of about 3,000 ft/min so as not to increase the aircraft’s air speed. According to the PIC, at the moment, the cabin altitude was about 12,400 ft.</p> <p>At around 18:02, in an emergency descent, when the Aircraft was at around FL 260 and about 90 km southwest of Miho Airport, EICAS displayed “PASS OXY ON” (Caution) and the oxygen masks in the cabin were automatically deployed. According to the PIC and the FO, at the moment, the cabin altitude was about 14,000 ft, and the differential pressure was 5.2 psid.</p> <p>At around 18:10, the aircraft reached (the flight altitude of) about 10,000 ft over near Iwami Airport and the cabin altitude also reached about 10,000 ft.</p> <p>At 18:21, communicating with Fukuoka Approach, the PIC declared an emergency.</p> <p>At 18:38, the aircraft landed at Fukuoka Airport.</p> <p>This serious incident occurred at around 18:02 on October 30, 2019, over Ohnan-cho, Ohchi-gun, Shimane Prefecture at FL260 (Latitude 34°55'18”N, Longitude 132°32' 27”E).</p>

A cabin pressurization system is usually controlled in automatic mode, but it can be controlled by the pilot in manual mode with the cabin pressurization control panel (Figure 6).
