AA2023-5

**AIRCRAFT ACCIDENT  
INVESTIGATION REPORT**

**Okayama Air Service Co., Ltd. (OAS)  
J A 1 2 3 R**

<b>Company</b>	Okayama Air Service Co., Ltd. (OAS)
<b>Type, Registration Mark</b>	Cessna 172R, JA123R
<b>Accident Class</b>	Aircraft damage due to bird strike
<b>Date and Time of the Occurrence</b>	At about 17:43 Japan Standard Time (JST: UTC+9 hours), December 10, 2022
<b>Site of the Accident</b>	At an altitude of about 150 ft (45 m) about 0.5 nm (900 m) west of Kohnan Aerodrome, Okayama City, Okayama Prefecture (34°35'N, 133° 55'E)

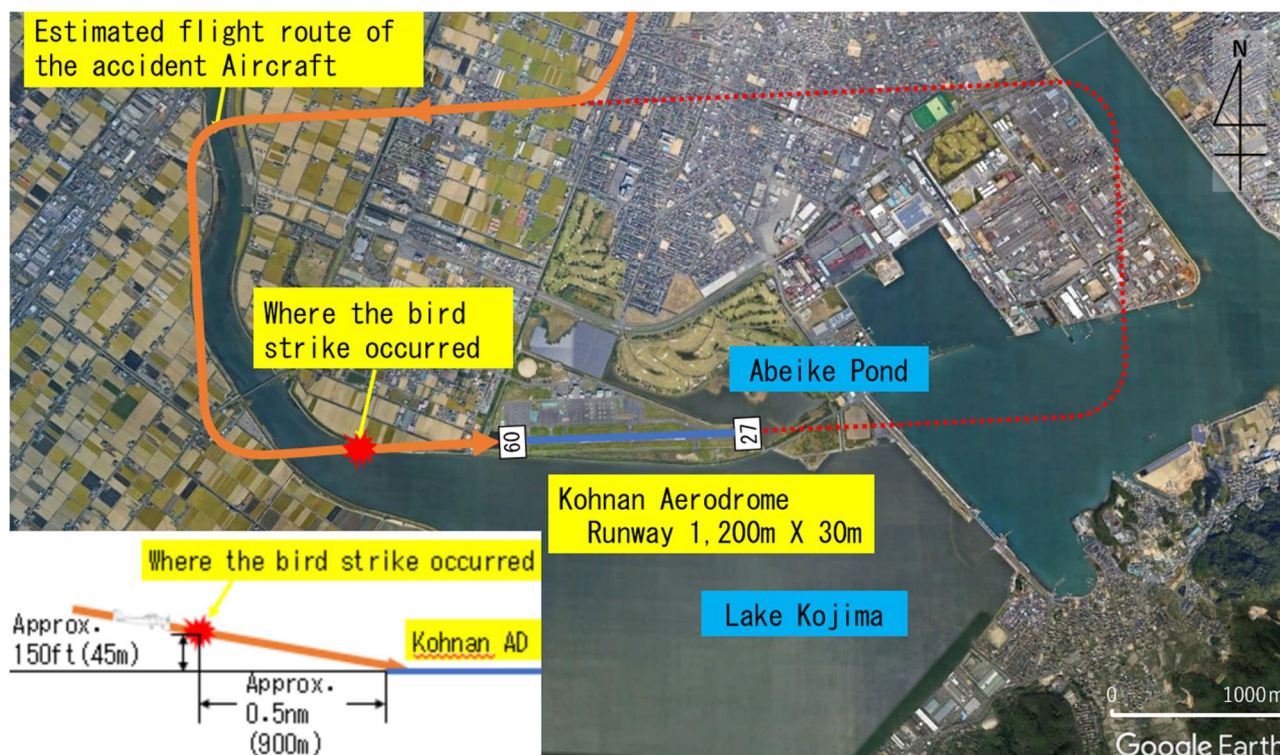
Figure 1: The Estimated Flight Route of the Accident Aircraft

At 17:30, the Aircraft took off from Kohnan Aerodrome for a sightseeing. In the Aircraft, the captain sat in the left pilot seat, the three passengers sat in the right pilot seat and rear seats. The sunset was 16:54 so it was getting dark around the Aerodrome. After flying for about 10 minutes over Okayama City, the Aircraft commenced the approach to Runway 09 via the north side traffic pattern in order to return to the Aerodrome and land there. On the final approach course, when the Aircraft was approaching at an altitude of about 150 ft (45 m) about 0.5 nm (900 m) from the runway threshold with an airspeed of about 65 kt, something like a flock of white birds appeared for a moment in the illuminated range of the landing light ahead, and immediately after that, the captain heard a banging sound as if something collided with the fuselage and felt like the Aircraft having hit something. As there was no anomaly in the flight control of the Aircraft, the Aircraft continued to the approach and landed at 17:45.
