AA2015-5

**AIRCRAFT ACCIDENT
INVESTIGATION REPORT**

**J-AIR CO., LTD.
JA 211J**

**CABIN ATTENDANT INJURY
BY THE SHAKING OF THE AIRCRAFT
J-AIR CO., LTD.
EMBRAER ERJ170-100STD, JA211J
AT AN ALTITUDE OF APPROX. 10,600 FT
OVER ISHIOKA CITY, IBARAKI PREFECTURE, JAPAN
AT AROUND 09:45 JST, APRIL 29, 2014**

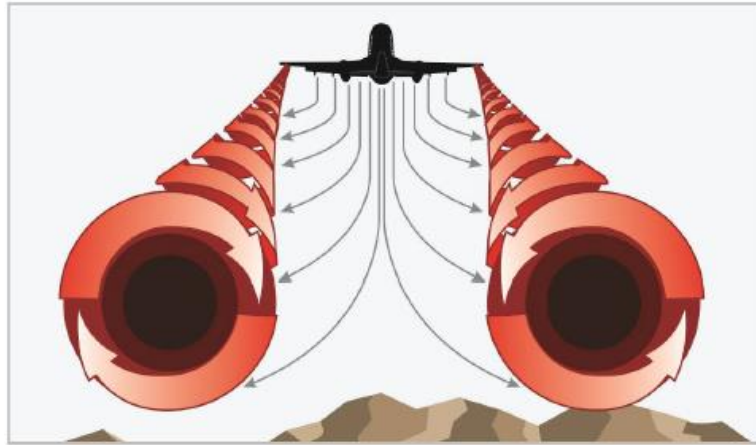
FIGURE 1. THE ROLLUP PROCESS

Lift is generated by the creation of a pressure differential over the wing surfaces. The lowest pressure occurs over the upper wing surface and the highest pressure under the wing. This pressure differential triggers the rollup of the airflow aft of the wing resulting in swirling air masses trailing downstream of the wing. After the rollup is complete, the wake consists of two counter-rotating cylindrical vortices

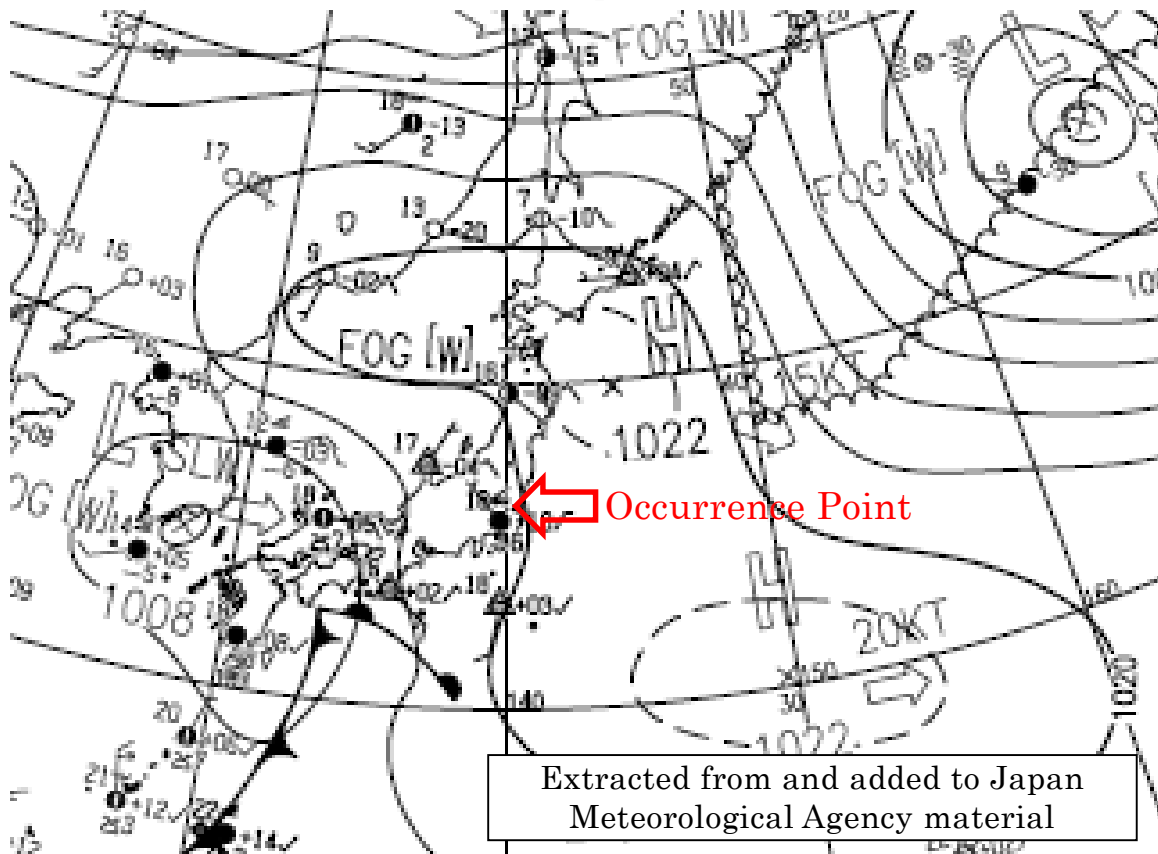
Figure 3: Asia Surface Synoptic Chart (09:00 on April 29)

As described in 2.7, it is highly probable that the meteorological conditions around the accident airspace were that there was no cloud associated with bad weather, calm winds and no atmospheric turbulence.

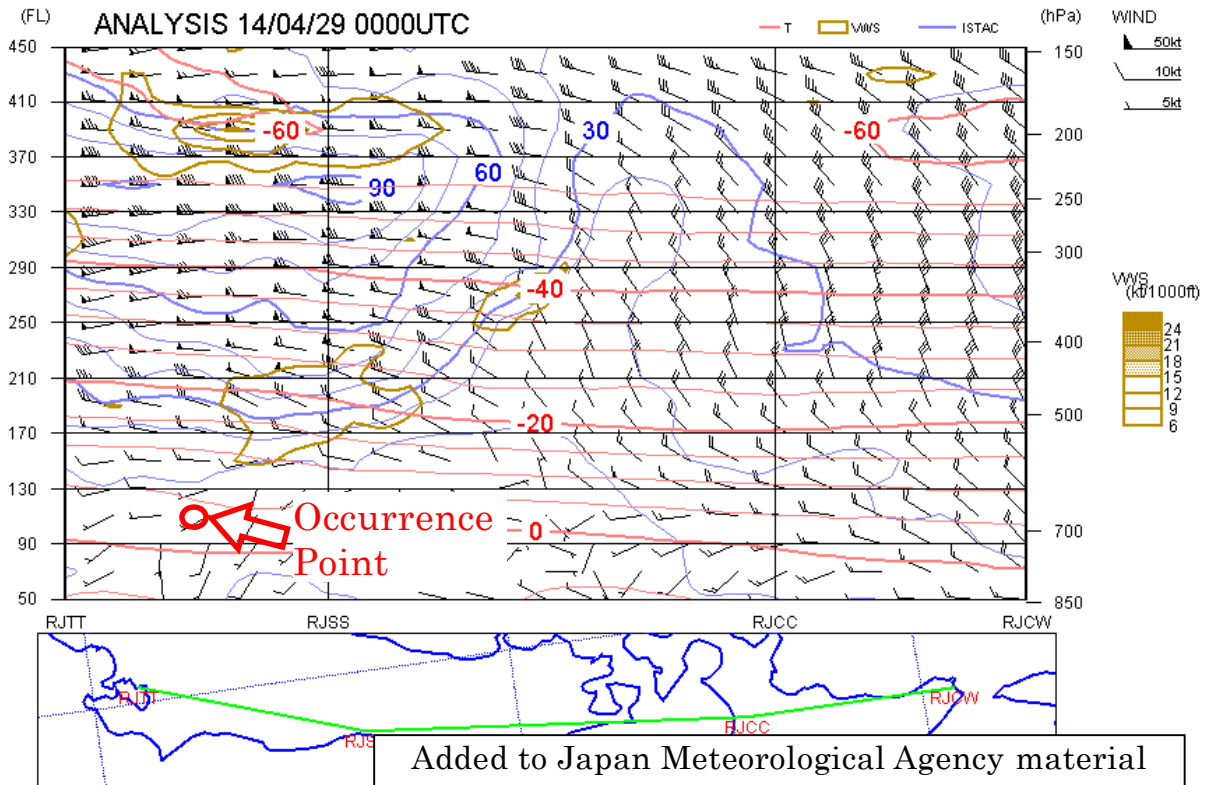
Figure 5: Hourly Atmospheric Analysis Chart
(09:00 on April 29)

As described in 2.11.1, wake turbulence is believed to decay earlier if there is an atmospheric turbulence; however, it is probable that the strong wake turbulence that the Aircraft encountered persisted longer than usual, because of the stable meteorological condition with calm winds in the airspace.
