**AIRCRAFT ACCIDENT  
INVESTIGATION REPORT**

**J A 2 4 0 5**

**February 26, 2015**

CRASH INTO THE MOUNTAIN SLOPE  
PRIVATELY OWNED  
HOFFMANN H-36 DIMONA (MOTOR GLIDER, TWO-SEATER),  
JA2405  
NORTHWEST SLOPE OF A MOUNTAIN 1,903M IN ELEVATION,  
LOCATED ABOUT 1.7KM NORTH OF  
MT. KAMUIEKUUCHIKAUSHI,  
NAKASATSUNAI-MURA, KASAI-GUN, HOKKAIDO, JAPAN  
AT AROUND 11:00 JST, MARCH 15, 2013

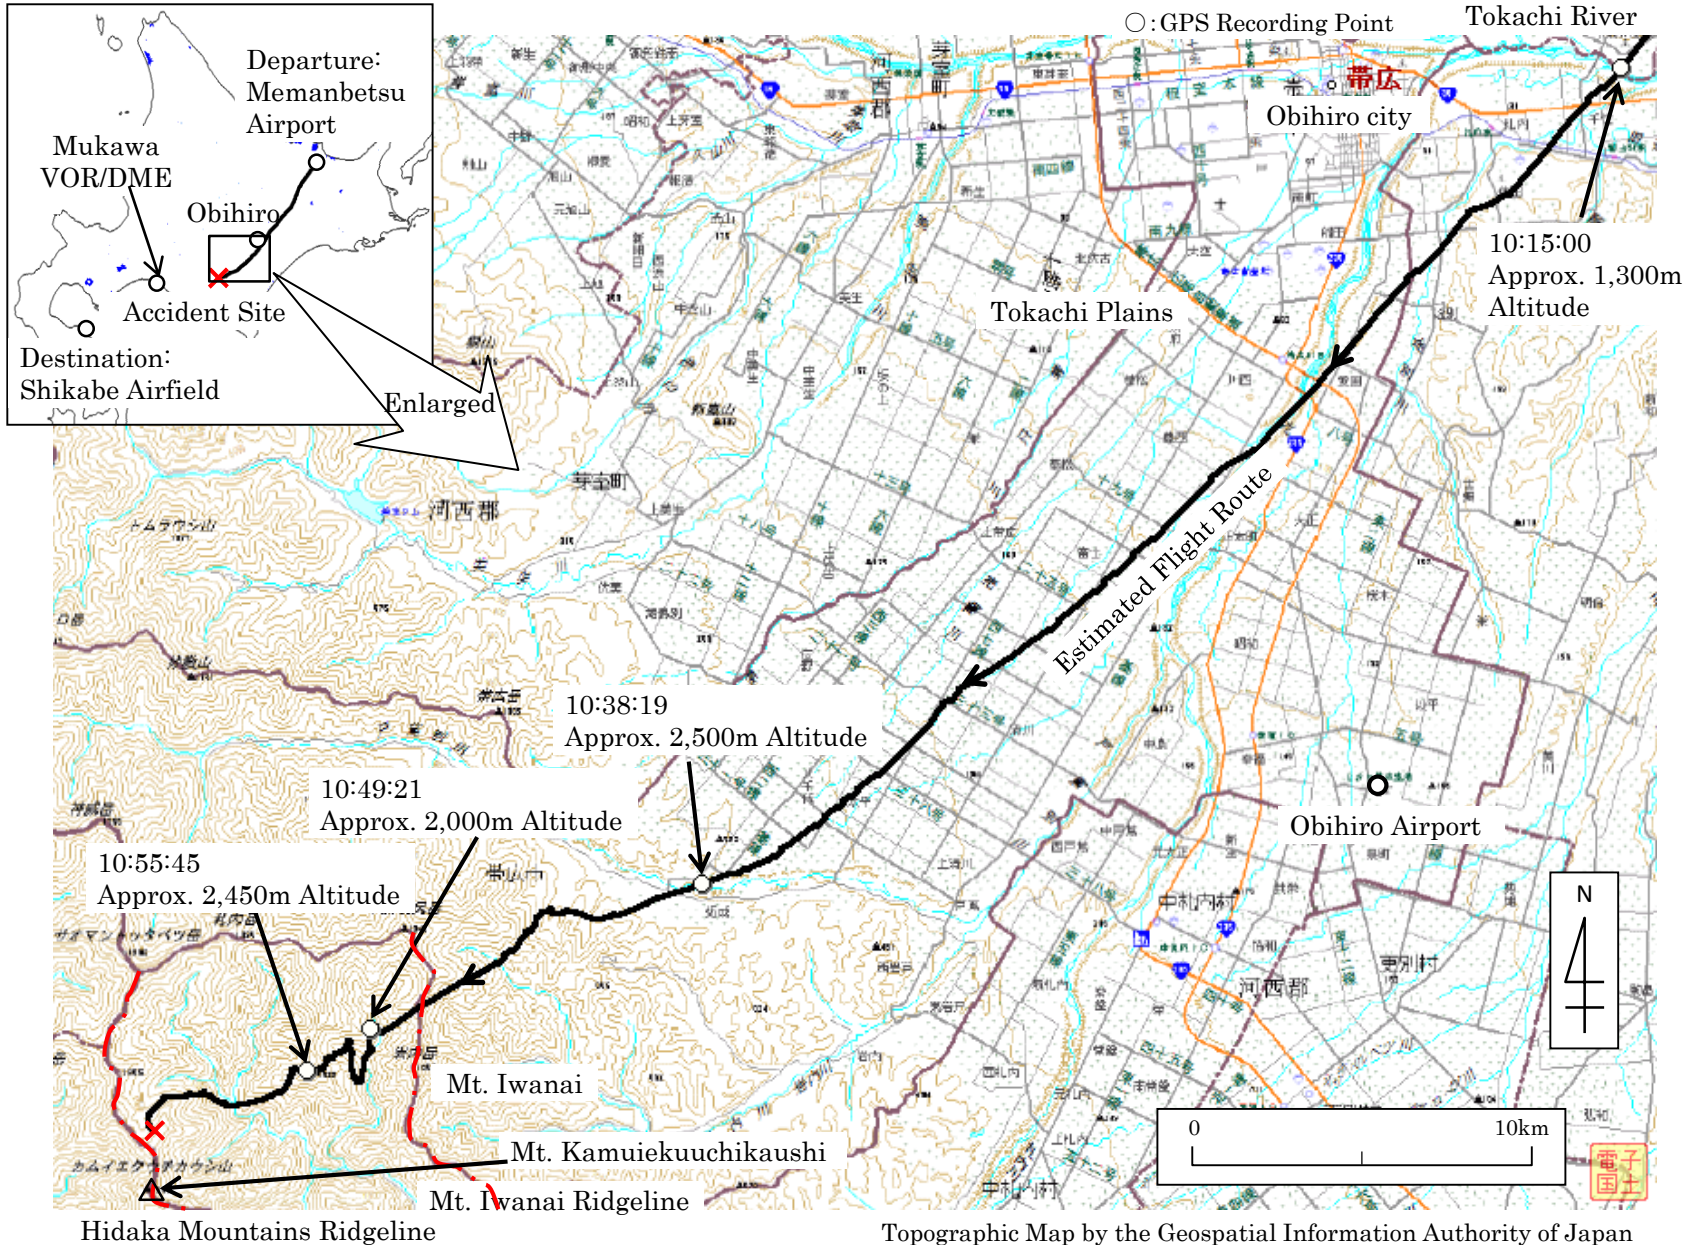
Figure 1: Estimated Flight Route (1)

As shown in Figure 1, the Aircraft took off from Memanbetsu Airport at 09:08 and passed through the east of Obihiro city at 10:15, heading for the Hidaka Mountains. It is highly probable that the Aircraft had been flying a route roughly based on its flight plan.

As shown in Figures 1 and 3, the Aircraft had climbed at 10:38:19 to an altitude of approximately 2,500 m over the southwest of Tokachi Plains. Then the Aircraft had changed its heading to the west-southwest and descended at 10:49:21 to an altitude of approximately 2,000 m while increasing or decreasing its ground speeds.

As shown in Figure 1, the Aircraft climbed from an altitude of approximately 2,000 m at 10:49:21 up to an altitude of approximately 2,450 m at 10:55:45 with a zigzag movement heading in the north-south direction on the west side of the Mt. Iwanai Ridgeline. It is probable that the pilot had climbed again before flying over the ridgeline while flying the Aircraft with a zigzag movement, taking advantage of an anabatic wind (a updraft blowing up along a windward slope) generated on the west side of the Mt. Iwanai Ridgeline.

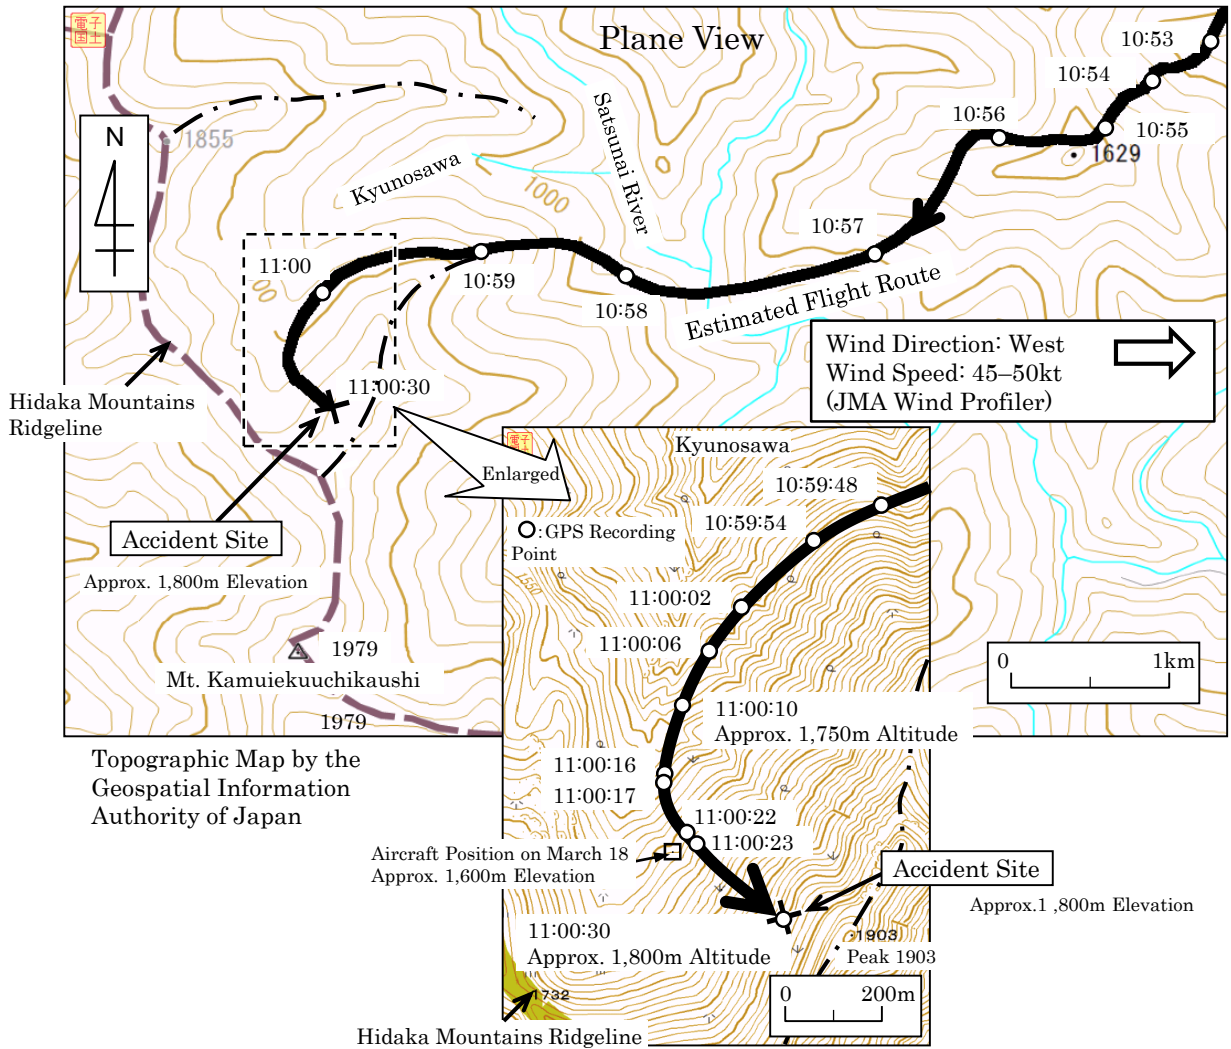
# Figure 2: Estimated Flight Route (2)

As shown in Figure 2 and 3, after reaching an altitude of approximately 2,450 m at 10:55:45, the Aircraft had been flying toward Kyunosawa Valley, while descending to an altitude of approximately 2,100 m until around 10:58 at a nearly constant rate of descent (about 140 m/min). During this period, the ground speed had increased from about 50 km/h to 100 km/h. It is somewhat likely that the pilot thought that the ground speed of 50 km/h was too slow to pass over the Hidaka Mountains at an altitude of approximately 2,450 m; therefore, the pilot had descended with the cruise power setting in order to recover its ground speed in the same way as a previous descent.

As shown in Figure 2, the Aircraft approached Kyunosawa Valley, where the accident occurred, at around 10:59 at an altitude of approximately 2,000 m.

As shown in Figure 2, the Aircraft approached the valley at around 10:59, and then turned slowly to the left along the slope of Peak 1903. At 11:00:10, the Aircraft descended to an altitude of approximately 1,750 m, about the same height as the ridgeline, which was 1,732 m in elevation.

As shown in Figure 2, the Aircraft began to climb at 11:00:10 after having descended to an altitude of approximately 1,750 m. It is probable that the Aircraft evaded from the downdraft near that point. It is somewhat likely that the Aircraft began to climb for the following reason. The downdraft became stronger than the pilot had expected after approaching Kyunosawa Valley and the Aircraft descended below the altitude needed to safely pass over the ridgeline. Then, the pilot turned the Aircraft to the left to try to climb again, taking advantage of an anabatic wind generated on the windward side of Peak 1903.

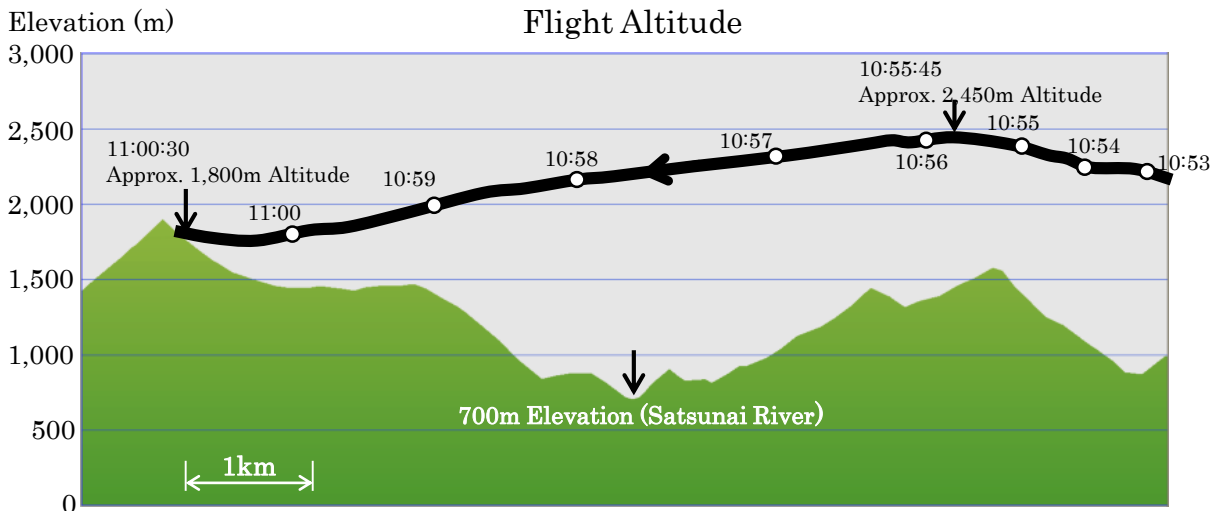
# Figure 3: Flight Altitudes and Ground Speeds

It is probable that if the situation when the Aircraft began descending had continued, it would have maintained at the ground speed of about 100 km/h after 10:58. As shown in Figure 3; however, the Aircraft descended at a constant rate of descent from around 10:58 to 10:59, and its ground speed decreased rapidly from about 100 km/h to 40 km/h.
