AA2023-4

**AIRCRAFT ACCIDENT
INVESTIGATION REPORT**

PASSENGER INJURY BY THE SHAKING OF THE AIRCRAFT STAR FLYER INC.

AIRBUS A320-214, JA24MC
AT FL 280 OVER KURASHIKI CITY,
OKAYAMA PREFECTURE, JAPAN
AT ABOUT 19:48, JANUARY 16, 2022

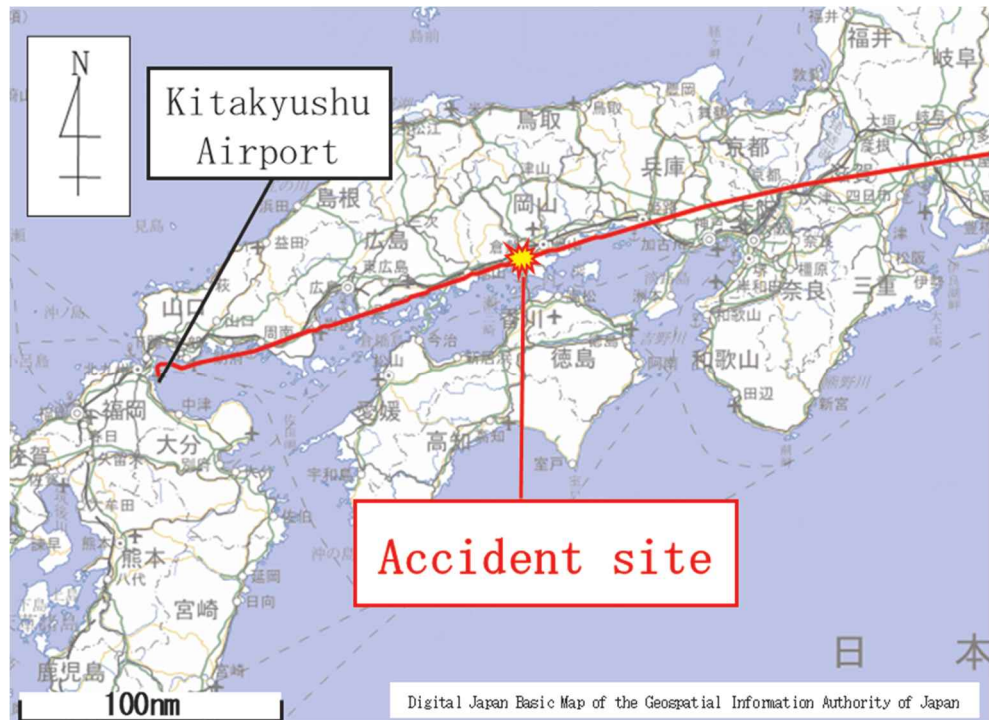
Figure 4: Estimated flight route

This accident occurred about 19:48, on January 16, 2022, at FL 280 over Kurashiki City, Okayama Prefecture (Latitude 34°34' 49" N and Longitude 133°49' 38" E).

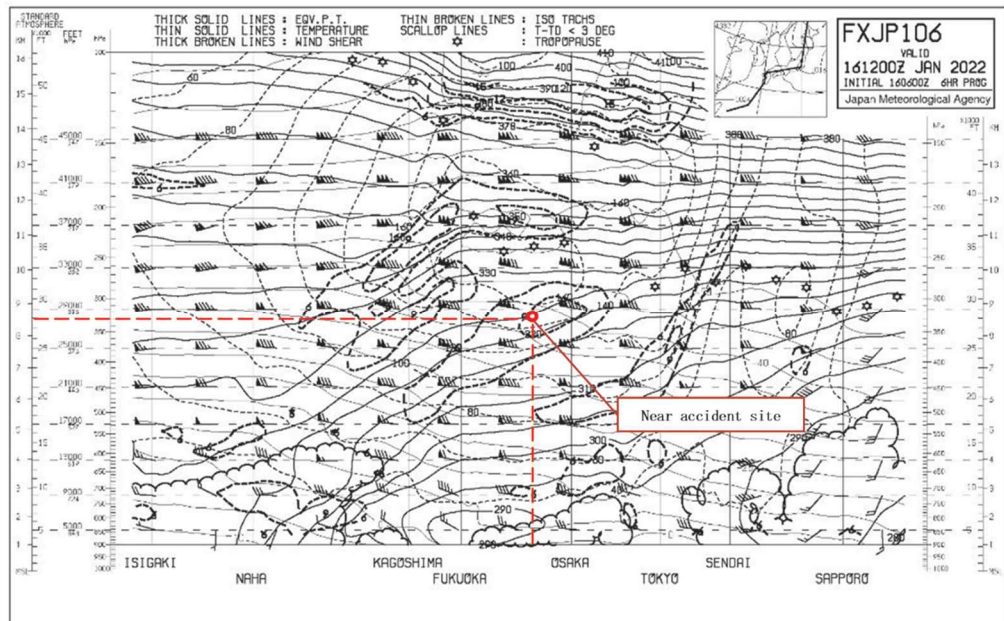
Figure 6: Domestic Air-route Forecast Cross Section Chart (FXJP106)

of 9-12 kt/1,000 ft was forecast at FL260 to FL290 in the vicinity of the accident site.

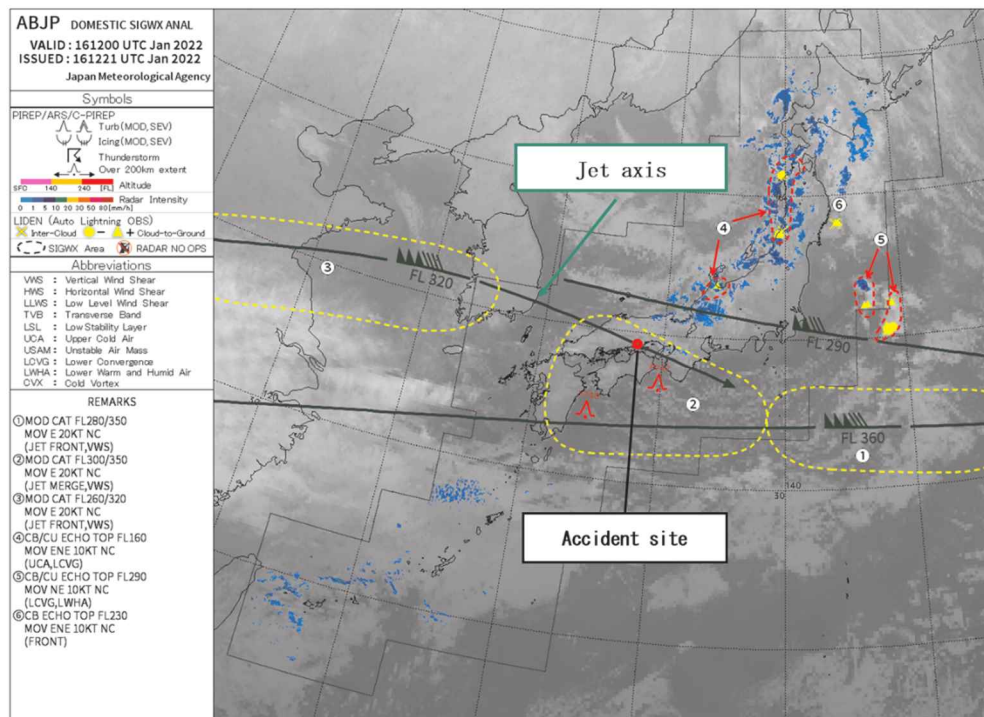
According to the domestic significant weather analysis for 21:00 on January 16, 2022 (Figure 7), issued by the Meteorological Agency, there was jet stream with the jet axis of 190 kt at FL 320 from San-in through Kinki regions.
